NUMBER: 08-079-20

DATE: September 4, 2020

UGQ Radio Enhancements

2018 - ****2020**** (JL) Jeep Wrangler

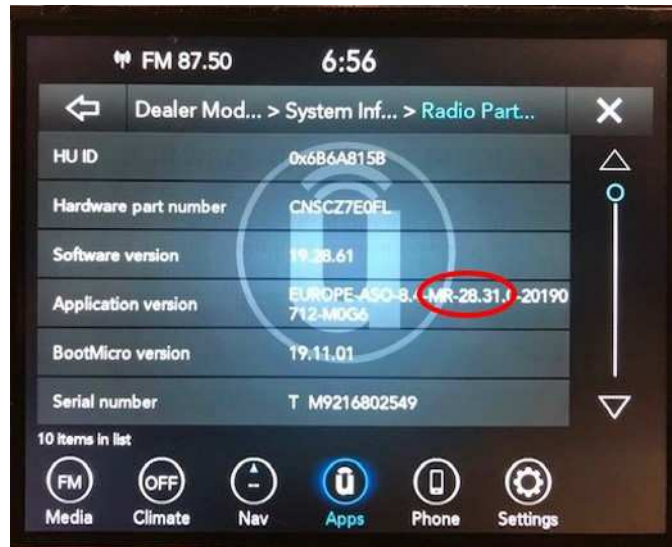
Fig. 1
Radio Software Level Screen

1. Verify the radio software version. Radio must be in Dealer Mode to verify by following these steps:
 - a. Push and hold the front defrost, driver temperature up and temperature down buttons simultaneously until the 'Dealer Mode' screen appears (approximately seven seconds). Release buttons.
 - b. Select "Radio Part Information". The software version will be listed next to "Application Version" (Fig. 1) .

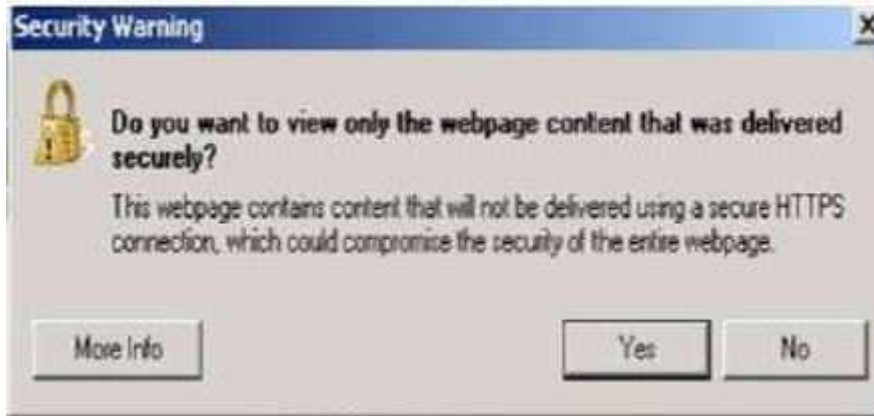
Fig. 2
Pop-Up Security Message

2. Go to DealerCONNECT>Service>Uconnect Command Center>Uconnect>More Information >Dealer software downloads to download the files.
3. If a security message appears “Do you want to view only the web page content that was delivered securely?” (Fig. 2) . Press “No” to continue.

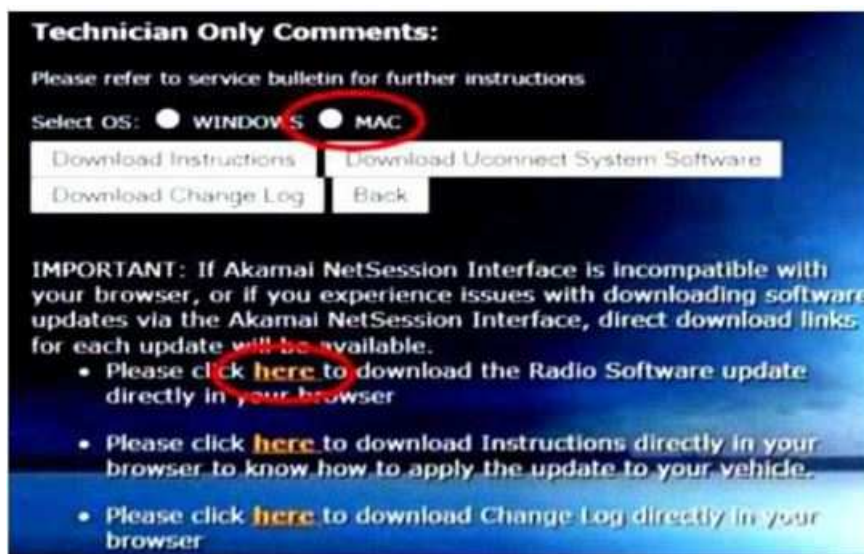
Fig. 3
MAC Download Steps

5. Download the software update file to your local PC’s desktop. Make sure to select the “MAC” radial button for all downloads (Fig. 3) .

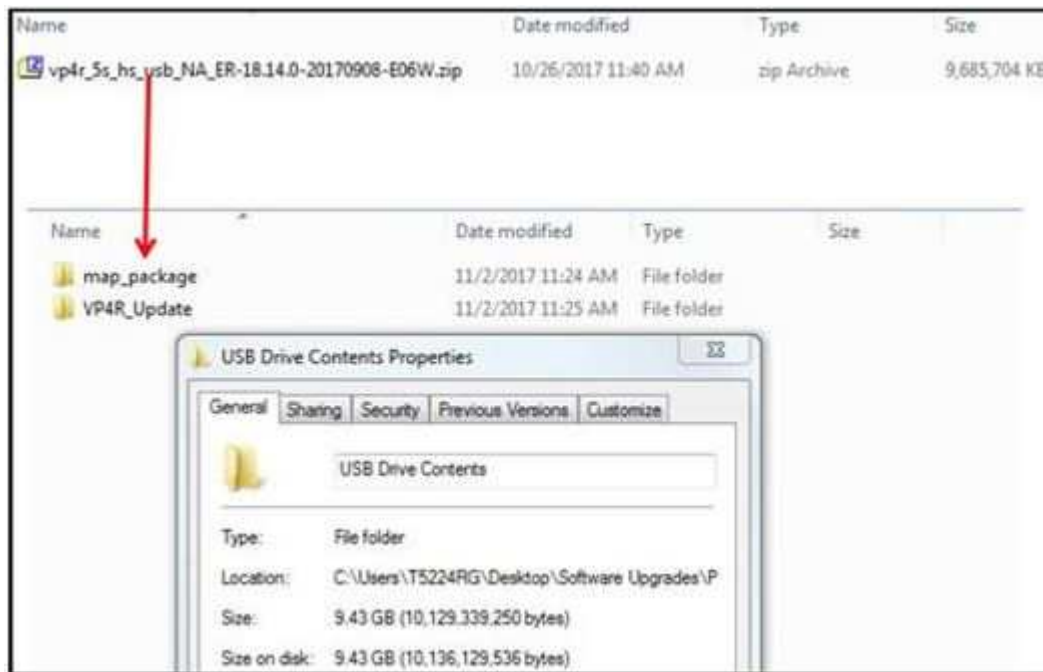
Fig. 4
Files/Folders In The USB Flash Drive

- Unzip all the files to the root folder of USB flash drive. Files should not be within a zip folder. Your USB files should look like (Fig. 4) when you open it, displaying multiple files/folders.

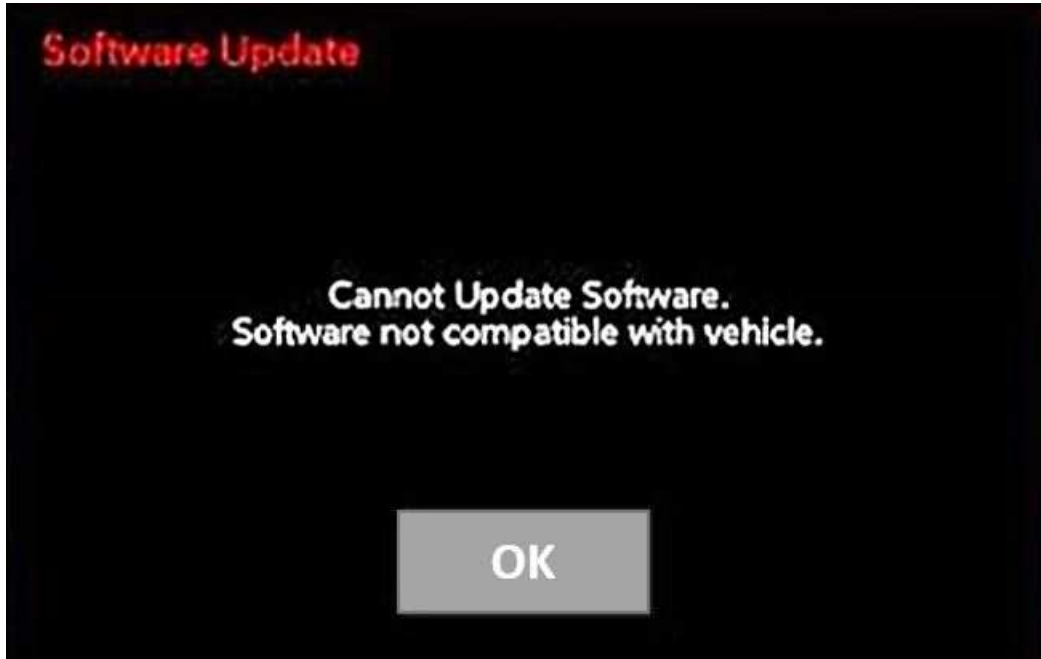
Fig. 5
Software Not Compatible

10. If the screen in (Fig. 5) is displayed, the USB flash drive was not set up correctly. Use a top name brand USB flash drive and create a new USB flash drive. Start the update again.

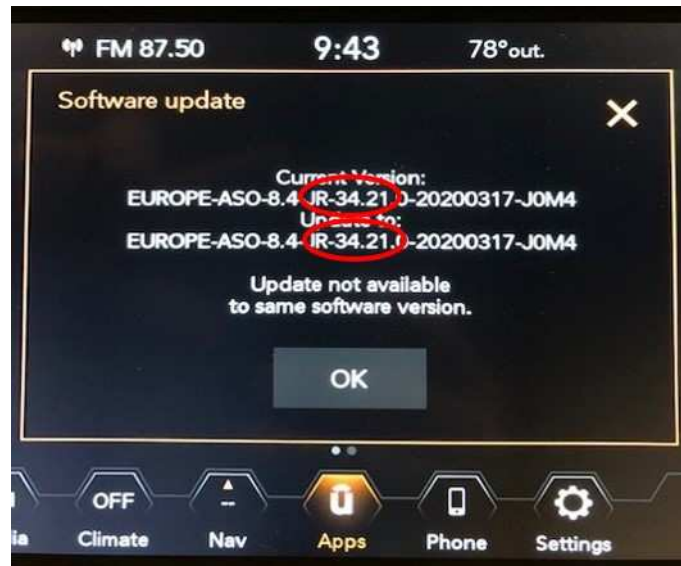
Fig. 6
Screen Displayed When Radio Software Level Is Up To Date

11. If the radio software is up to date, the screen in (Fig. 6) will be displayed. Press "OK" and remove the USB flash drive.

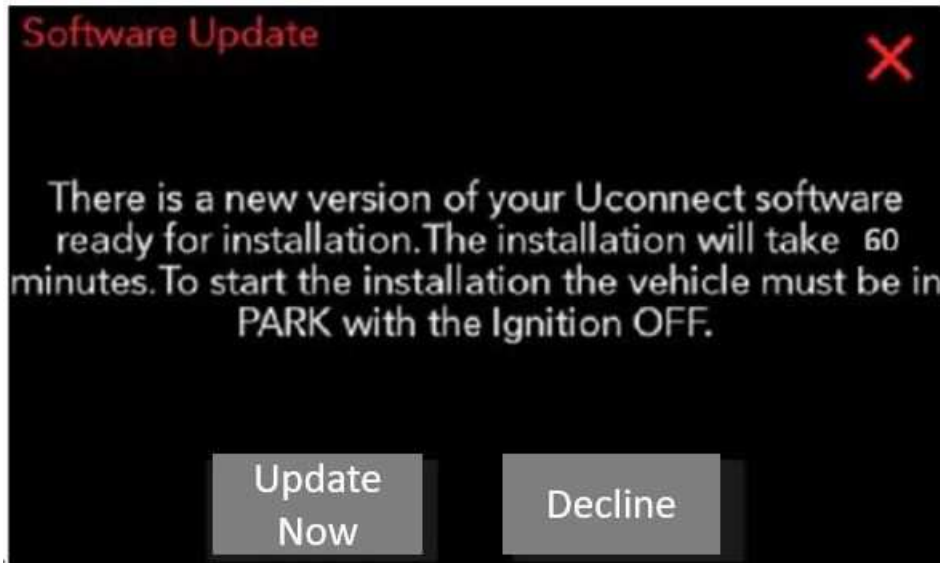
Fig. 7
Software Update Is Available

12. Once the system has verified there is an available update, press the “Update Now” button. Make sure the vehicle is in park. **Do NOT turn off the ignition until the two minute timer has expired. The ignition doesn’t have to be turned off to update the radio’s software.** (Fig. 7) .

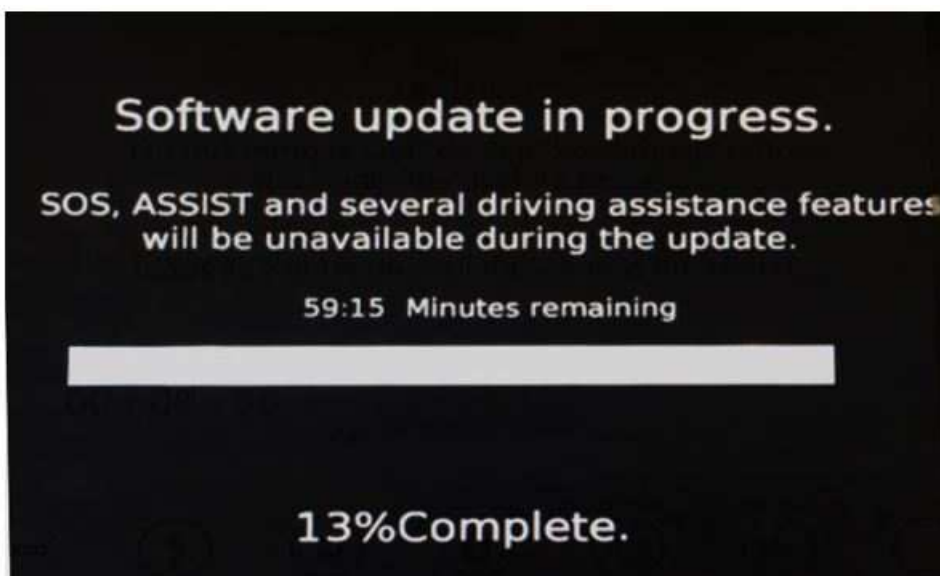
Fig. 8
Software Update In Progress

13. When the radio starts updating, the screen in (Fig. 7) will be displayed.
14. The radio will reboot and the update will begin. The update should only take 30 minutes, the timer on the screen may display the incorrect time remaining, (Fig. 8) .

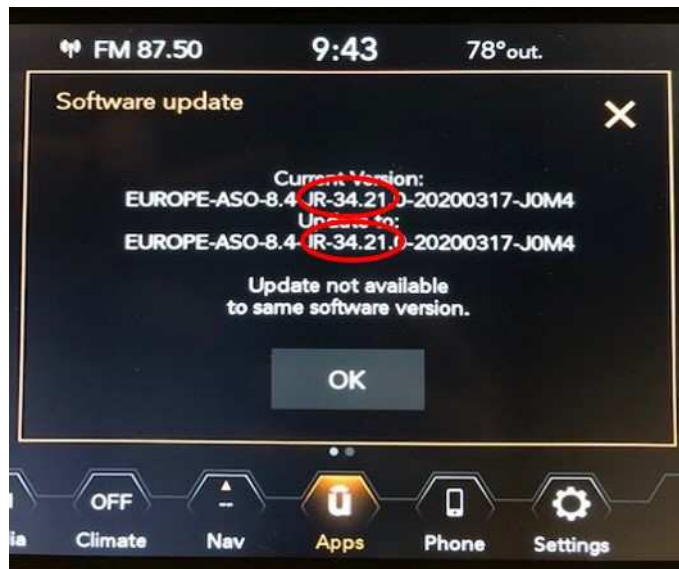
Fig. 9
Radio Software Has Been Updated.

15. After the update has completed, the radio will shut down. With the USB flash drive still inserted in the USB port, turn the ignition back to the run position. If the radio has been updated correctly, the screen in (Fig. 9) will be displayed. Press "OK" and remove the USB flash drive.
