NUMBER: 08-081-20

Telematic Box Module (TBM) Enhancements

This bulletin involves performing a two step Firmware Over The Air (FOTA) on the Telematic Box Module (TBM). The first step will take the ECU SW from 201772 to 201774 and the second step will take the software from 201774 to 201775.

2020	(M7)	Jeep Compass
2020	(BV)	Jeep Renegade

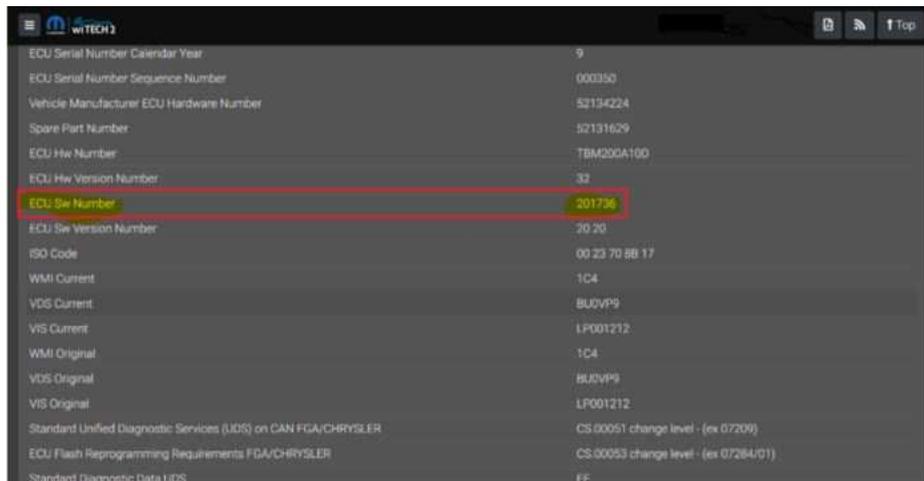
Fig. 1
TBM ECU SW Level

- Using wiTECH check the TBM ECU software level. Select TBM2 on the Topology screen, then select ECU details and check for ECU Sw Number value (Fig. 1) .

- Is the ECU software level at 201775 or higher?
 - YES>>> This bulletin has been completed. Use inspection LOP (18-19-55-A1) to close this active RRT.
 - NO>>> Proceed to [Step 1](#) of the Repair Procedure.

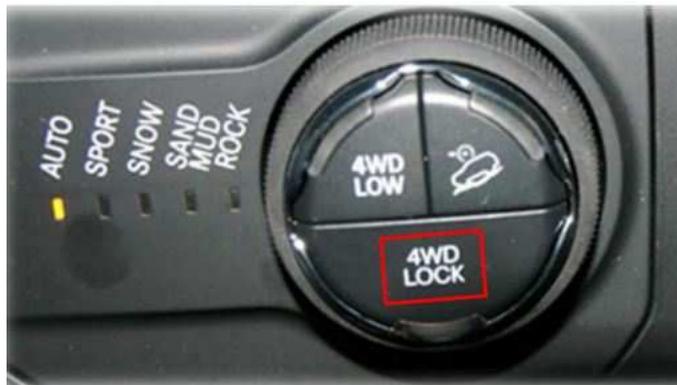
Fig. 3
4WD Lock Must Be Active

11. Turn on the vehicle and make sure “4WD Lock” is active. When 4WD is active ICE will start and run all the time (Fig. 3) .

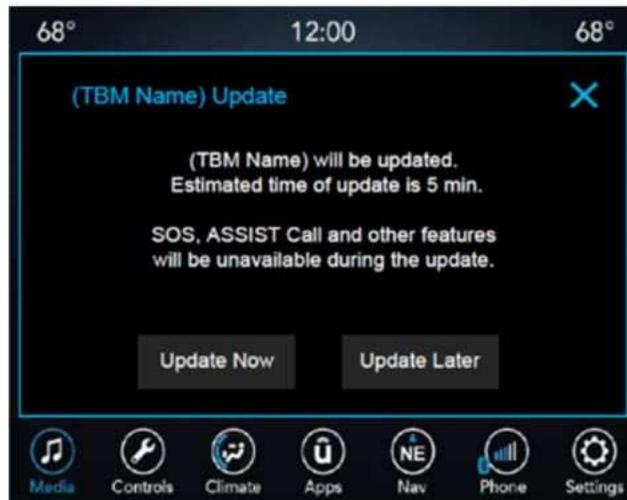
Fig. 4
Start Update Now Display

16. Wait 30 seconds with the key in the “Off” position. During this time, a pop-up should appear on the radio display. Press “Update Now” soft key on the radio screen (Fig. 4) .

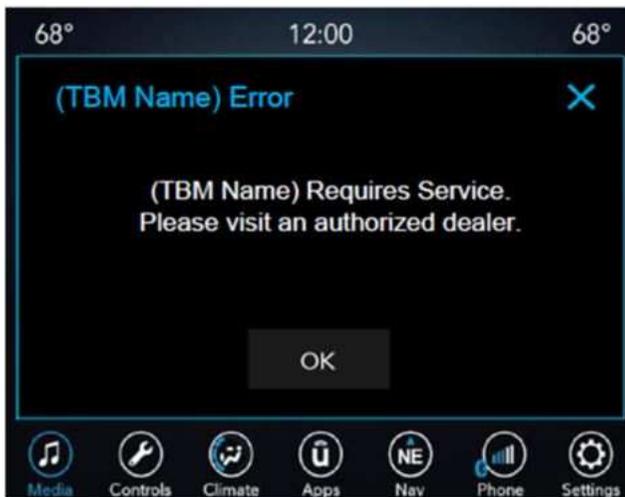
Fig. 6
Error Message

21. If no pop-up appears or the following error pop-up appears (Fig. 6) the FOTA update procedure has failed. The vehicle will need additional diagnostics, **open an eContact ticket for advanced technical support.**

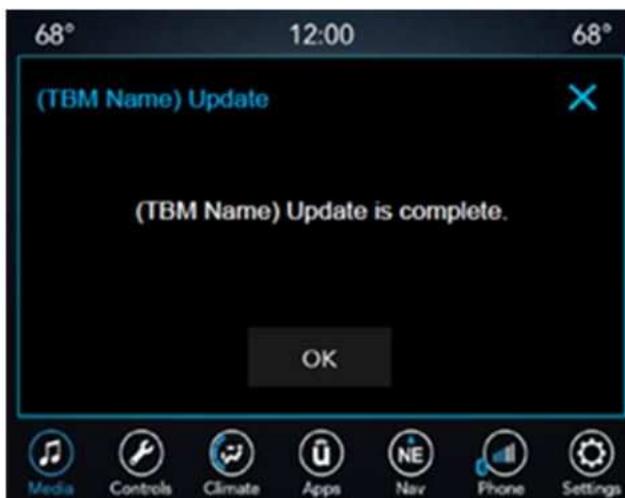
Fig. 7
Update Complete

22. Wait for a pop-up to appear on the radio display to indicate update completed press "OK". **Do not** switch off the engine (Fig. 7) .
