NUMBER: 18-086-20

DATE: September 15, 2020

Flash: Powertrain Control Module (PCM) Updates

2020	(DD)	RAM 3500 Cab Chassis
2020	(DP)	RAM 4500/5500 Cab Chassis

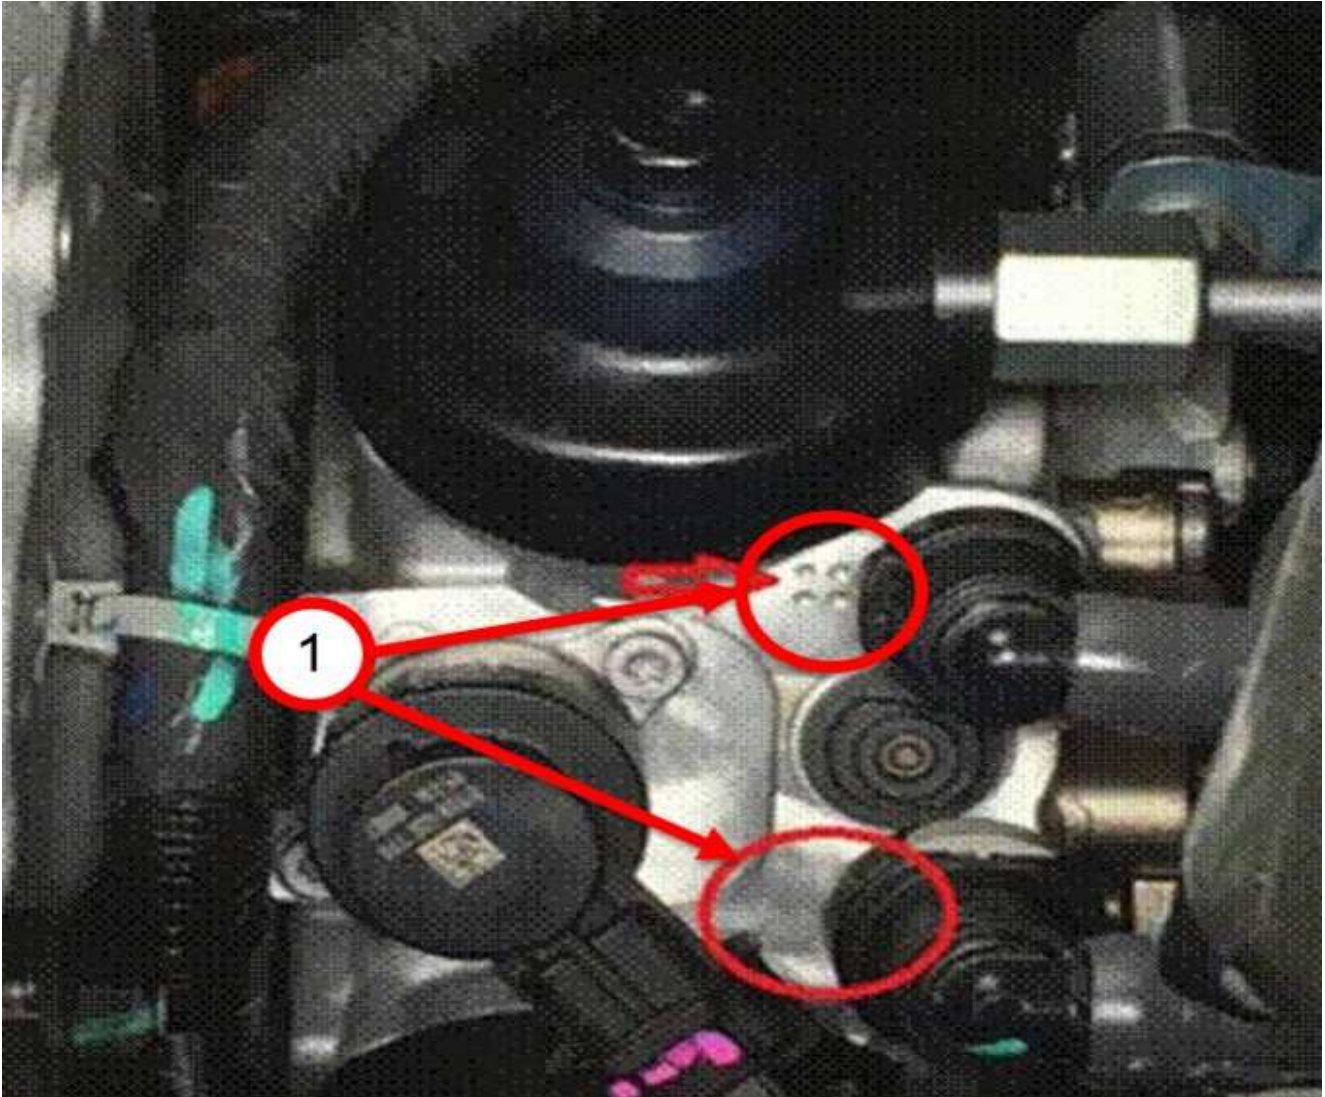
Fig. 2
Old Style Asymmetrical Cam Design Pump

- Vehicles with the old style Asymmetrical Cam design will have multiple dots embossed in the pump housing (Fig. 2) .
- For vehicles with an Asymmetrical Cam pump, choose the calibration labeled Asymmetric Cam or Asym Cam.

1 - Multiple Dots on Housing
