NUMBER: 08-081-20 REV. A

Telematic Box Module (TBM) Enhancements

2020	(M7)	Jeep Compass
2020	(BV)	Jeep Renegade

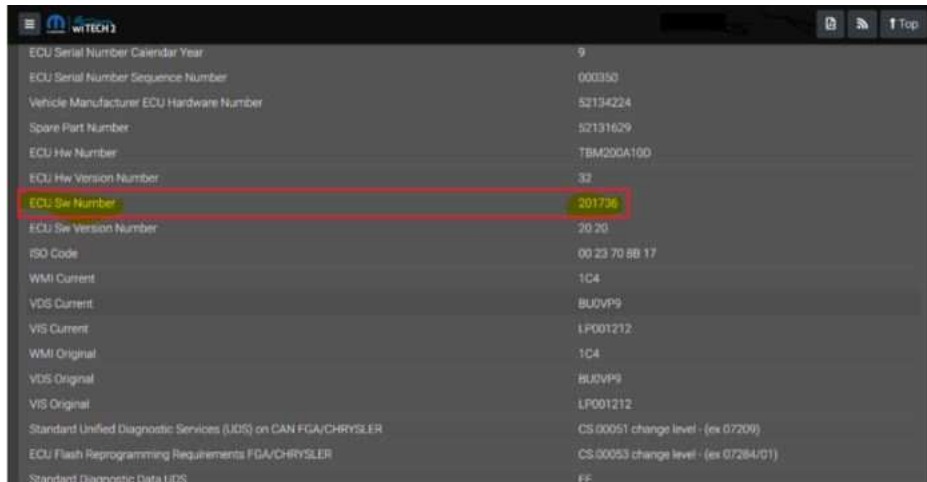
Fig. 1
TBM ECU SW Level

- Using wiTECH check the TBM ECU software level. Select TBM2 on the Topology screen, then select ECU details and check for ECU Sw Number value (Fig. 1) .

- Is the ECU software level at 201775 or higher?
 - YES>>> This bulletin has been completed. Use inspection LOP (18-19-55-A1) to close this active RRT.
 - NO>>> Proceed to [Step 1](#) of the Repair Procedure.

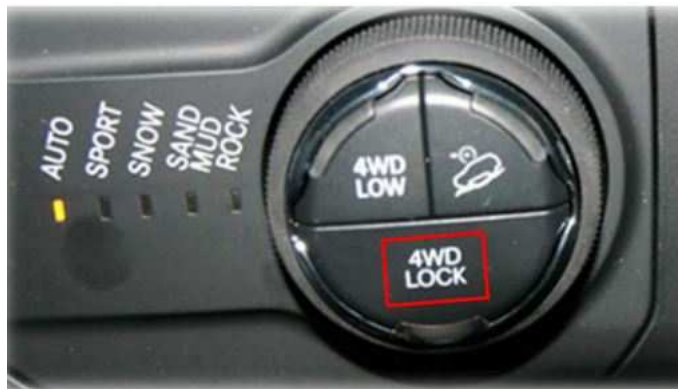
Fig. 3

4WD Lock Must Be Active

11. Turn on the vehicle and make sure “4WD Lock” is active. When 4WD is active ICE will start and run all the time (Fig. 3) .

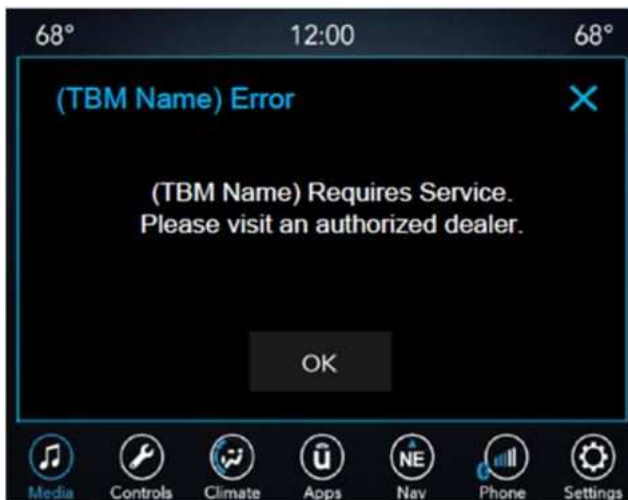
Fig. 6
Error Message

21. If no pop-up appears or the following error pop-up appears (Fig. 6) the FOTA update procedure has failed. The vehicle will need additional diagnostics, **open an eContact ticket for advanced technical support.**
