NUMBER: 08-088-20

Squeak, Rattle, Or Metallic Tapping Sound From Under The Instrument Panel

This bulletin involves Inspecting and replacing the AMP bracket fastener.

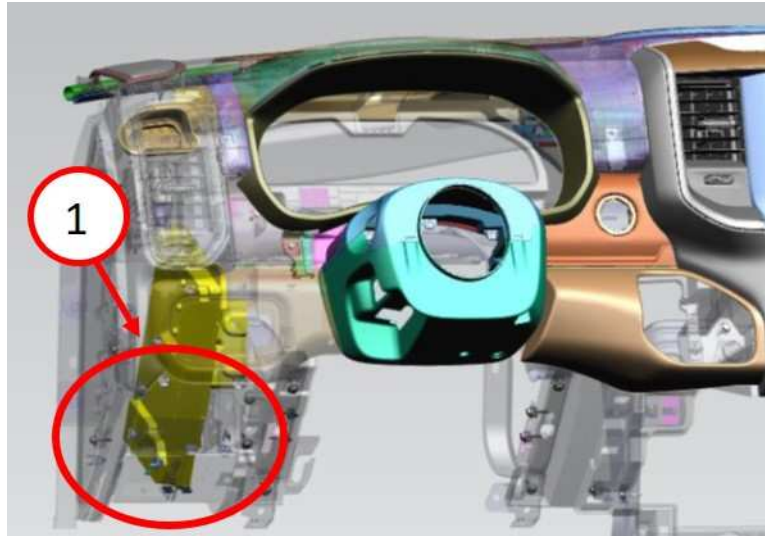
Fig. 1
IP Access to View Amplifier

1 - Inspection Area

1. Remove the steering column opening cover. Refer to the detailed service procedures available in DealerCONNECT/Service Library under: Service Info 23 - Body/Instrument Panel/Cover, Steering Column Opening/Removal and Installation . Inspect bolt location (Fig. 1) and grab amplifier assembly to confirm solid attachment by trying to rock side-to-side.

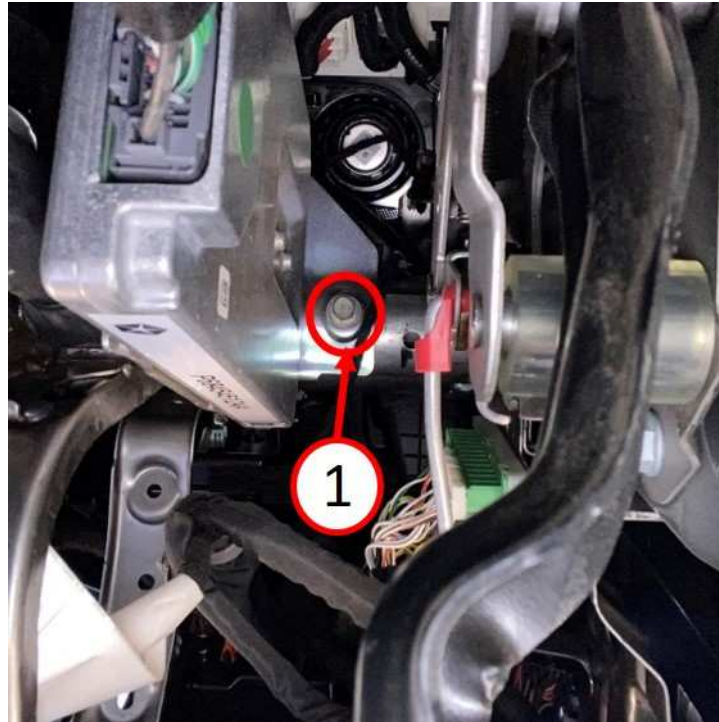
Fig. 2
Amp Bracket Bolt - Good

1 - Amp Bracket Bolt

1. If loose, but not broken - remove amplifier to IP Cross Car Beam (CCB) bolt (Fig. 2) and proceed to Step 4.

4. Install new bolt (PN 06511791AA) and tighten to 5 N·m (44 in lbs.).

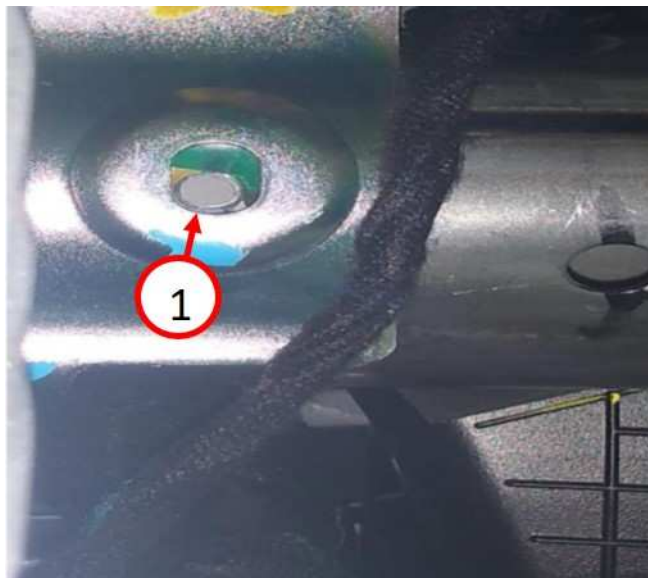
Fig. 3
Amp Bracket Bolt - Broken

1 - Broken Amp Bracket Bolt

2. If broken, remove broken/remaining portion of fastener still in the IP CCB (Fig. 3) .
