GLOBAL SAFETY FIELD INVESTIGATIONS
DCS5498
URGENT - DISTRIBUTE IMMEDIATELY

Date: September 9, 2020
Subject: N192291620 - Special Coverage
Camshaft Cover Replacement
Models: 2016 Buick Cascada
To: All General Motors Dealers

N192291620 Camshaft Cover Replacement

Release Date: September 2020

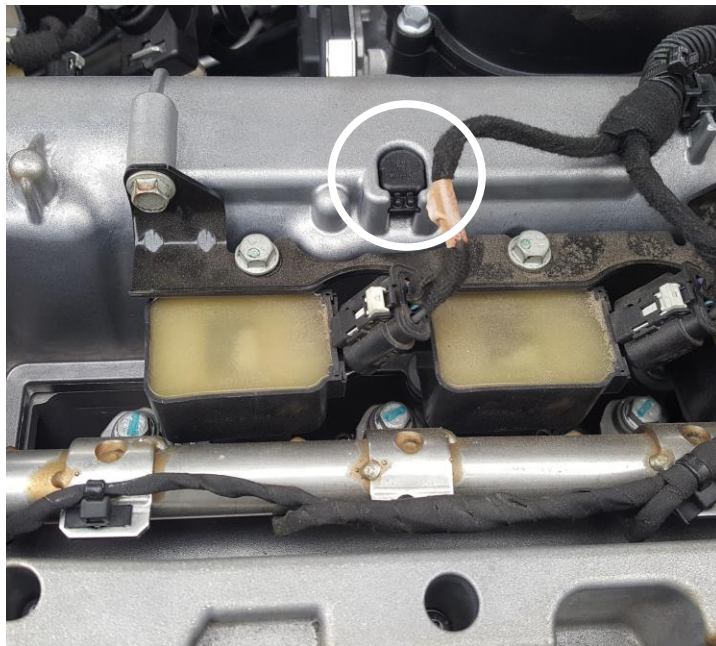
5509278

1. A vehicle may come in with DTC P0171 – Fuel Trim System Lean, or other airflow-related DTCs. The vehicle may also exhibit rough engine operation or stalling at idle. Following the diagnostics in SI for that DTC may lead to the PCV system as a potential source of external airflow.
2. Confirm a bad PCV valve.
 - 2.1 Remove the engine cover. Refer to *Engine Cover Replacement* in SI.
 - 2.2 Check to make sure the engine oil dipstick is fully seated and the oil fill cap is fully tightened.

- 2.3 With the engine running, listen for noise coming from the PCV valve, shown above. If noise is heard, check to see if the noise gets quieter or disappears with the engine oil dipstick removed.
- 2.4 Reinsert the dipstick.
- 2.5 Check to see if there is vacuum at the PCV vent at the front of the PCV valve by placing a piece of tissue near it. The tissue will be sucked against the vent and held if vacuum is present.
 - If the PCV valve is making noise and there is vacuum present at the PCV valve vent, replace the Camshaft Cover. Refer to *Camshaft Cover Replacement* in SI.
