GLOBAL SAFETY FIELD INVESTIGATIONS
DCS5504
URGENT - DISTRIBUTE IMMEDIATELY

Subject: A202295530 - Service Update
Brake Pad Life Software Error

Models: 2020-2021 Buick Encore GX
Equipped with Brake Pad Life Monitor System (RPO JBP)

A202295530 Brake Pad Life Software Error

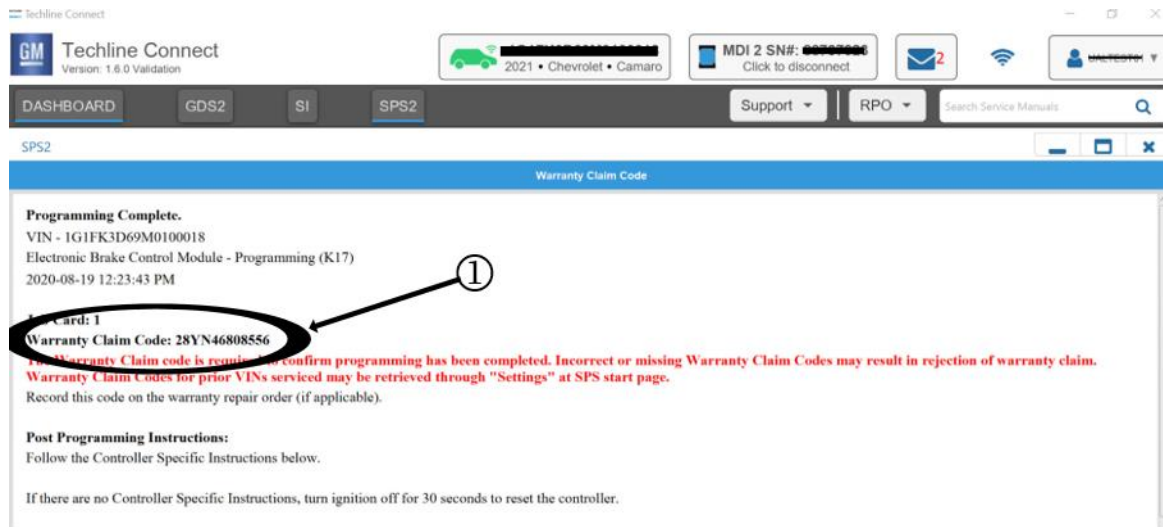
56444478

Important: If the same Calibration/Software Warning is noted on the SPS or TLC Summary screen, select OK and follow screen instructions. After a successful programming event, the WCC is located in the Service Programming System dialogue box of the SPS Summary screen. No further action is required. Refer to the Warranty section of the bulletin.

1. Reprogram the Brake System Control Module. Refer to *K160 Brake System Control Module: Programming and Setup* in SI.

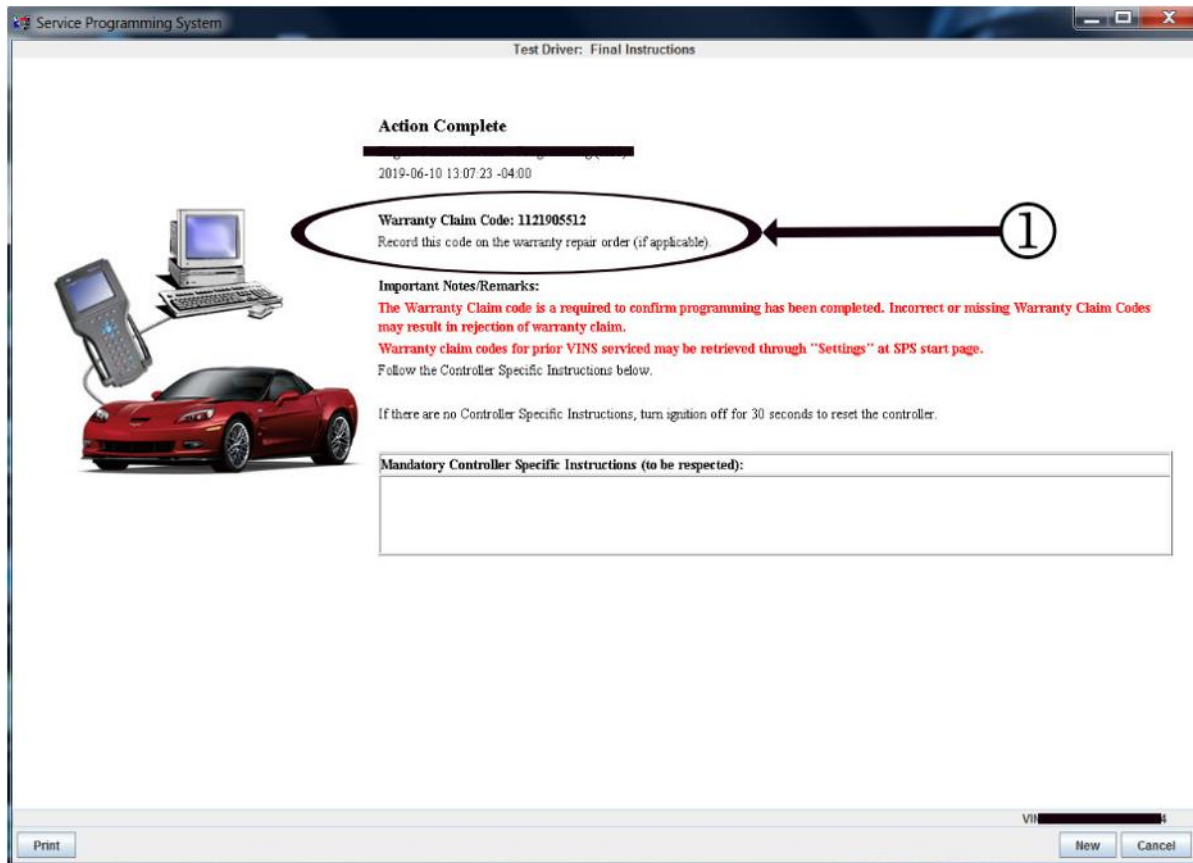
5431209

Important: To avoid warranty transaction rejections, you **MUST** record the warranty claim code provided on the Warranty Claim Code (WCC) screen on the job card. Refer to callout 1 above for the location of the WCC on the SPS/TLC screen.

2. Record SPS Warranty Claim Code on job card for warranty transaction submission.
