GLOBAL SAFETY FIELD INVESTIGATIONS
DCS5503
URGENT - DISTRIBUTE IMMEDIATELY

Subject: N202312030 01 - Service Update
Engine Control Module Reporting Incorrectly
Revised Service Procedure

Models: 2018 Buick LaCrosse
Equipped with 4 CYL, 2.5 L Gas-Engine (RPO LHN)

N202312030 Engine Control Module Reporting Incorrectly

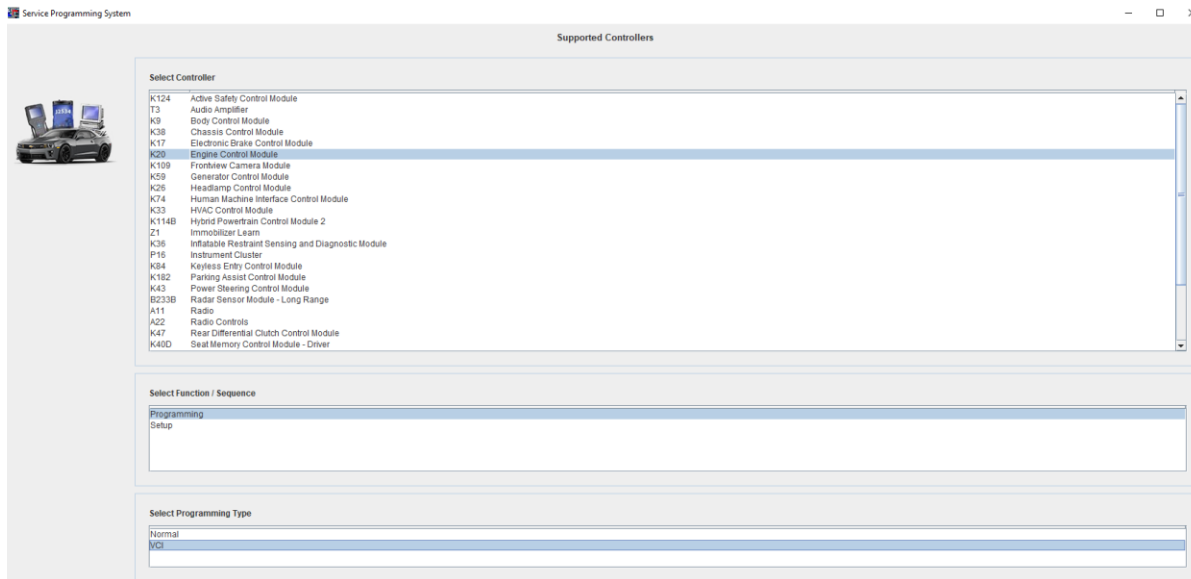
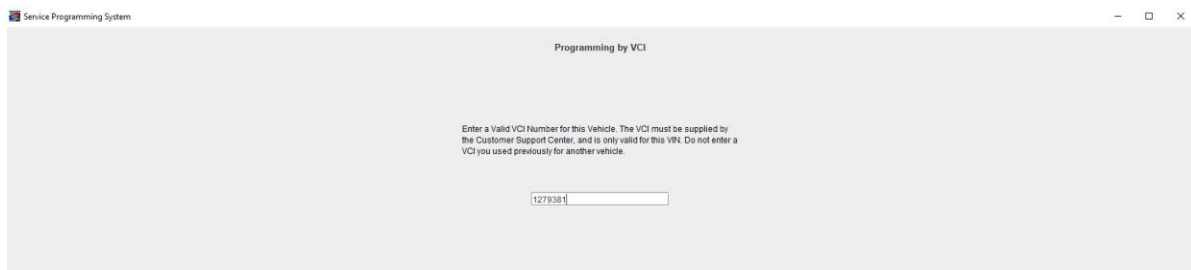
5646069

1. You will be required to perform two ECM reprogramming procedures to complete this recall. The first will load an older calibration using a VCI programming number. The vehicle should NOT be driven, started, or returned to the customer until AFTER the second programming event has been completed.
2. Call TCSC to obtain the VCI programming number you will use during this recall. Dial 1-800-828-8680 (English) or 1-800-503-3222 (French) and provide the VIN of the vehicle you are programming to obtain a VCI code.
3. Reprogram the ECM. Refer to *K20 Engine Control Module: Programming and Setup* in SI.

4. Select VCI programming and hit next.
5. Enter the VCI programming number provided by TCSC.
6. Once programming is finished, record the warranty claim code, cycle the key off and wait for 60 seconds before turning the vehicle back on and proceeding with the second programming event.
7. Reprogram the ECM again regularly using standard procedures to upload the latest cal. Refer to *K20 Engine Control Module: Programming and Setup* in SI.

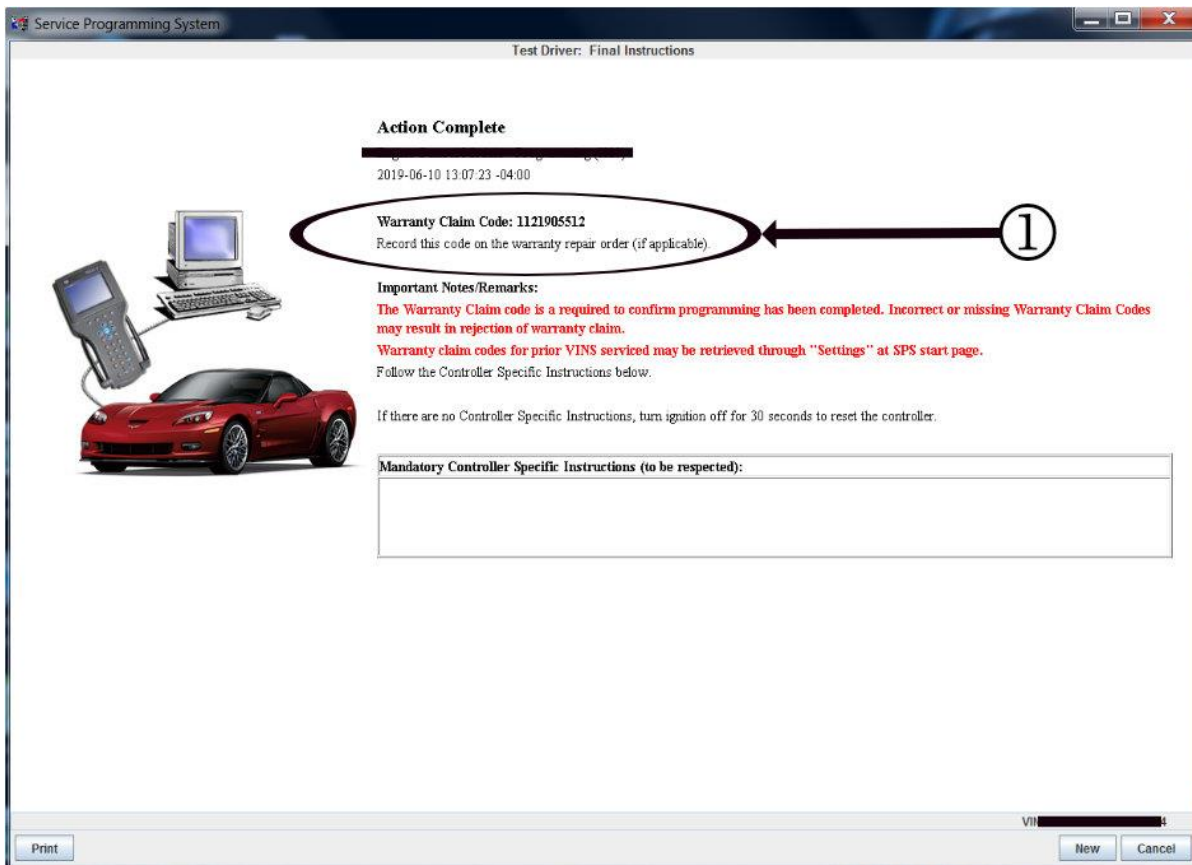
5431209

Important: To avoid warranty transaction rejections, you MUST record the warranty claim code provided on the Warranty Claim Code (WCC) screen shown above on the job card. Refer to callout 1 above for the location of the WCC on the screen.

8. Record SPS Warranty Claim Codes on job card for warranty transaction submission.
