GLOBAL SAFETY FIELD INVESTIGATIONS
DCS5516
URGENT - DISTRIBUTE IMMEDIATELY

Subject: N202294740-02 - Service Update
Software Update for Multiple Modules
Revised Service Procedure

Models: 2020 Cadillac CT5

N202294740 Software Update for Multiple Modules

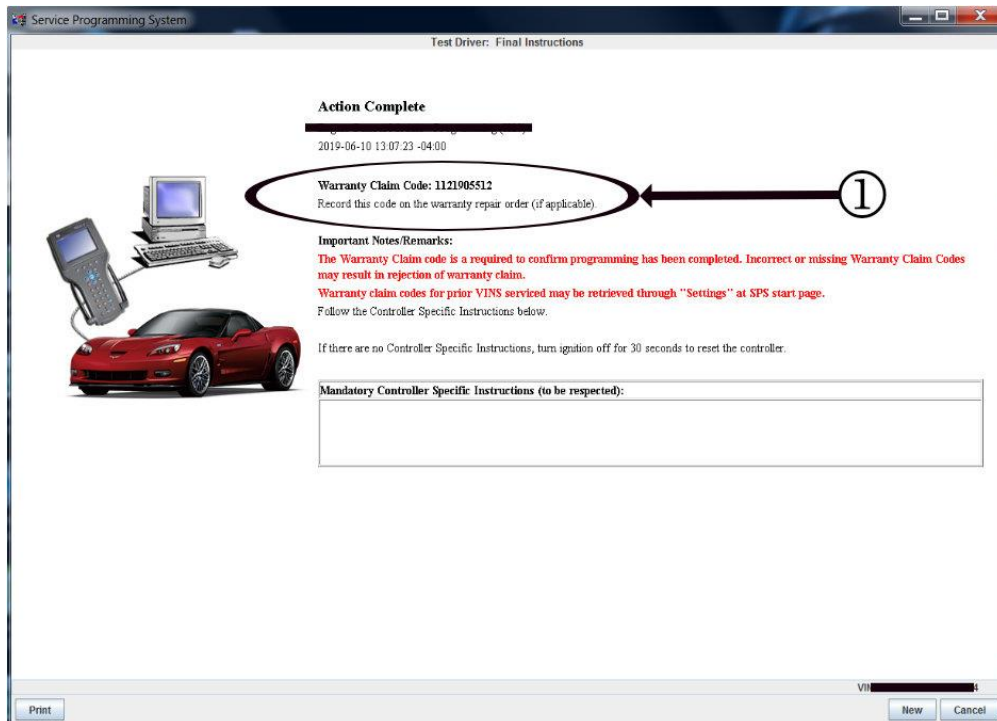
5431209

1. Reprogram the instrument panel cluster control module:
 - 1.1. Select P16 Instrument Panel Cluster Control Module under "Select Controller" and Programming" under "Select Function/ Sequence", click next and follow on screen instructions.
 - 1.2. After programming has completed, Select P16 Instrument Panel Cluster Control Module under "Select Controller" and Graphics Programming under "Select Function/ Sequence", click next and follow on screen instructions.
2. Reprogram the sequential multiple modules through SPS/Techline Connect (SPS and Techline Connect screens shown) by selecting "ZFA - Multimodule Coordinated Sequence-Bulletin N202294740" on the select controller screen as shown. Select "Next" and follow all onscreen instructions.

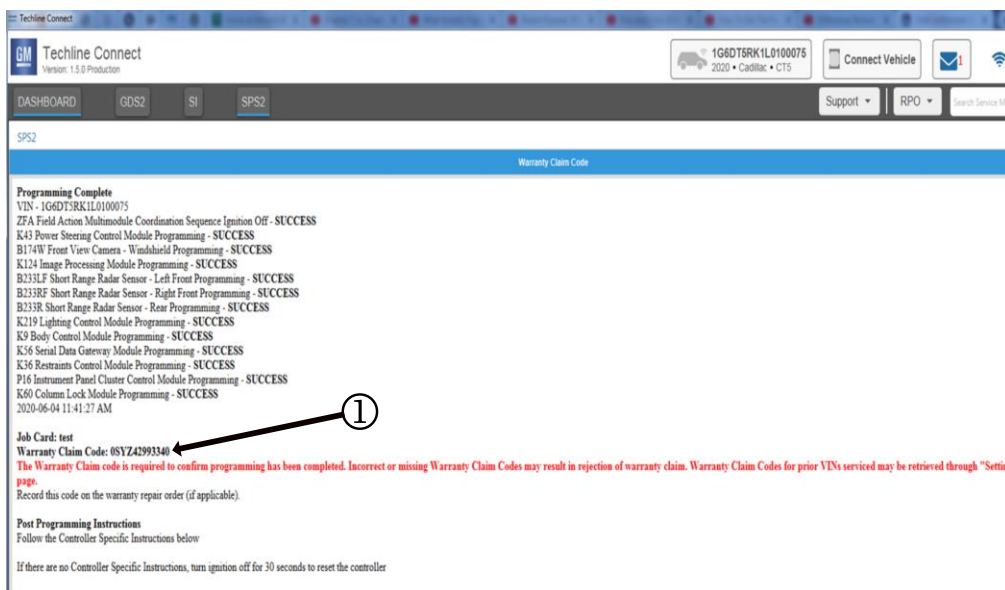
5618451

Important: SPS and Techline Connect screen shown.

Important: To avoid warranty transaction rejections, you **MUST** record the warranty claim code provided on the Warranty Claim Code (WCC) screen shown above on the job card. Refer to callout 1 above for the location of the WCC on the screen.

- Record SPS Warranty Claim Code on job card for warranty transaction submission.
