Subject: N202300240-02 - Customer Satisfaction Program  
Transfer Case Leak  
Updated Warranty Information

Models: 2019 Chevrolet Silverado 4500 HD / 5500 HD / 6500 HD

## N202300240 Transfer Case Leak

**Revision:** 02

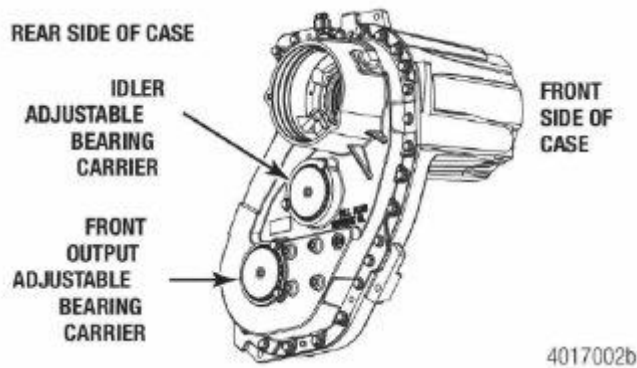
5600859

This bulletin provides instructions for identifying and replacing the adjustable bearing carrier O-rings on MTC-3203-AD02-100-300 model transfer cases. These procedures apply only to the forward output and idler adjustable bearing carriers. These procedures apply only to MTC-3203-AD02-100-300 model transfer cases. Refer the U.S. Dealer Special Tool Loan Program for information on how to obtain the *Front Output / Idler Bearing Adjusting Ring Tool* DT 52973-2. The *Front Output / Idler Bearing Adjusting Ring Tool* DT 52973-2 is also included in Tool Kit DT 52973.

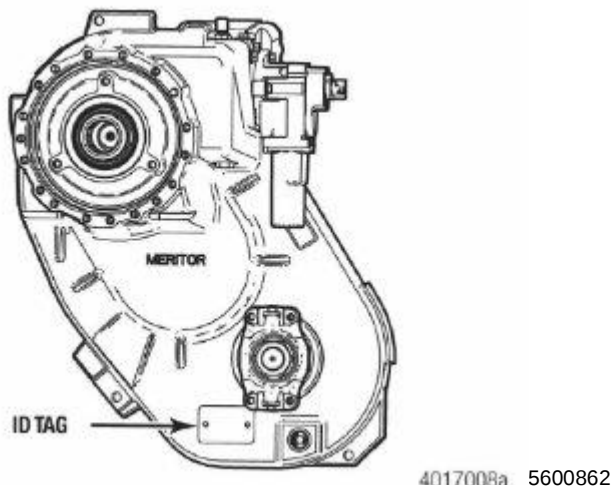
**Note:** Some vehicles may have chassis paint overspray on the transfer case identification label, making it difficult to read. If this condition exists, verify the VIN in IVH. With the VIN verified in IVH, replace the O-rings per the repair steps.

1. Locate the identification tag on the front of the transfer case.
2. Check and record the serial number on the transfer case ID tag.

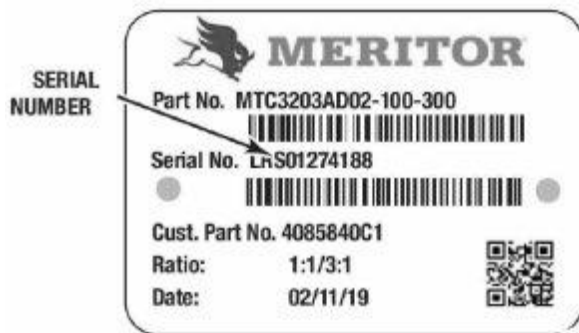
5600868

3. If the serial number is between LRS01290649 and LRS01318770, proceed with the repair. If the serial number is outside of the specified range, no further action is required. If an oil leak is present on a transfer case outside of the specified serial number range, use SI diagnostic steps to repair the leak.

**Note:** If a leak is discovered, note which adjustable bearing carrier location shows evidence of the leak.
