Service Bulletin

Bulletin No.: 16-NA-289

Subject: Front Seat Back Cover Material Pulling Loose Around Easy Entry Release Handle

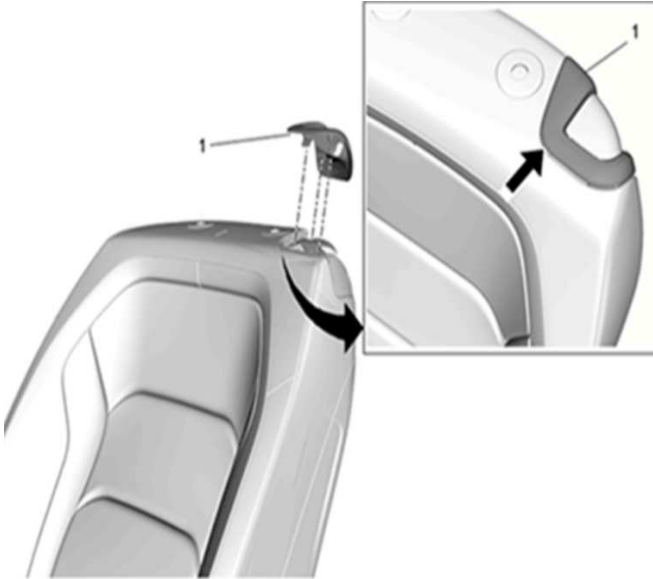
4571158

Involved Region or Country	North America, Europe, Russia, Middle East, Israel, Argentina, Brazil, Bolivia, Chile, Colombia, Paraguay, Uruguay, Japan, GM Korea Company, China
Condition	  <p style="text-align: right;">4581014</p> <p>Some customers may comment that the cover material on the driver or passenger seat back is pulling loose around the easy entry release handle bezel. Examples of a cloth and leather seat cover are shown in the graphic above.</p>
Cause	The cause of the condition may be that the cover material is currently not secured underneath the handle.

1. Carefully remove the front seat back latch release handle bezel (1) on the affected seat. Refer to *Front Seat Back Latch Release Handle Bezel Replacement* in SI.
