Service Bulletin

Bulletin No.: 16-NA-303

Subject: Radio Display Blank, Instrument Cluster Gauges Inoperative and/or Steering Stiff

Brand:	Model:	Model Year:		VIN:		Engine:	Transmission:
		from	to	from	to		
Chevrolet	Malibu	2013	2016	—	—	—	—
Holden	Malibu	2013	2015	—	—	—	—

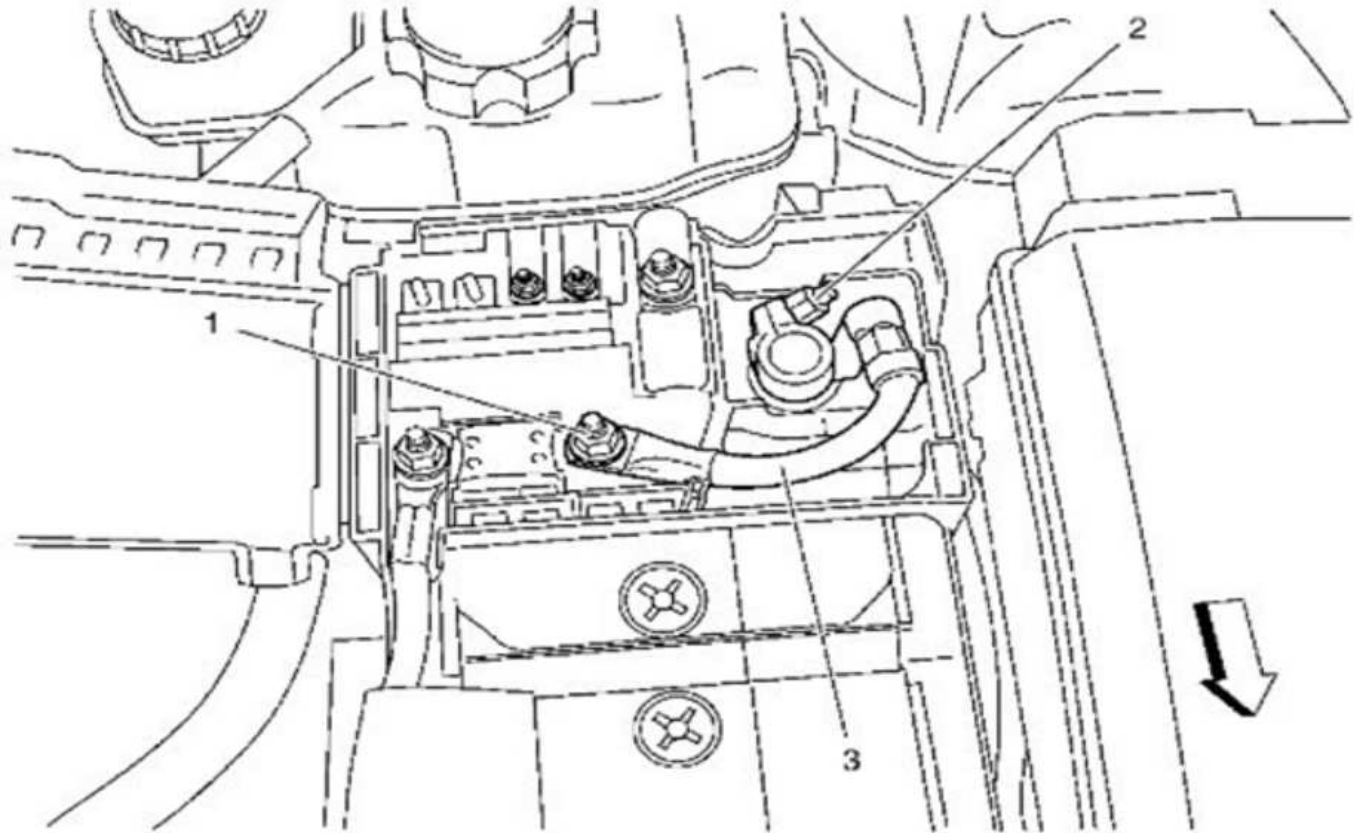
4855770

Involved Region or Country	United States, Canada, Australia, New Zealand, Israel, Palestine, Greenland
Additional RPO	Equipped with Electric Power Steering (NJ1) without Stop-Start (KL9)
Condition	Some customers may comment that the radio display goes blank, the instrument cluster gauges are inoperative and/or the steering is stiff. This may be an intermittent concern, but more likely to duplicate when driving at slower speeds, such as in a parking lot and/or making a turn.
Cause	This condition may be caused by reduced system voltage.
Correction	Perform the Service Procedure below.

1. Using a DVOM, perform a voltage drop for the positive side battery cable (3):
 - Set the DVOM to Min/Max voltage.
 - Apply the DVOM leads at the positive cable clamp (2) and the positive cable terminal (1) at the UBEC.
 - Start the vehicle.
 - Record the maximum voltage.

⇒ If the voltage exceeds 200 millivolts, replace the positive battery cable.
2. Disconnect the battery negative cable. Refer to *Battery Negative Cable Disconnection and Connection* in SI.
