Service Bulletin

Bulletin No.: 17-NA-140

Subject: Rattle Noise from Rear of Vehicle and/or Wind or Buffeting Noise While Driving with One Window Lowered

Brand:	Model:	Model Year:		VIN:		Engine:	Transmission:
		from	to	from	to		
Chevrolet	Camaro	2016	2021	—		All	All

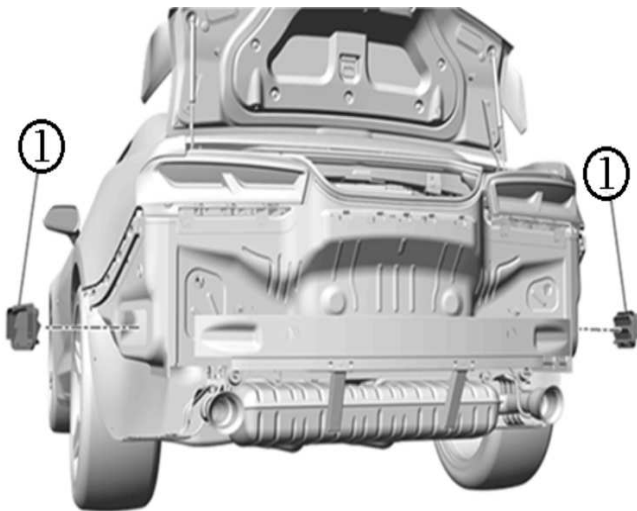
4773146

Note: The noise can generally be duplicated by driving at speeds greater than 48 km/h (30 mph), with one window lowered. If another window in the vehicle is lowered, even slightly, the buffeting noise will stop instantly.

For vehicles exhibiting this condition, replace both of the original body pressure relief valves (1) with two of the four-flap design valves listed in the Parts Information table. Refer to *Body Pressure Relief Valve Replacement* in SI.
