# Service Bulletin

Bulletin No.: 18-NA-056

**Subject:** Driver Side Object Sensing Alert Module Not Working Correctly and/or Incorrect Side Mirror Notification

Brand:	Model:	Model Year:		VIN:		Engine:	Transmission:
		from	to	from	to		
Buick	Encore	2017	2020	—	—	All	All

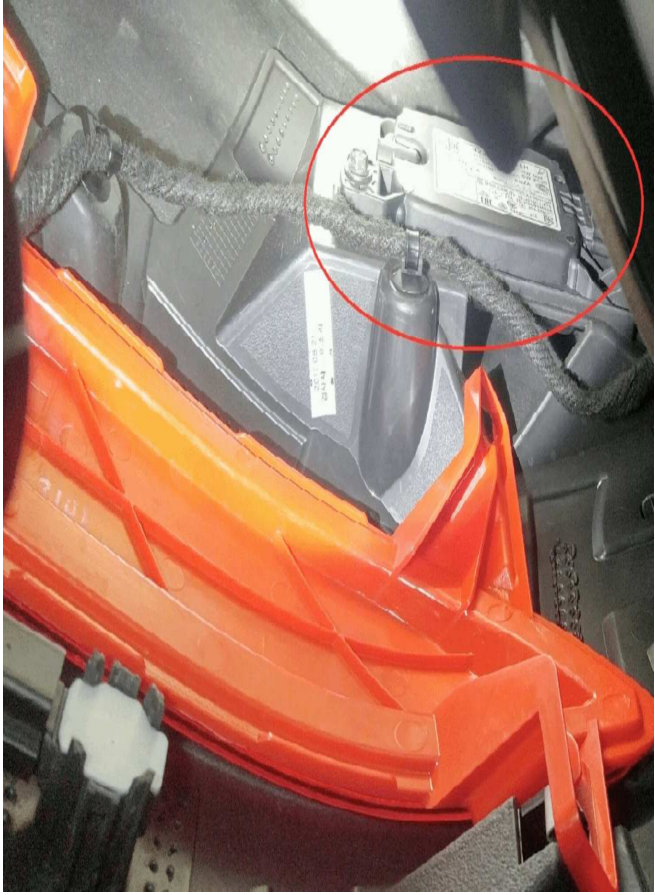
<b>Involved Region or Country</b>	North America
<b>Additional Options (RPOs)</b>	Equipped with SIDE ACTIVE SAFETY-OBSTACLE DETECTION (RPO UFT)
<b>Condition</b>	Some customers may comment that when driving, the side mirror indicates there is a vehicle present when there is not.
