Service Bulletin

Bulletin No.: 18-NA-161

Subject: Steering Jerks Or Kicks Back / Reduced Power Steering Assist / Engine Stall / No Start / Service Stabilitrak / IPC / Radio / HVAC Goes Blank Various DTCs

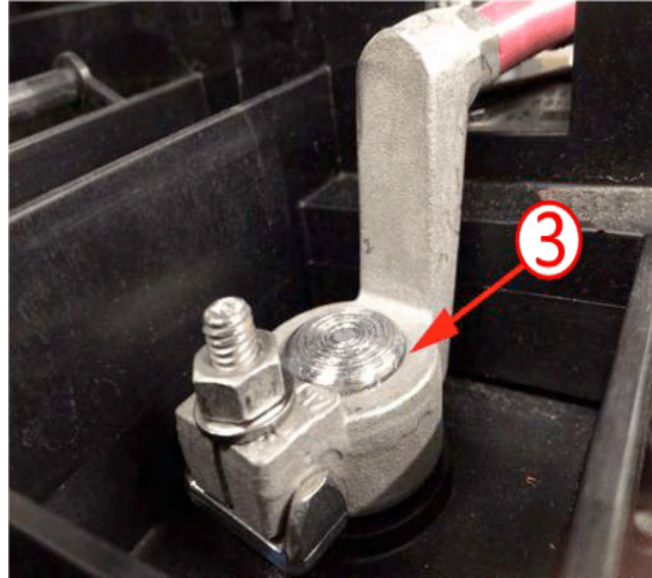
5073701

⇒ It is imperative that both the positive and negative battery top posts protrude above the battery cable clamps 1-2 mm (0.040 - 0.080 in) to be properly installed, as shown (3).

3. Check both the positive and negative battery cable clamp nuts and make sure they are properly tightened to 7 Nm (62 lb in).
4. After the positive and negative battery cables are fully installed and tightened to 7 Nm (62 lb in), grasp each battery cable near the battery post and make sure they are secure and that they do not spin on the post. If they spin, replace the battery cable.

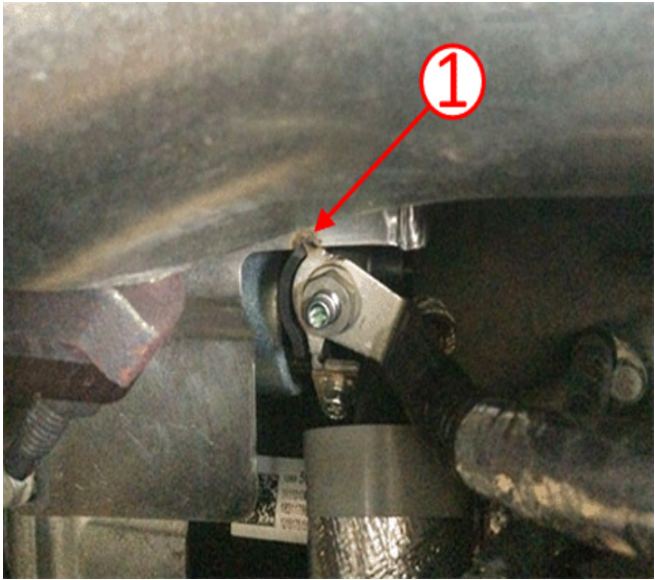
<p>5073866</p> <p>Inspect the starter solenoid B+ battery cable for possible contact at the starter heat shield (1) or a loose shield resting on terminal.</p> <p>⇒ If the battery cable is shorting out on the starter heat shield, replace the B+ battery cable and starter heat shield.</p> <p>⇒ After installing the new starter heat shield and B+ battery cable, ensure there is adequate clearance and each fastener is torqued properly so it will no longer short out.</p>
<p>Correction 4</p>	<p>Perform the "Battery Inspection/Test" procedure in SI, using the GR8, and replace the battery if it fails the test.</p> <p>⇒ Technicians must attach the GR8 test print out with a Battery Replace decision, that includes the Warranty Code, to the repair order.</p>
