# Service Bulletin

Bulletin No.: 19-NA-111

**Subject:** Ticking/Rattle Noise from B-Pillar Area

| Brand: | Model: | Model Year: | | Date Breakpoint: | | Engine: | Transmission: |
|---|---|---|---|---|---|---|---|
| Chevrolet | Blazer | 2019 | 2020 | See below | See below | All | All |

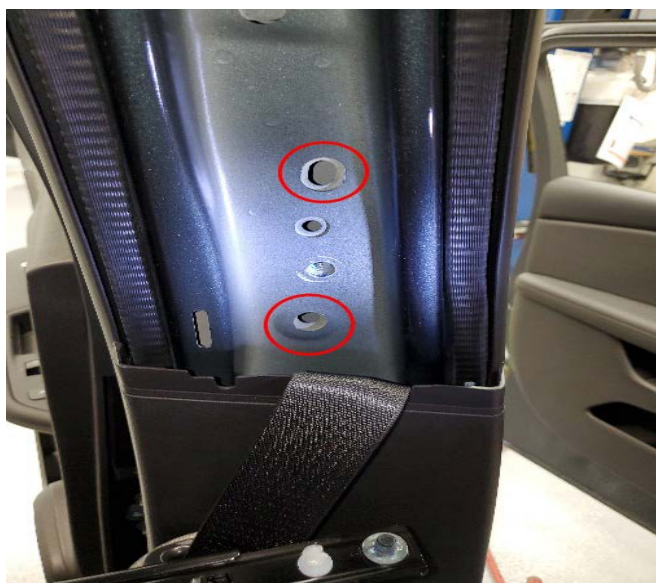
5389868

| <b>Cause 1</b> | <b>Note: This repair for Cause and Correction #1 is ONLY for vehicles from SOP 2019 and built Prior to Date Breakpoint, July 22, 2019. Later built vehicles with the condition should be repaired by Cause and Correction #2</b><br><br>This condition may be caused by sheet metal surface to surface contact, between the inner panel and the sheer plate, located behind the upper trim panel on the B-pillar. |

3. Locate the 2 holes in the center pillar. Note that at each hole, an inner sheet metal shear plate is visible.

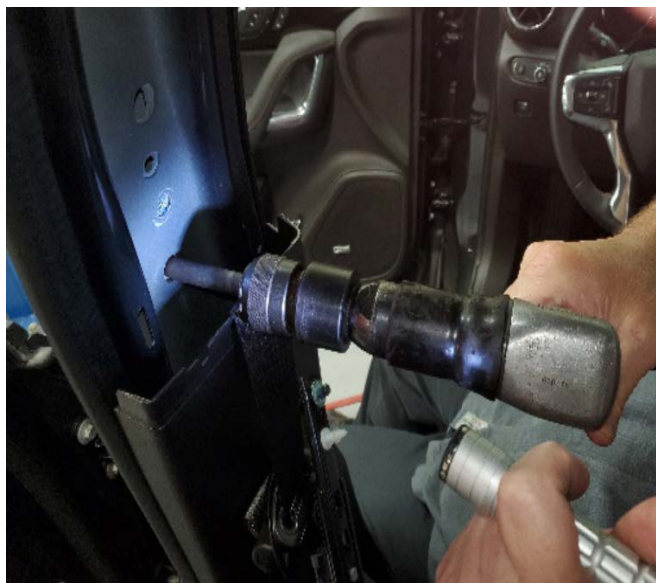
5389872

**Note:** The intent on using the punch is to increase clearance between the inner shear plate and inner sheet metal, to avoid the rub condition.

4. Using an air hammer with a blunt punch, tap the inner shear plate away from the outer panel to increase clearance. Repeat at the second hole location.

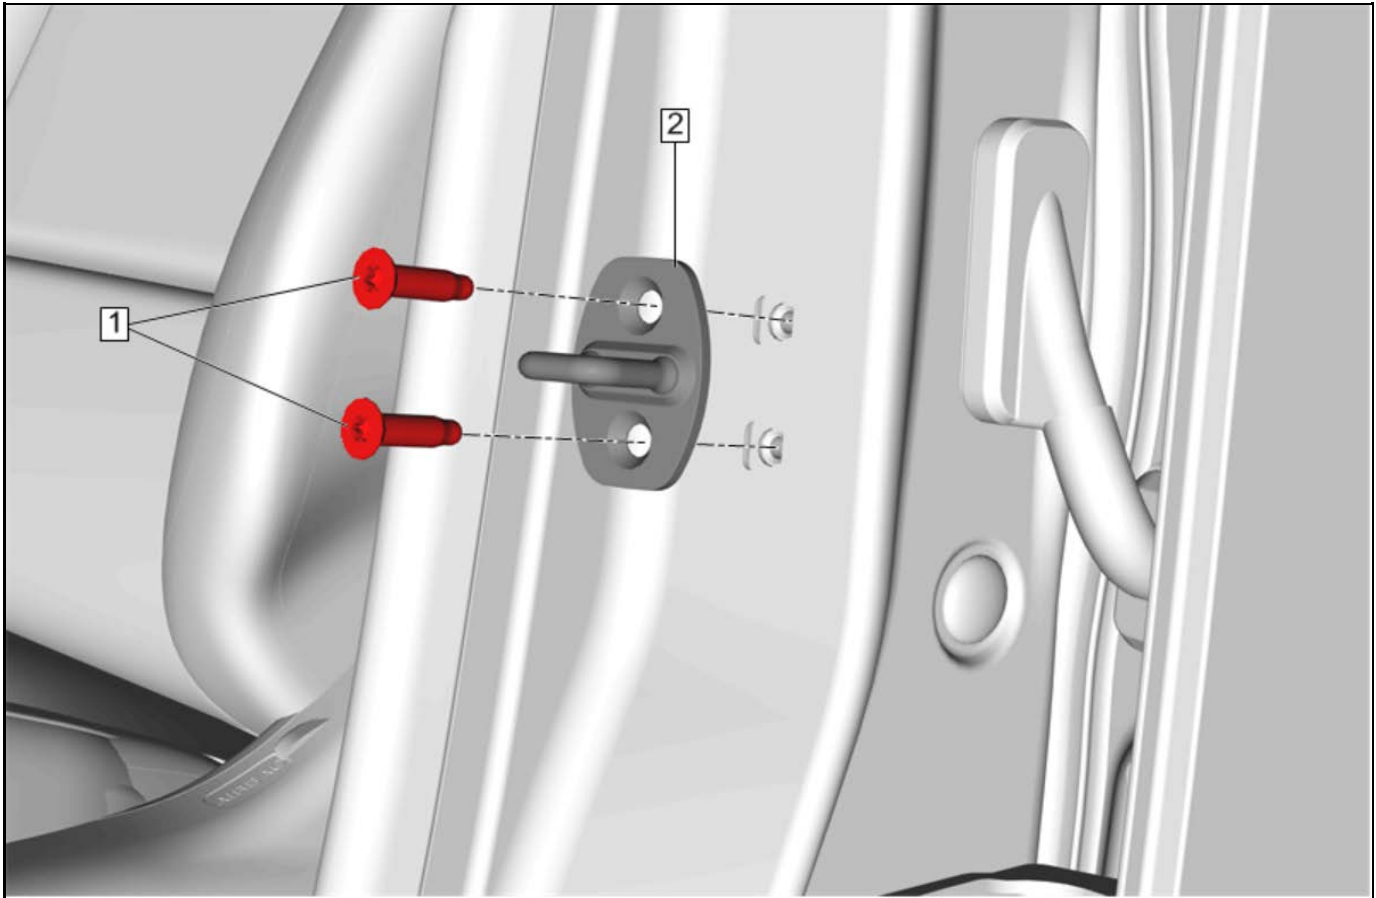
4573545

| <b>Cause 2</b> | <b>Note: This repair for Cause and Correction #2 is ONLY for vehicles built On or After Date Breakpoint, July 22, 2019, and up to current production.</b><br><br>This condition may be caused by the fasteners on any of the four side door lock strikers NOT being torqued to proper specification. |

1. Verify proper torque specification on the fasteners of ALL FOUR side door lock strikers.

Tighten the screws to 22 N•m(16 lb ft).
