Service Bulletin

Bulletin No.: 20-NA-135

Subject: Power Liftgate and/or Instrument Panel Cluster (IPC) Inoperative, No Audio, AWD/ 2WD Light Toggles Randomly, Malfunction Indicator Lamp (MIL) Illuminated - DTC P0650, P15A1, P159F-00, U0184-00, U0198-00 and/or U1501-00 Set

Brand:	Model:	Model Year:		Date Breakpoint:		Engine:	Transmission:
		from	to	from	to		
Buick	Encore GX	2020	2020	SOP	March 6, 2020	All	All
Chevrolet	Trailblazer (VIN M)	2021	2021

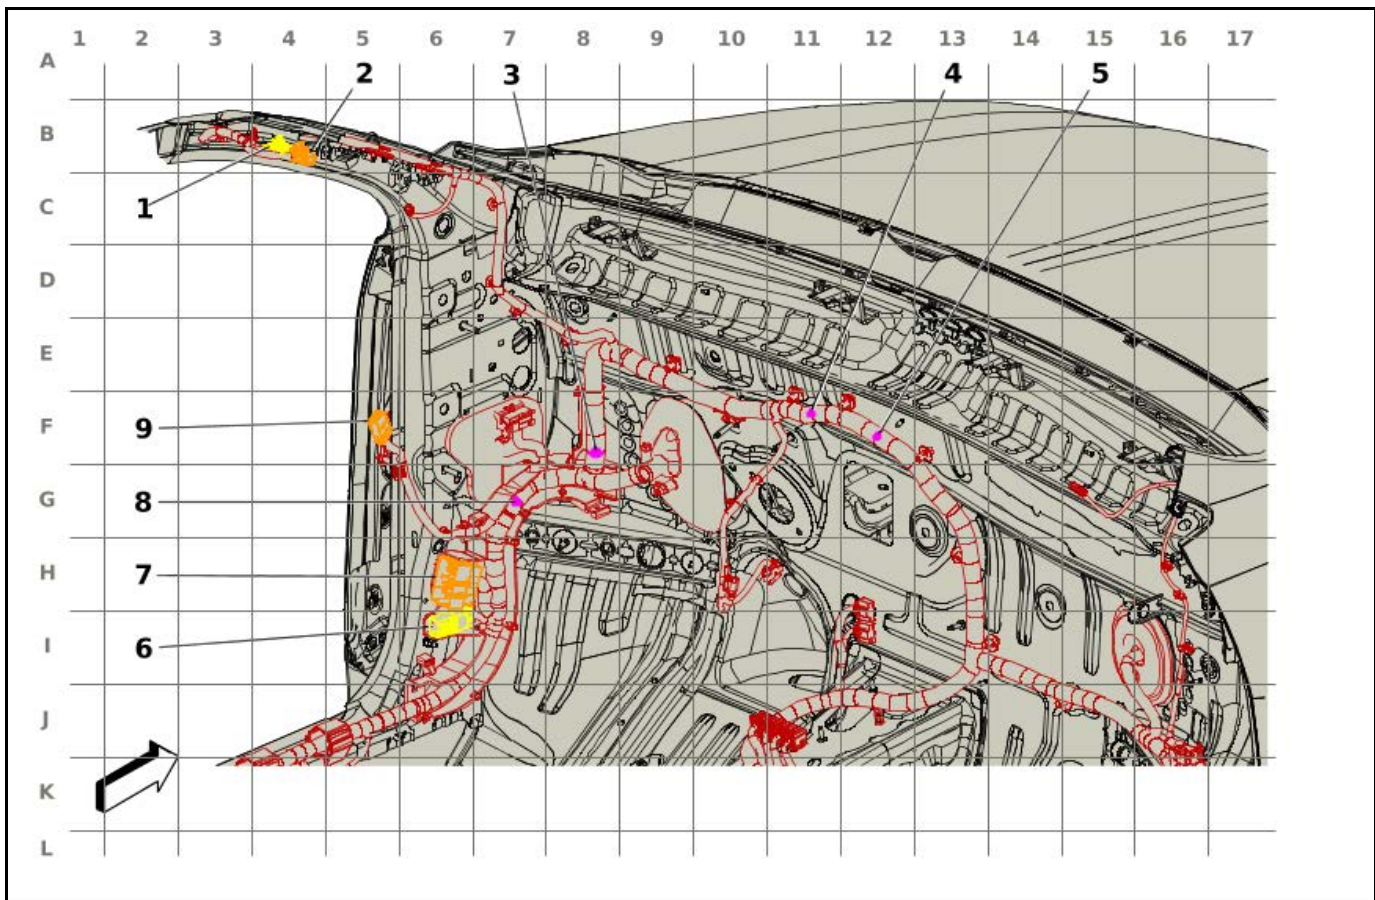
5437484

Involved Region or Country	North America, China, Israel, GM Korea Company, Ukraine
Additional Options (RPOs)	Power Liftgate (TC2) (if equipped)
Condition	<p>Some customers may comment on one or more of the following conditions:</p> <ul style="list-style-type: none"> • MIL being illuminated, and: • No audio from the radio. • Liftgate inoperative • IPC is inoperative • AWD/ 2WD light toggles randomly <p>Some technicians may find one or more of the following DTCs set:</p> <ul style="list-style-type: none"> • P0650: Malfunction Indicator Lamp (MIL) Control Circuit • P15A1: Fuel Economy Mode Switch Performance • P159F 00: Fuel Economy Mode Switch Circuit Low Voltage • U0184-00: Lost Communication With Radio • U0198-00: Lost Communication with Telematics Communication Interface Control Module • U1501-00: LIN Bus
Cause	The cause of the condition may be that the X200 connector was not fully connected and locked or poor terminal tension, resulting in an open circuit.

Note: First inspect the X200 connection BEFORE disconnecting.

2. Inspect the X200 IP harness to Body harness connector (7), located at the lower Left A-Pillar, for possibly not being seated correctly.
3. Ensure that the wires are not twisted, not too taut, and the routing is correct.
4. Also ensure that the connection is correctly seated on all 4 sides.
 - ⇒ If the connector is seated correctly but the condition still exists inspect the terminals for proper terminal tension or backed out terminals.
5. Verify that the condition has been eliminated.
