Service Bulletin

Bulletin No.: 20-NA-142

Subject: Shudder/Surging While Driving

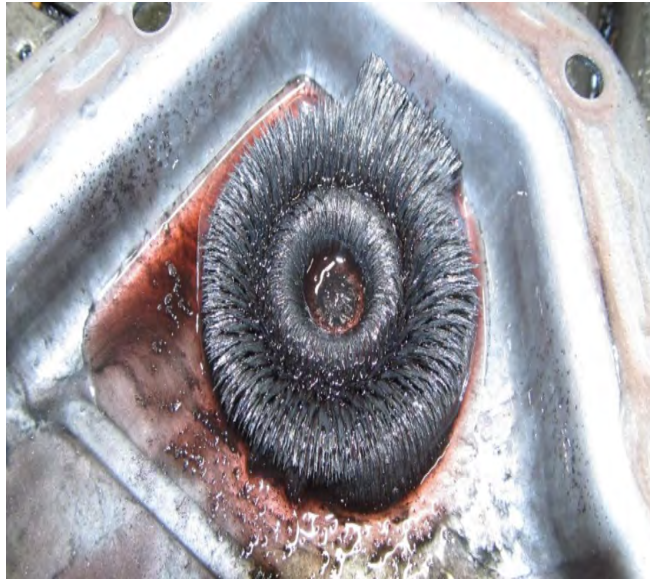
5360216

Involved Region or Country	North America
Condition	Some customers may comment that a surging condition is felt when driving. Some technicians may find during diagnosis or performing PIP5504F, may identify the surging as a torque converter shudder.
Cause	This condition may be caused by additives in the transmission fluid may have been depleted during vehicle operation. – Some of these additives assisted with regulating a consistent slip rate of the clutches.
Correction	1. Raise the vehicle. 2. Remove the transmission pan.

- If metallic debris is present remove transmission and replace torque converter, replace filter. Refer to *Torque Converter Replacement* in SI.
- If metallic debris is not present replace the transmission filter, reinstall transmission oil pan and perform the steps in the Service Procedure below.
