Service Bulletin

Bulletin No.: 20-NA-155

Subject: Service Engine Soon Message at Start Up or Shortly after Start Up

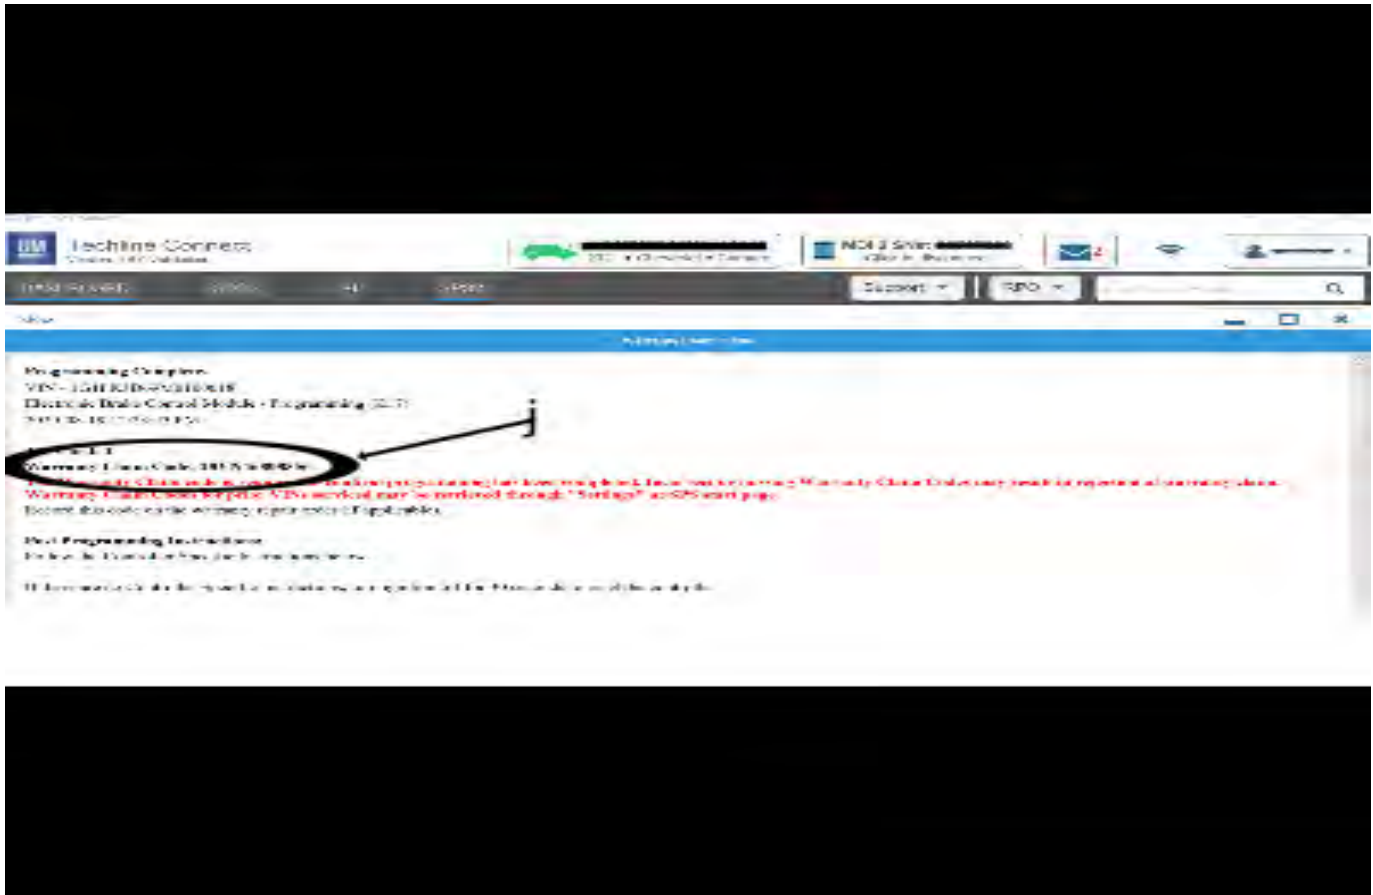
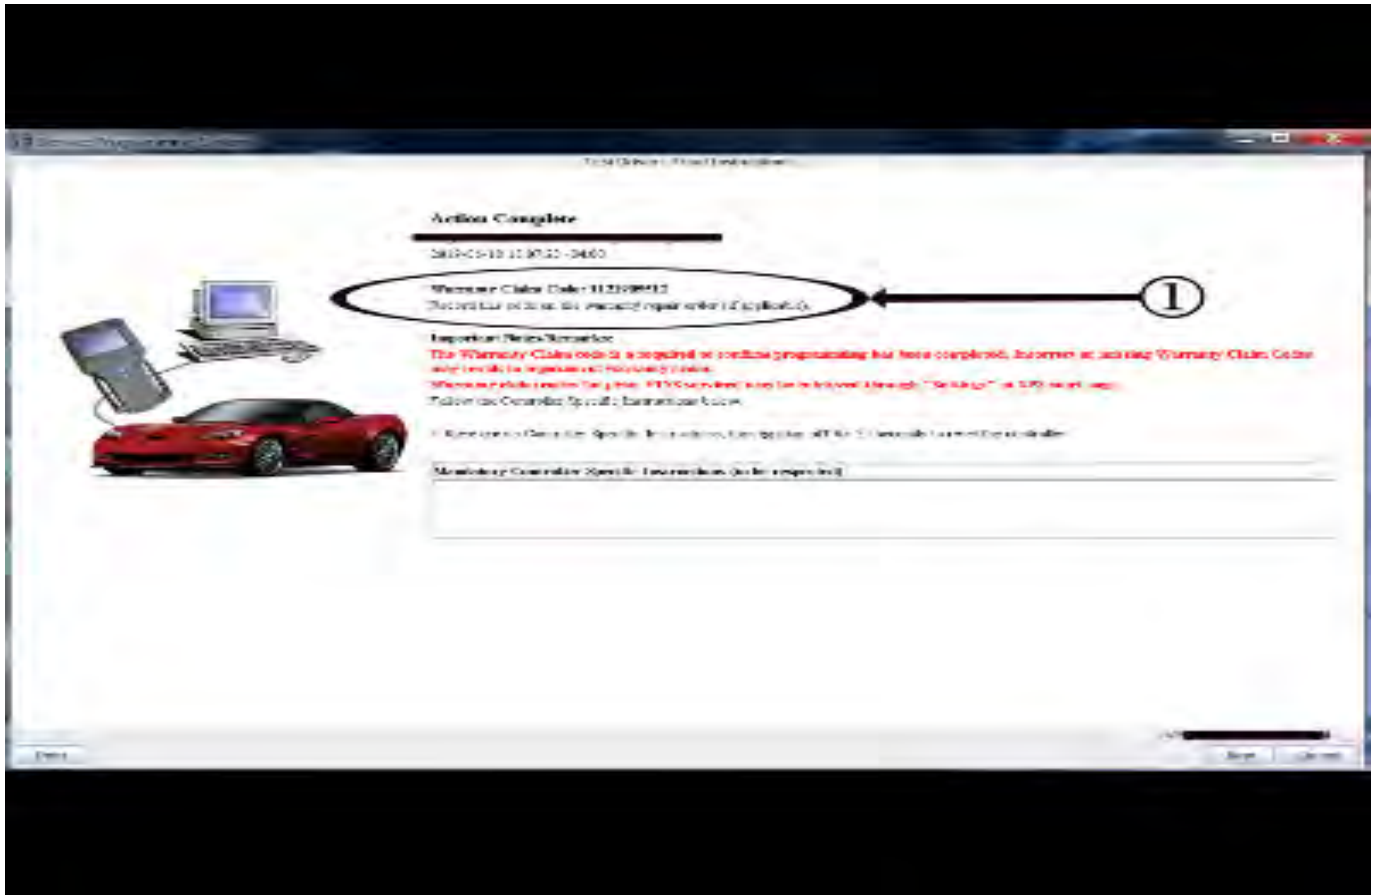
5431209

Important: To avoid warranty transaction rejections, you **MUST** record the warranty claim code on the SPS Warranty Claim Code (WCC) screen provided on the job card. Refer to callout 1 above for the location of the WCC on the SPS screen

- Record SPS Warranty Claim Code on job card for warranty transaction submission.
