# Service Bulletin

Bulletin No.: 20-NA-165

**Subject: Flutter or Boom Noise at 1200 RPM- Service Calibration**

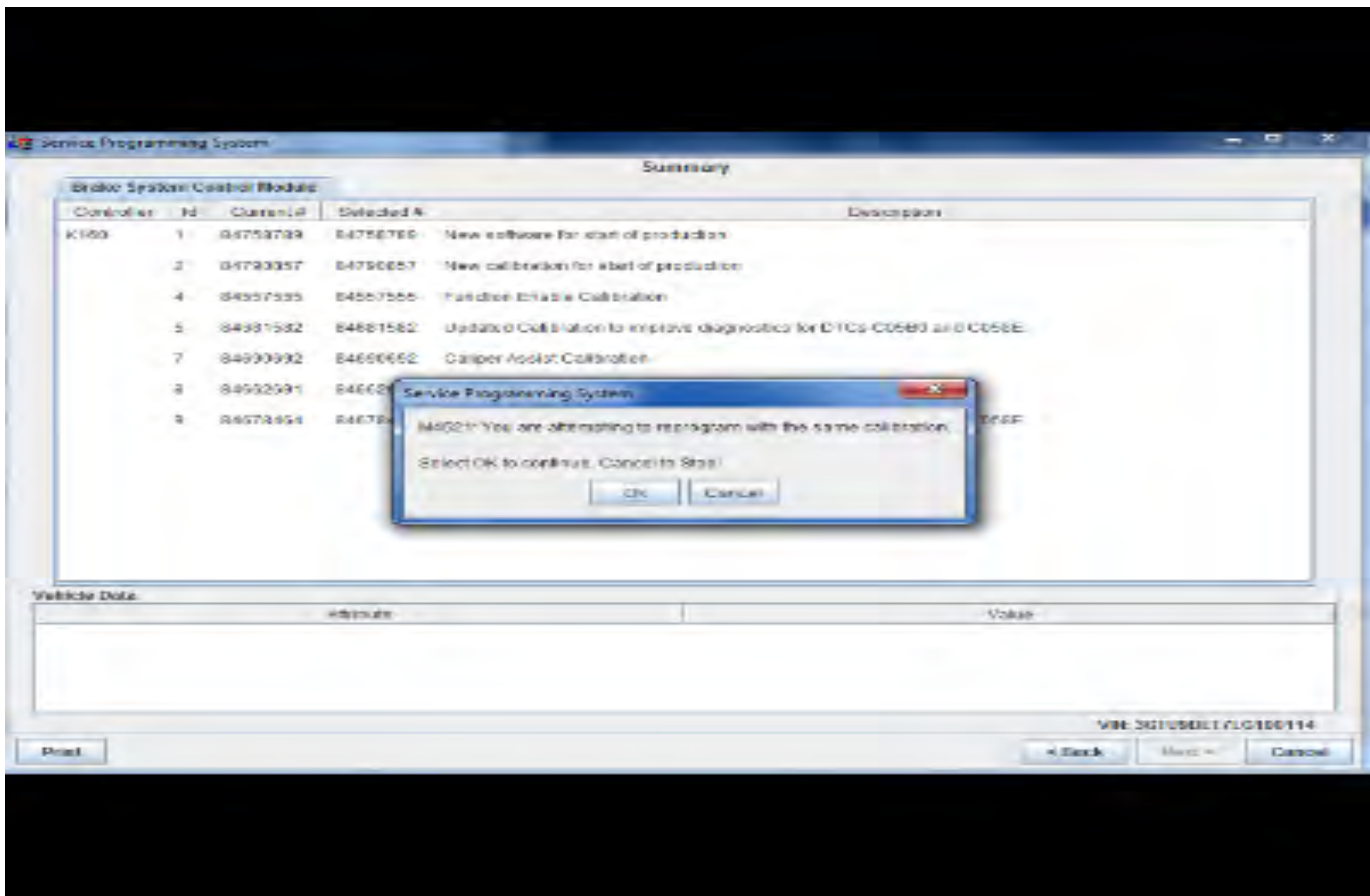
5431207

**Important:** If the Same Calibration/Software Warning is noted on the SPS screen, select OK and follow screen instructions. After a successful programming event, the WCC is located in the Service Programming

1. Reprogram the Engine and Transmission Control Modules. Refer to *K20 Engine Control Module: Programming and Setup* and *K71 Transmission Control Module: Programming and Setup* in SI.

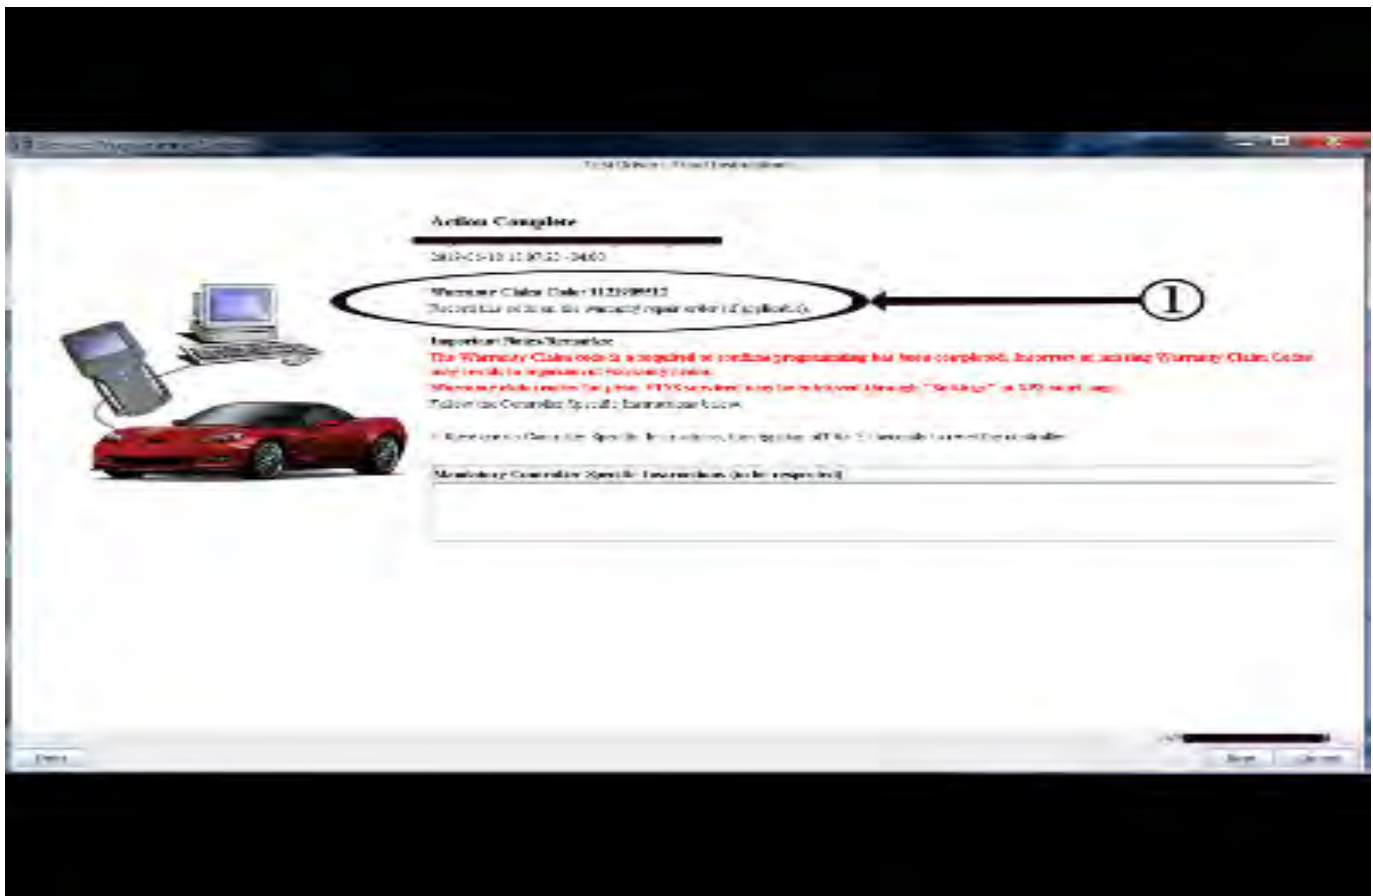
5431209

**Important:** To avoid warranty transaction rejections, you **MUST** record the warranty claim code provided on the SPS Warranty Claim Code (WCC) screen on the job card. Refer to callout 1 above for the location of the WCC on the SPS screen

2. Record SPS Warranty Claim Code on job card for warranty transaction submission.
