Service Bulletin

Bulletin No.: 20-NA-169

Subject: Creak, Pop and/or Snap Type Noise Heard Coming from Passenger Side B-Pillar Area

Brand:	Model:	Model Year:		Breakpoint:		Engine:	Transmission:
		from	to	from	to	Eligilie.	mansinission.
Chevrolet	Traverse	2020	2020	-	-	-	-

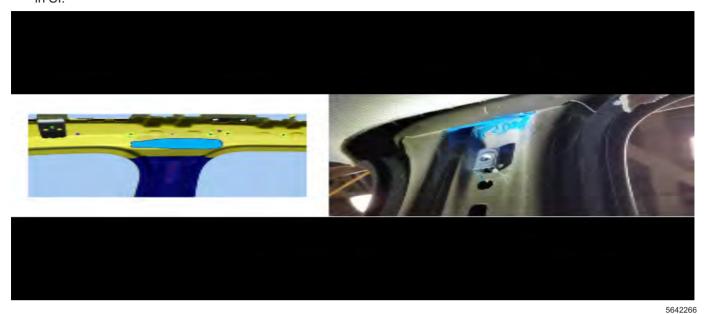
Involved Region or Country	United States, Canada, Mexico, Uzbekistan, Israel, Palestine, Colombia (West), GM Korea Company		
Condition	Some customers may comment on a creak, pop and/or snap type noise heard coming from passenger side B-Pillar area.		
Cause	This condition may be caused by metal to metal contact between the front roof inner front side rail and the center pillar inner panel (1), as shown in the picture above.		
Correction	Apply structural adhesive into the gap between the Roof Rail Inner and the Center Pillar Inner Panel follow the procedure below.

2. Apply Fusor 2098, or equivalent, into the entire length, covering the complete fore/aft distance, as shown in the picture above.

Important: Structural adhesive requires 24 hr. cure time.
