# Service Bulletin

Bulletin No.: 20-NA-175

**Subject: Vertical Misalignment Between Cab and Pickup Box on Driver Side of Vehicle**

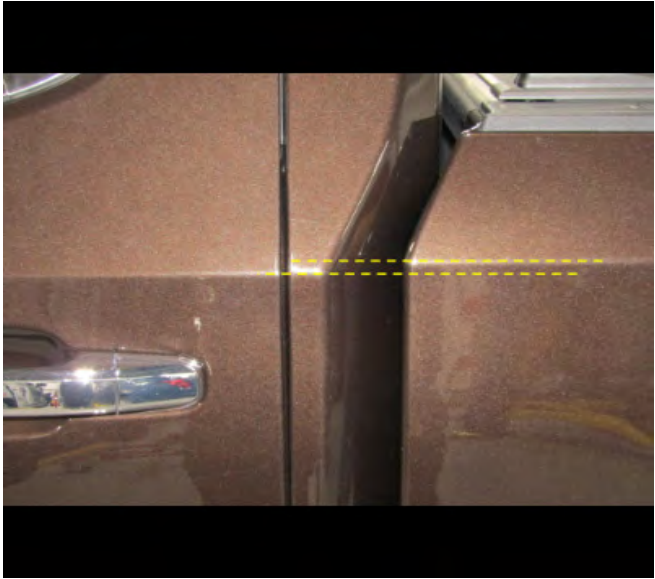
<p style="text-align: right;">5645798</p> <p>Some customers may comment on noticing anywhere from 2 –10 mm (0.08 – 0.4 in.) vertical misalignment of the body feature line between the cab and the pickup box, on the driver's side of vehicle.</p>
<b>Cause</b>	The cause of the condition may be pickup box structure variation.
<b>Correction</b>	Realign the left side of the cab and install shim washers, following the steps in the Service Procedure below.

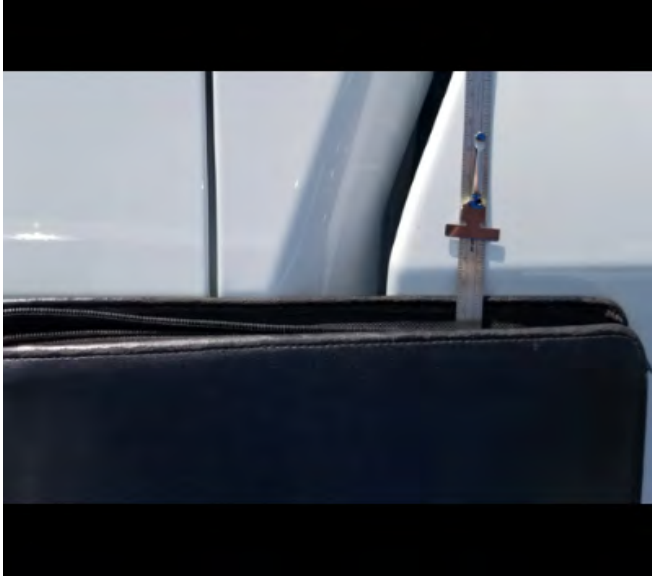
5645804

1. Verify the condition by visually checking, and measuring, the body feature line variance, on the left side of the vehicle.
2. Raise and support the vehicle. Refer to *Lifting and Jacking the Vehicle* in SI.
