Service Bulletin

Bulletin No.: 20-NA-183

Subject: Summit White Paint on Front Impact Bar Appears Off-Color, Slightly Yellow

Brand:	Model:	Model Year:		from Date Breakpoint	to VIN Breakpoint:	Engine:	Transmission:
		from	to				
GMC	Sierra 1500	2020	2020	July 7, 2020	1GTP9EEL1LZ317323	All	All

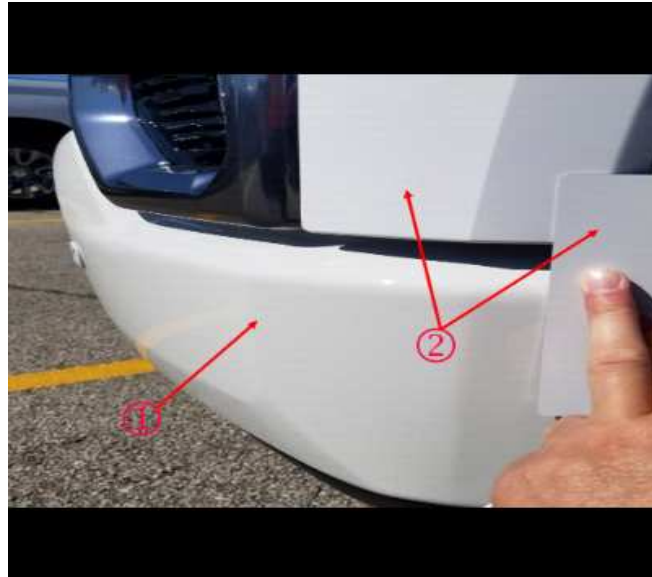
5647156

Some customers may comment on, in comparison to adjacent painted panels (2), the Summit White paint on front impact bar (1) appears off-color; slightly yellow.
Cause	The cause of the condition may be that contaminated paint from the bumper supplier may have been applied to a small window of the bumpers installed on vehicles.
Correction	Note: There are approximately 70 vehicles known to be affected by this condition Verify the vehicle is within the breakpoints of the condition, then follow the steps in the Service Procedure below.
