# Service Bulletin

Bulletin No.: 20-NA-184

**Subject:** Rattle Noise Heard Above Driver or Passenger Seat Area

Brand:	Model:	Model Year:		VIN:		Engine:	Transmission:
		from	to	from	to		
Chevrolet	Camaro Convertible	2016	2020	—	—	All	All

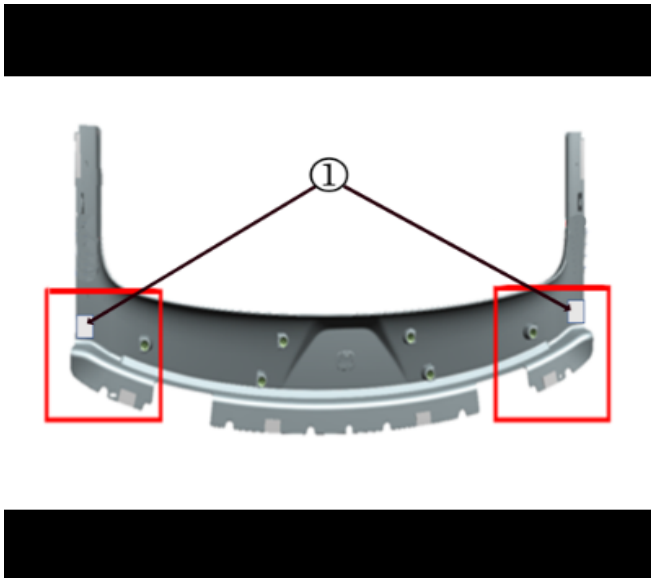
5645948

2. Note the 2 locations (1) of foam currently installed at the front corners of the header panel.
3. Cut 2 pieces of \*Kent Automotive Adhesive Back Shim Stock P46475, or equivalent, approximately the same size as the current foam.
