Service Bulletin

Bulletin No.: 20-NA-186

Subject: Unwanted Electric Park Brake Setting

Brand:	Model:	Model Year:		VIN:		Engine:	Transmission:
		from	to	from	to		
Chevrolet	Trailblazer (VIN M)	2021	2021			All	All

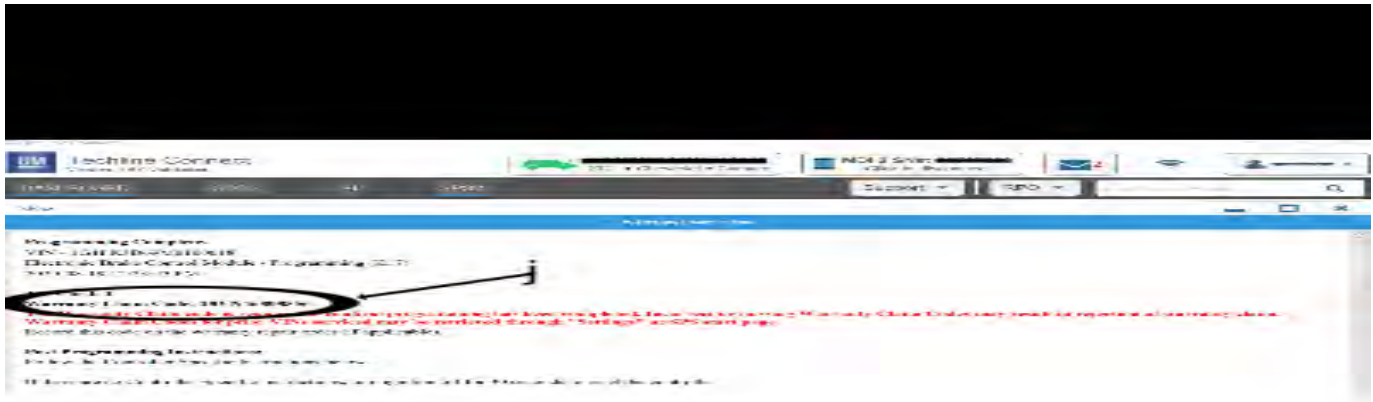
5644478

Important: To avoid warranty transaction rejections, you **MUST** record the warranty claim code provided on the SPS Warranty Claim Code (WCC) screen shown above on the job card. Refer to callout 1 above for the location of the WCC on the SPS screen

2. Record SPS Warranty Claim Code on job card for warranty transaction submission.
