Service Bulletin

Subject: Delayed and/or Harsh Engagement of Transmission Shift After Vehicle Sitting with Engine Off

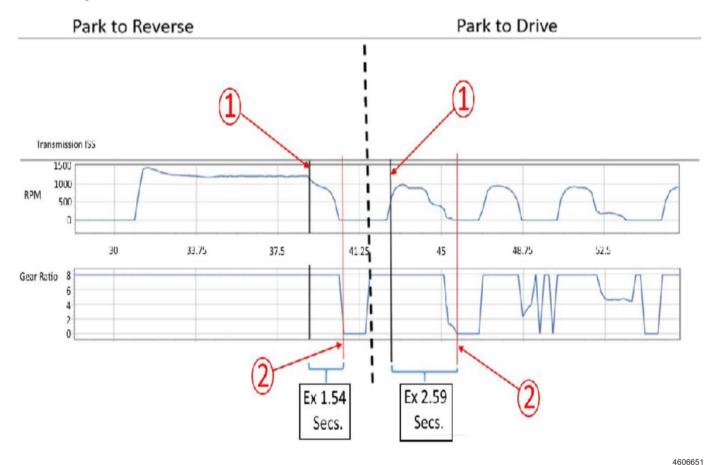
Delayed Engagement Park to Reverse or Drive is present if the time difference between Gear Selected (Pt. 1) and Transmission Input Shaft Speed reaching 0 RPMs (Pt. 2) exceeds 3 seconds. Foot is HELD on Brake during maneuver.

In most cases the transmission will engage in 3 seconds or less, which is considered an acceptable engagement time and no repairs should be attempted.

If engagement time exceeds 3 seconds, refer to the following procedures:

- Attempt to learn the C3 Drive and C5 Reverse -Clutch using the following steps:
- 1. Allow the transmission sump temperature to rise between 20° and 30°C (68° and 86°F).

- Perform 20 Park to Reverse shifts or 20 Park to Drive shifts releasing the brake pedal with each shift, allowing the vehicle to roll 5-10 feet (1.5-3.0 m) per engagement into gear.
- If the learn procedure does not correct the condition, disassemble the transmission and inspect the 1-3-5-6-7 Clutch (C3) for a delay into Drive and inspect the 4-5-6-7-8 Reverse Clutch (C5) for a delay into Reverse. The respective clutch plates and seals should be inspected for wear and or damage and repaired accordingly.
