Service Bulletin

Bulletin No.: 20-NA-194

Subject: Hard Tri-Fold Tonneau Cover Water Leaks at the Front Corners of the Pickup Box

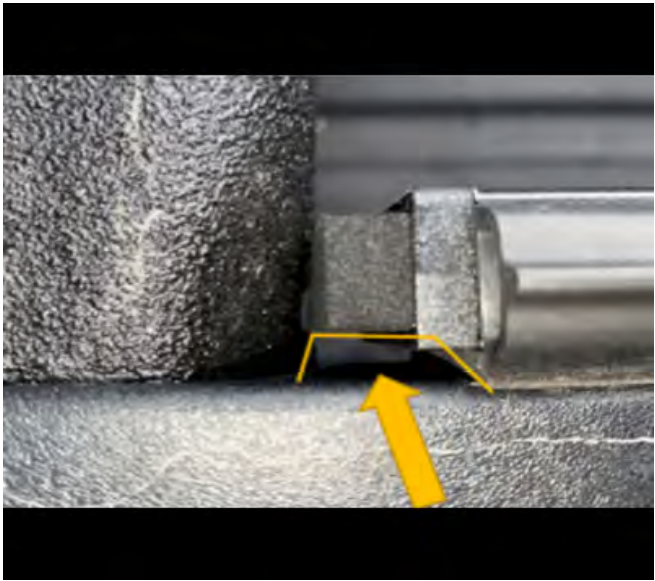
5651955

Involved Region or Country	North America, Middle East, Israel, Palestine, Chile, Paraguay and Thailand
Additional Options (RPOs)	
Condition	Some customers may comment that for vehicles with the Hard Tri-Fold tonneau cover installed, they are seeing water leaks at front corners of the pickup box.
Cause

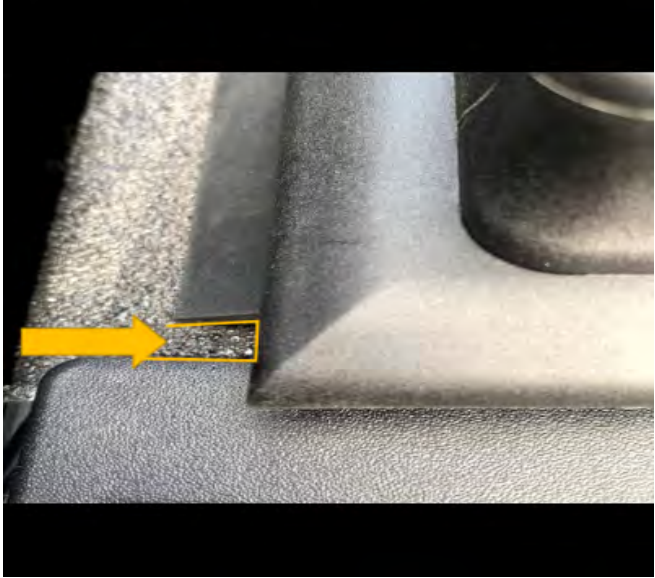
<p data-bbox="1419 739 1484 758">5651957</p> <p data-bbox="539 768 1406 821">Note: Several examples of these cavity openings are shown at the arrow heads, in graphics above.</p> <p data-bbox="539 833 1463 886">The cause of the condition may be that the side rail seals do not completely close out the front corners of the pickup box and may allow water to enter through an opening.</p>
<p data-bbox="131 936 253 961">Correction</p>	<p data-bbox="539 894 1422 947">Important: All tonneau covers are water resistant, however are not water proof. The pickup box is a wet environment and does NOT seal the endgate to the box.</p> <p data-bbox="539 951 1468 1003">After verifying the condition, follow the steps in the Service Procedure below, to close out these openings with expandable foam.</p>
