Service Bulletin

Bulletin No.: 20-NA-198

Subject: Trailer Running Lights Shut Off Due to Excessive Load on the Running Lamp Circuit

Brand:	Model:	Model Year:		VIN:		Engine:	Transmission:
		from	to	from	to		
Chevrolet	Silverado 1500 (New Model)	2019	2019			All	All
GMC	Sierra 1500 (New Model)

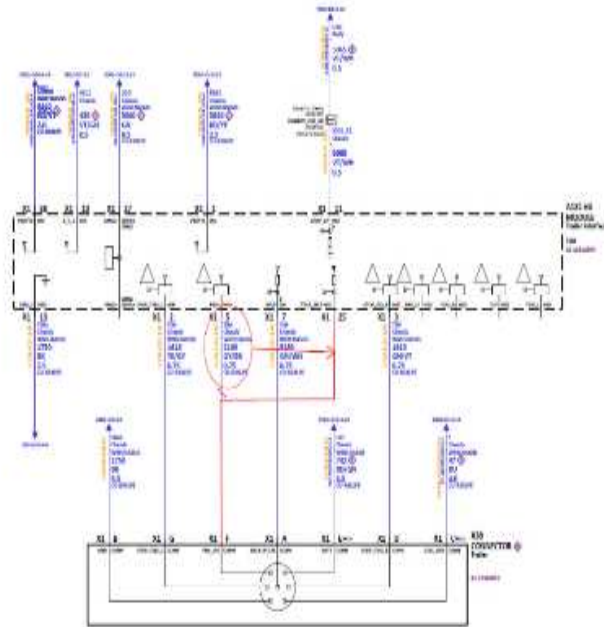
5652571

Additional Information	<p>2019 Model Year vehicles, equipped with U1D, use the K68 Trailer Lighting Control Module to control all trailer lighting through pulse width modulated (PWM) voltage. The Trailer Lamp Control Module has a current handling capability on the running lamp circuit of about 9 amps. On a trailer with a large number of incandescent lights, in-rush current can exceed 20 amps before it settles back to around 8-9 amps. During this inrush or "marriage" current period, the Trailer Lamp Control Module sees the current as an "overload" and goes into protection mode.</p> <p>This was changed for MY 20 to allow 16 amps of continuous current flow by routing the current through an internal relay in the Trailer Lamp Control Module. 2019 Trucks can be modified to operate in the same way. If we use 2020 design software and re-pin the running lamps to pin 25 using the internal relay to operate the running lamps. This requires a terminated lead to be inserted into cavity 25 on the chassis harness X1 connector. Wiring connected to pin 5 on the X1 will be cut and reconnected to Pin 25. Terminal in cavity 5 will remain, be blunt cut, and sealed with a closed end duraseal splice to prevent water entering through pin 5.</p> <p>Software will have to be managed by TCSC. A record must exist of what trucks have been flashed and that the bulletin has been completed. Software will not work with the production configuration of wiring. This also changes the trailer connection detection flashing of LED lighting from every 10 seconds to every 42 minutes. (Connection detection will still be enabled if trailer theft deterrent is enabled).</p>

Following the steps in the Service Procedure below, move circuit 2109 on the trailer Lamp Control Module from X1 cavity 5 to X1 cavity 25, and load new software from SPS into the Trailer Lamp Control Module.
