TRD Skid Plate Noise

2014-2020 Tundra

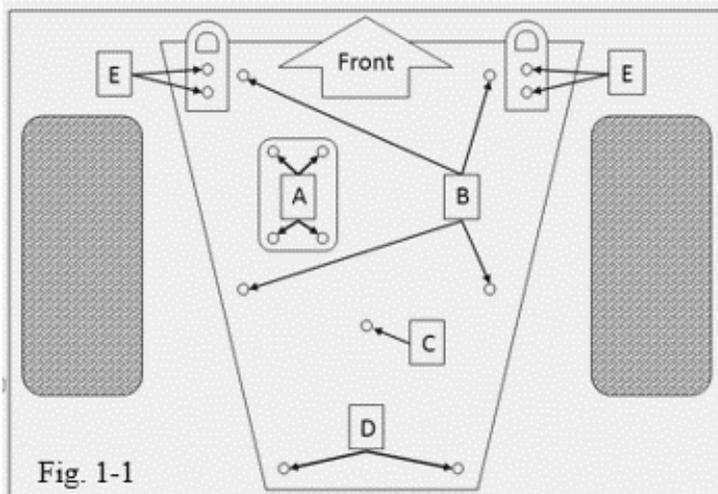
Fig. 1-1

Some 2014-2020 model year Tundra vehicles with a TRD skid plate may exhibit a “creaking” or “crackling” noise coming from the lower front end. The source of this noise has been pinpointed in several cases to the TRD skid plate contacting the frame crossmember.

Contact between skid plate and frame crossmember is by design. **DO NOT MODIFY** skid plate hardware, add shims, washers, insulating material, etc. The TRD skid plate has been engineered for use as a front lifting point. Deviation from the designed hardware could result in damage to the skid plate during lifting.

Skid plate fastener torques are **CRITICAL** to prevent abnormal noise and ensure safe usage of integrated jack point. See torque reference table, Fig. 1-1.

Reference TRD Skid Plate installation instructions for proper re-installation of the skid plate assembly.

Bolt	Qty	Tool	Torque
A	4	5mm hex bit	18 ft-lb (25 N-m)
B	4	12mm socket	21 ft-lb (28 N-m)
C	1	5mm hex bit	21 ft-lb (28 N-m)
D	2	15mm socket + wrench	38 ft-lb (51 N-m)
E	4	17mm socket	43 ft-lb (58 N-m)
