PREVOST

## SERVICE CENTER INFORMATION

**SCI20-16**

| SUBJECT : | <b>FAN CLUTCH PLATE BOLTS RE-TORQUING</b> | |

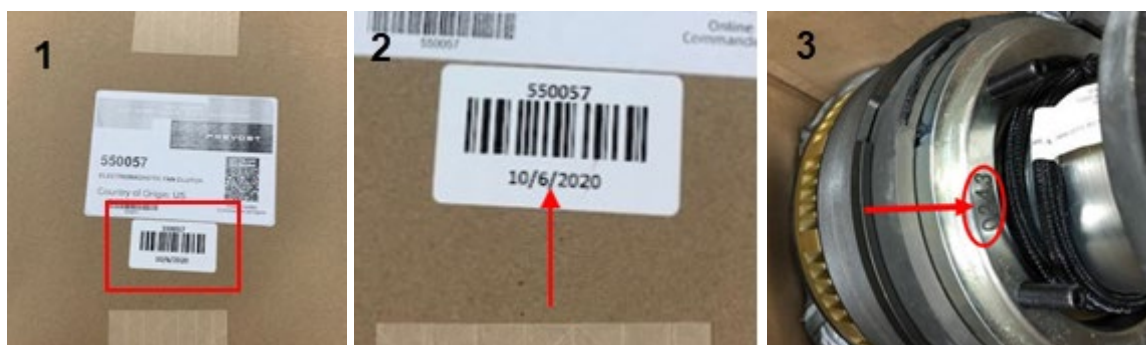
**Figure 1 & 2 :** If a bar code tag with a 10/6/2020 (and up) date is present on the box, the clutch is a late model production and does not need to be re-torqued (all models).

**Figure 3 :** Position of the clutch serial number (must be from 0448 to 0578)

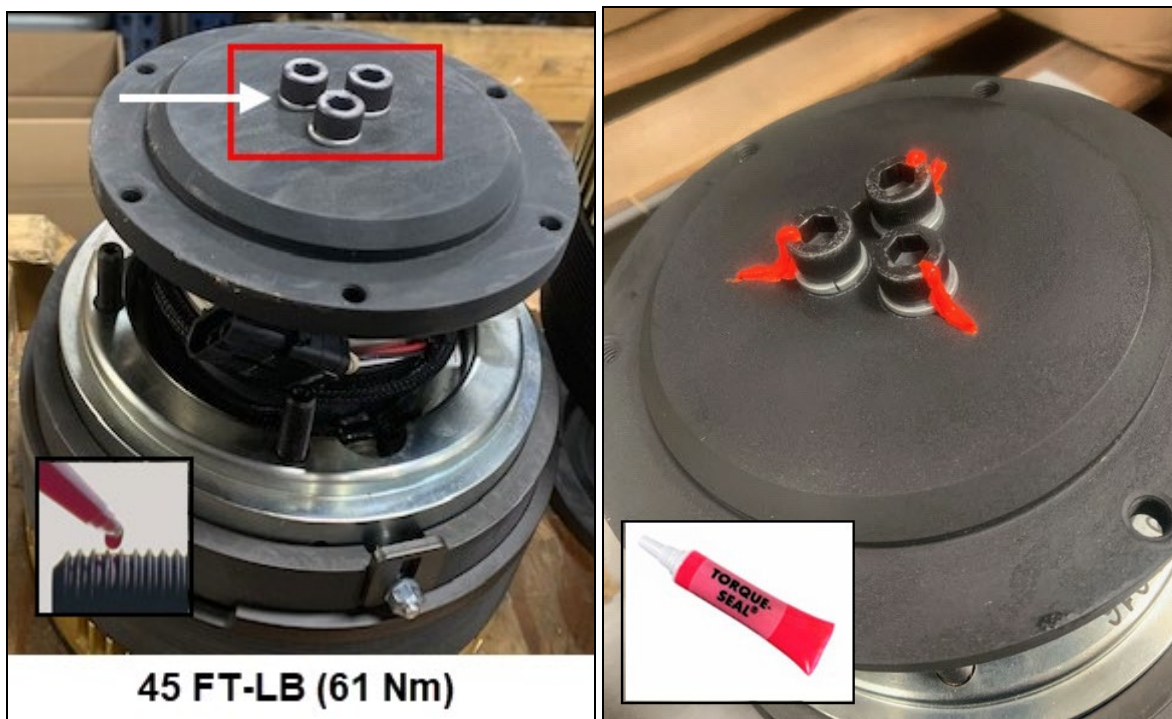
On the clutches affected by this bulletin, the three fan plate hex cap bolts (Allen type) may not have been torqued sufficiently and may become loose during operation. All units affected must have their bolts removed and torqued to proper spec using high strength (red) threads locker. This will ensure maximum service life and maximum performance of the clutches (see complete procedure below for details).

1. Unbolt the fan blade from the clutch (6 bolts). Lay the fan down in the fan shroud taking care not to damage the radiator core.
2. Remove and clean the 3 socket head fan plate bolts (M10x1.5 30 mm long).
3. Apply 272 high strength Loctite thread locker (or equivalent) to the 3 bolts.
4. Torque the 3 M10x1.5 bolts to **45 ft-lb (61 Nm)**.
5. Apply a stripe of tamper proof indicator paint (torque seal) to the bolt heads.
6. Reinstall the fan and torque the 6 bolts **32 ft-lb (43 Nm)**.

1. Remove 3 socket head fan plate bolts (M10x1.5 30 mm long).
2. Clean bolt threads and threads in the shaft with wire brush.
3. Apply 272 high strength Loctite thread locker (or equivalent) to the three bolts.
4. Torque the 3 M10x1.5 bolts to **45 ft-lb (61 NM)**.
5. Apply a stripe of tamper proof indicator paint (torque seal) to the bolt heads.
