IMPORTANT UPDATE

TECHNICAL INSTRUCTIONS FOR SPECIAL SERVICE CAMPAIGN K0B MILLIMETER WAVE RADAR SENSOR

**CERTAIN:
2018 – 2019 TACOMA
2018 – 2019 TUNDRA**

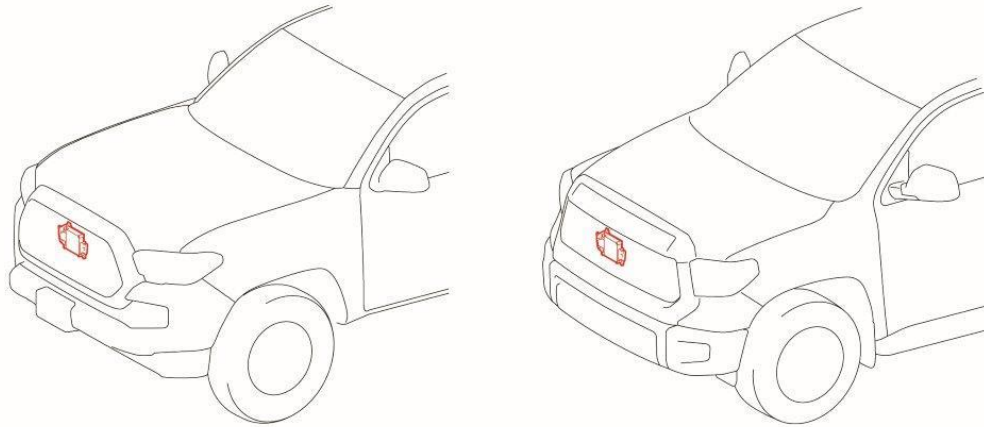
The involved vehicles are equipped with a Pre-Collision System (PCS) that may automatically apply the brakes if the system detects a potential collision. Due to the mounting of one of the system's sensors, it is possible for water to enter the sensor. This can lead to PCS deactivation or inadvertent brake activation resulting in limited deceleration for a short duration of time.
