# SHIFT SHAFT REPLACEMENT

**AFFECTED MODEL:  
 2020 1290 SUPER DUKE R**

**RESTRICTIONS: AFFECTED MODELS ARE LINKED BY VIN IN KTM DEALER.NET**

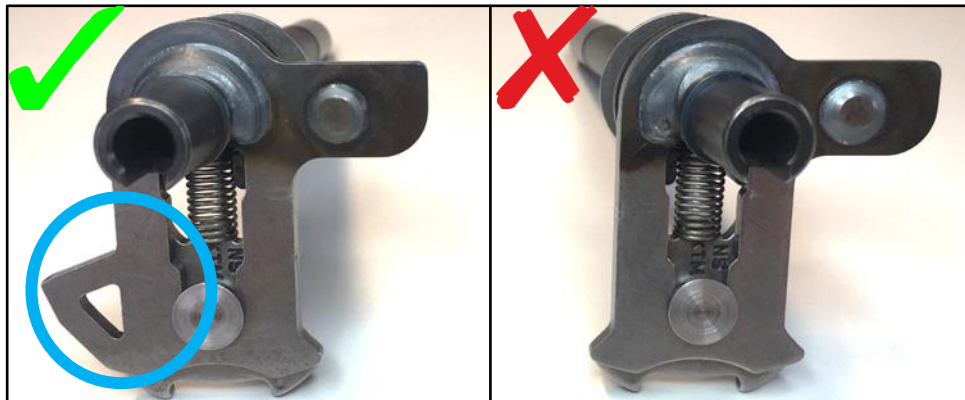
Fig. 1

KTM North America, Inc. has determined that a deviation has been found with the shift shaft stop of certain 2020 1290 Super Duke R models. On affected VIN's the shift shaft stop may not be the proper length intended during gear changes. During operation this could cause the motorcycle to feel hard to shift. To remedy this the shift shaft must be replaced with a new revised version. The revised shift shaft P.N. 61734005044 (Fig.1) has a new additional stop which is pictured below to compare to with the original shift shaft.

P.N.- 61734005044

Originally installed part
