Technical Service Bulletin

66 Exterior black optic trim discoloration

66 20 67 2060333/2 October 16, 2020. Supersedes Technical Service Bulletin Group 66 number 20-66 dated August 4, 2020 for reasons listed below.

Model(s)	Year	VIN Range	Vehicle-Specific Equipment
All	2018 - 2020	All	Black Optic

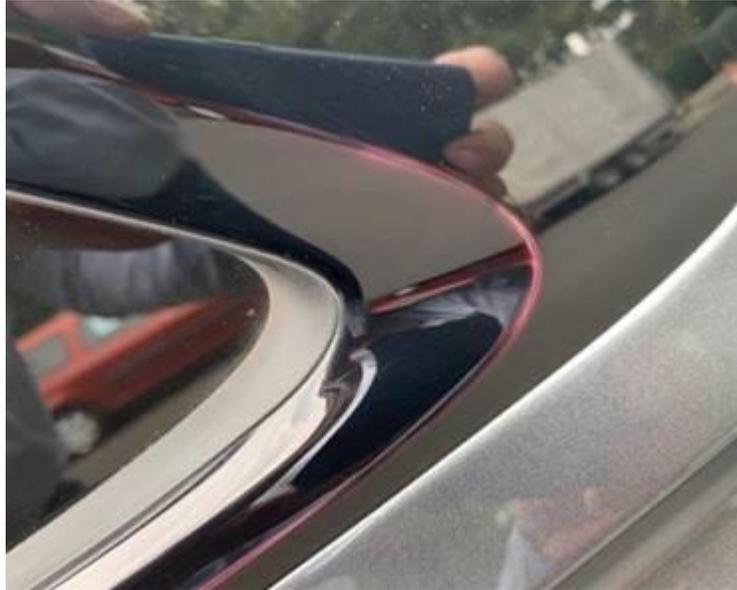
- The exterior trim on a vehicle with black optic package is discolored. It appears to take on a red or purple hue and, in some cases, may take on a grey or metallic appearance.

The ultraviolet radiation resistance in the trim coating was found to be insufficient.

Figure 1. The black optic trim takes on a red, purple, grey or metallic hue.

2. Should the symptom described in this TSB present as described, then replace the affected trim. Any other symptom on a black optic trim piece or an issue with a non-black optic trim piece may require AASM authorization as specified in the Warranty Policies and Procedures.

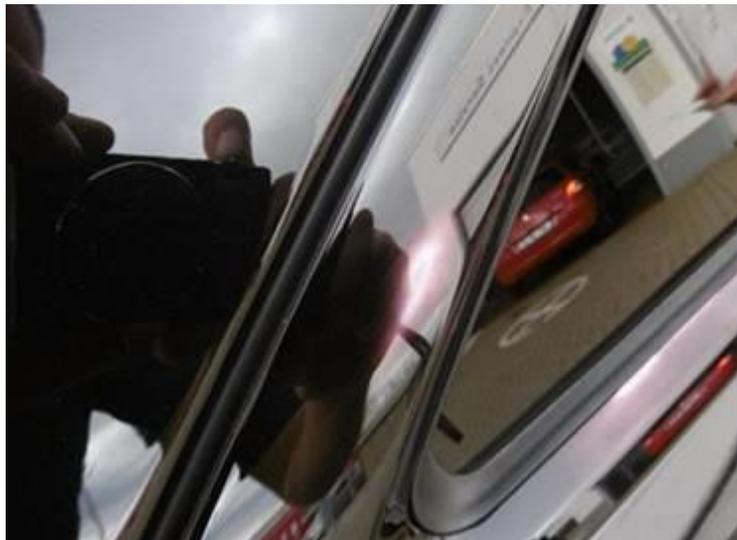
Figure 2. An additional example of the trim discoloration.

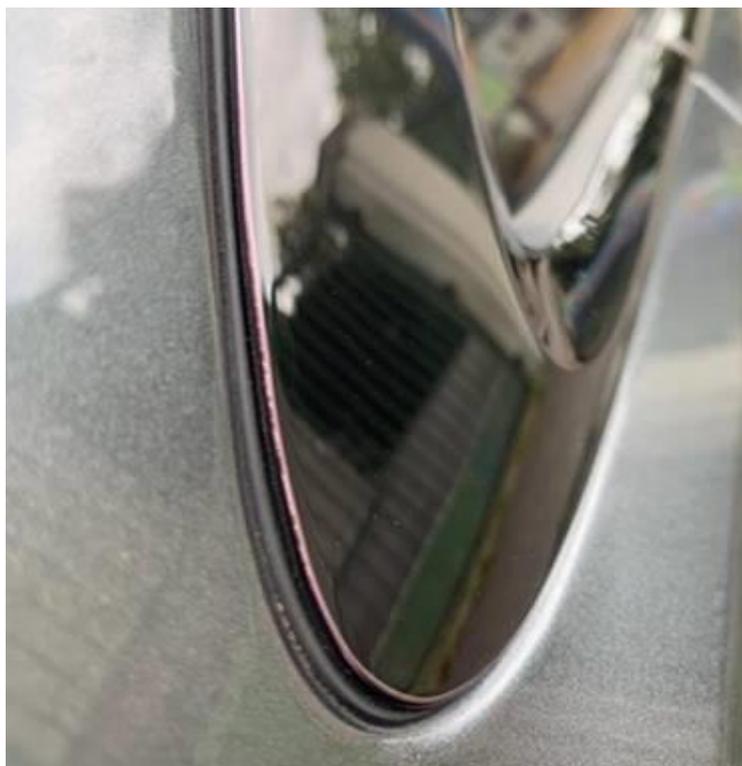
Figure 3. Discolored black optic trim around rear side window.
