# SN KB3779 TS Help - Shutting off while...

**SN KB3779 TS Help - Shutting off while driving - codes: 523515/31 & 639/14** May 29, 2018 9:49 PM

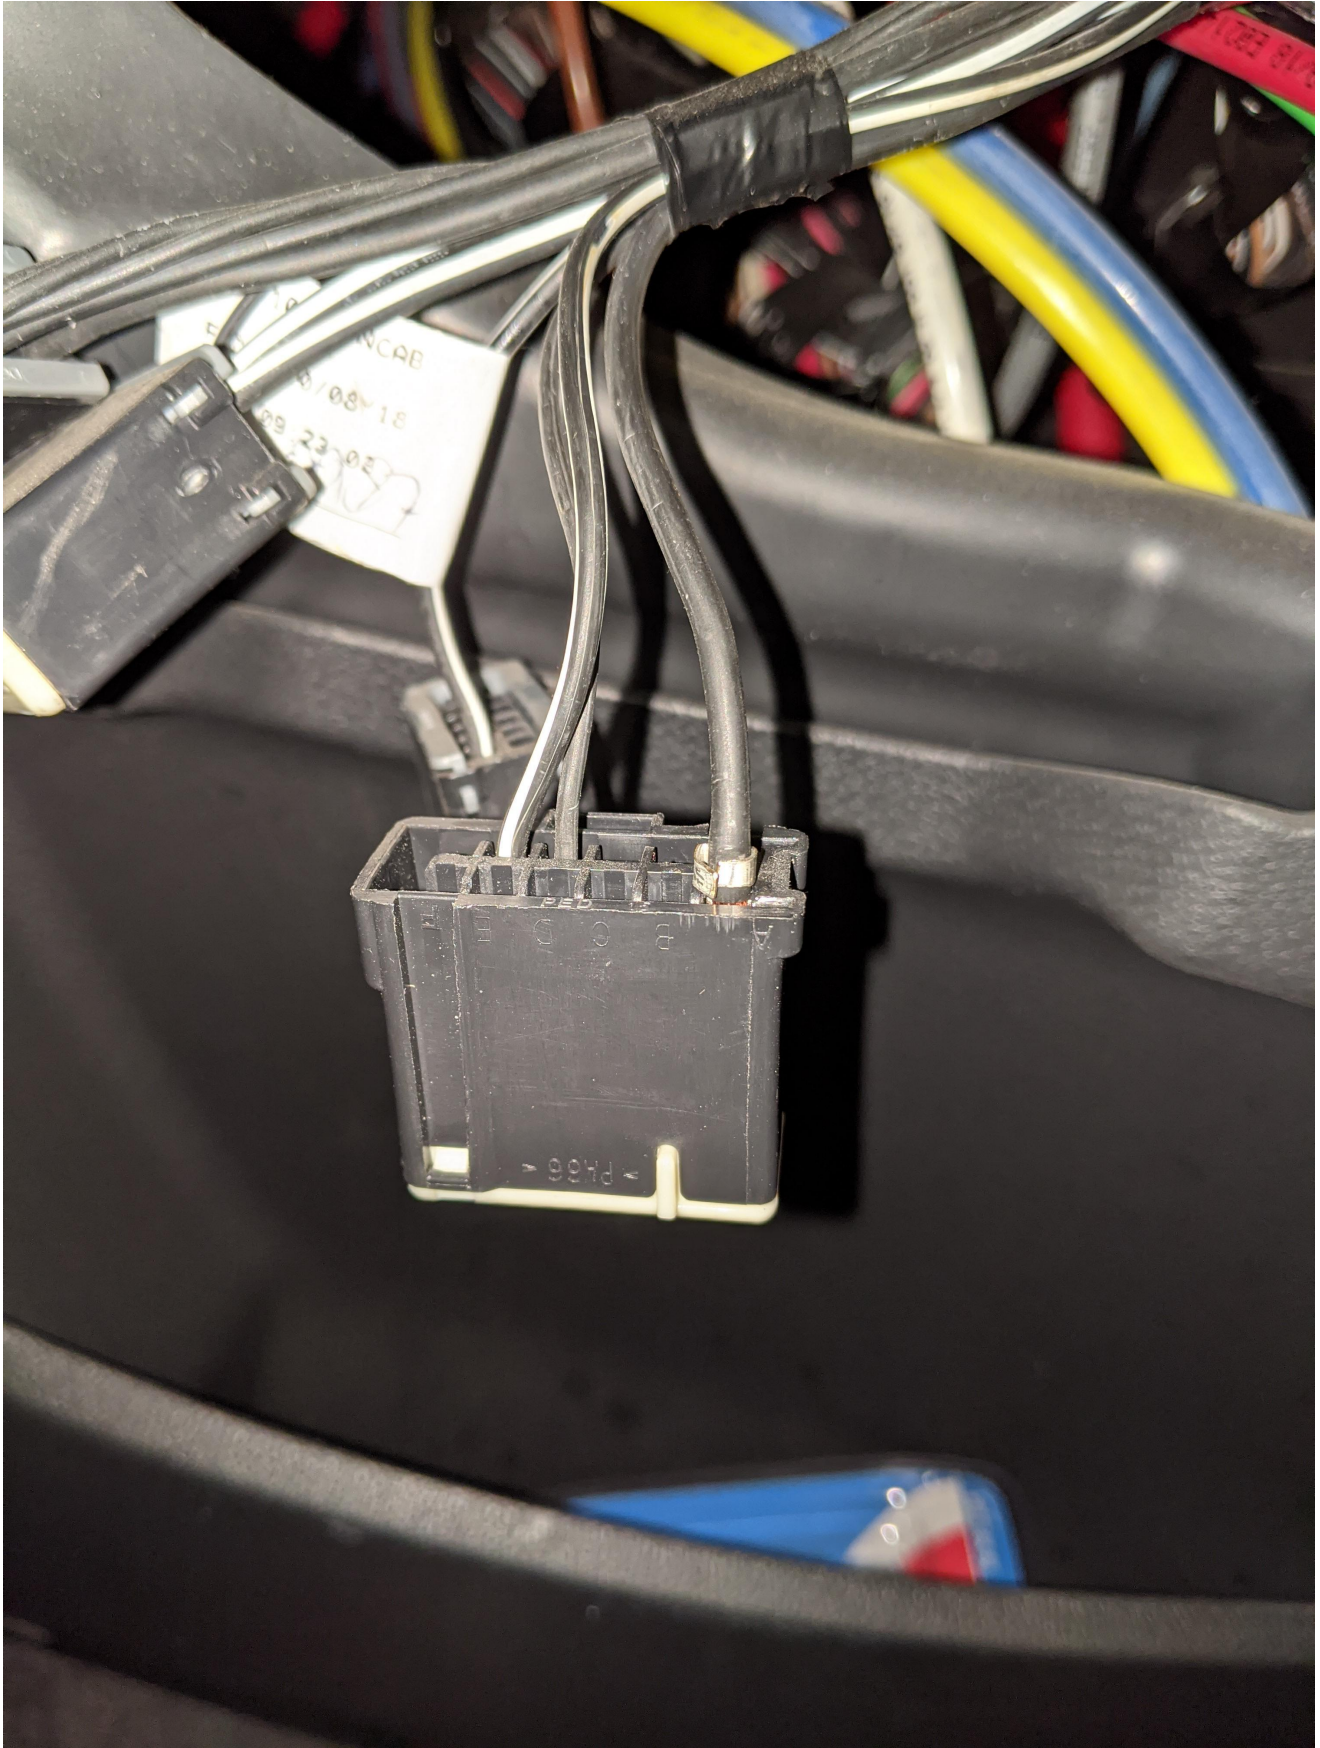
Had the same 2 codes and found this at the ground splices behind the pull panel. Crimped so badly at the top that it wouldn't even lock into place. Was able to repair it and no more code.
