UPGRADE BULLETIN: 200915REV

Fleetwood Fortis, manufactured 5/5/2020 - 7/24/2020

Holiday Rambler Invicta, manufactured 5/12/2020 - 5/21/2020

Reinforcing the slideout platform bed top

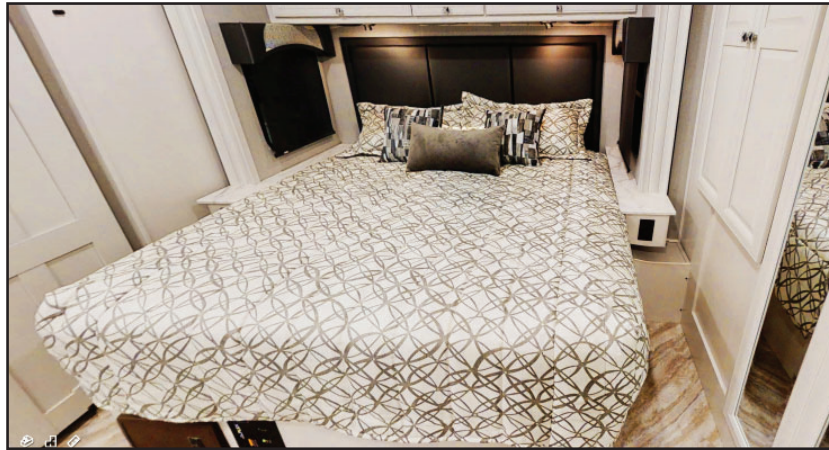
Figure 1

3. Locate the slideout platform bed. Refer to Figure 1. Lift up or remove the mattress to inspect the platform bed's plywood top for the presence of metal reinforcement strip(s) and to ensure it is level and not bent or otherwise damaged. See Figure 2.

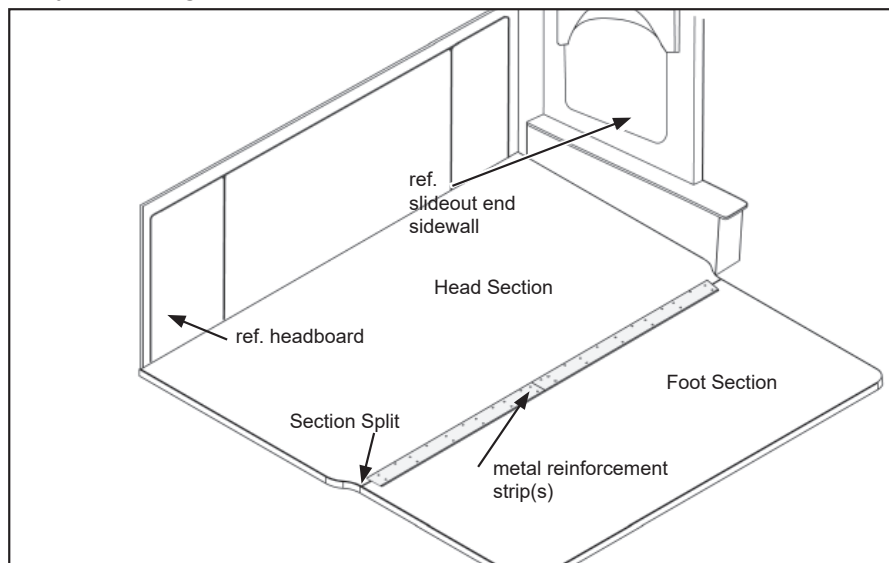
Note: There may be 1 long metal reinforcement strip or 2 half-strips installed at the section split.

- a. If metal reinforcement strip(s) are installed at the section split on the platform bed's plywood top (as shown in Figure 2), and it is level and undamaged, take a few clear photos of the bed top which clearly show the metal reinforcement strip is installed. **The photos MUST be attached to the claim in REV RV's Dealer Warranty portal in order for the claim to be eligible for reimbursement.** Use the Flat Rate code for "Inspected/Not Defective", as listed on Page 4. No further work is required if the unit was inspected and determined not defective.

Referring to Figure 2 on the previous page, locate the center of the bed top and butt the strips up against each other lengthwise, centering the pair from the left side of the platform to the right side. It may be helpful to use a tape measure and mark the locations with a pencil.

9. Position one of the new metal strips over the bed platform section split; it is to be 5/8" overlap over the outer (head) platform section, and 2 7/8" overlap over the inner (foot) platform section. Repeat with the second metal strip on the opposite side of the bed top. Refer to Figures 2 and 3.
10. Install #6 X 1 5/8" PFH self-tapping screws (included with the repair kit) through the two rows of pre-drilled holes of each reinforcing strip which straddle the section split (total qty. 23 screws). It is very important to ensure the screws pass through the 3/4" plywood and into the aluminum tube.
11. Fasten through the last row of holes in each reinforcing strip and into 3/4" plywood using (qty. 12) #8 X 3/4" PFH wood screws.
