## Oil Filler Plug, Hub Cap Side, Adjustment VN, VHD

### FSB 773-004 Oil Filler Plug, Hub Cap Side, Adjustment

(October 2020)

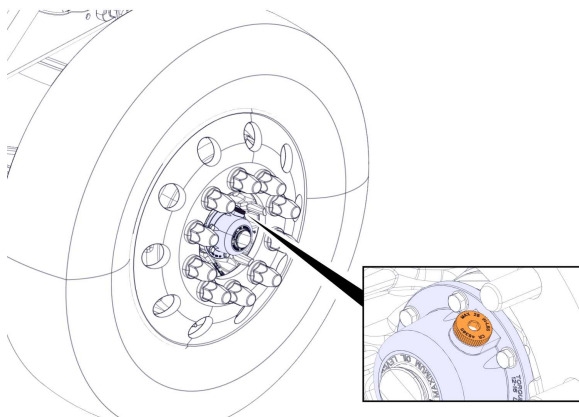
T7164480

On certain Volvo trucks, models VN and VHD built from June 29th, 2020 through July 24th 2020 and equipped with SKF hubcap part number 23873065, a loose fill plug has been reported in some cases.

- 4 Check oil level in the hub.  
**Note:** Ensure oil level is correct.
- 5 Tighten the fill plug to 25 in.lbf (Finger tight).
