TECHNICAL SERVICE BULLETIN

Unintended Exterior Mirror Movement In Wet Weather Conditions

20-2372
20 October 2020

Ford 2013-2014 Fusion
Lincoln 2013-2020 MKZ

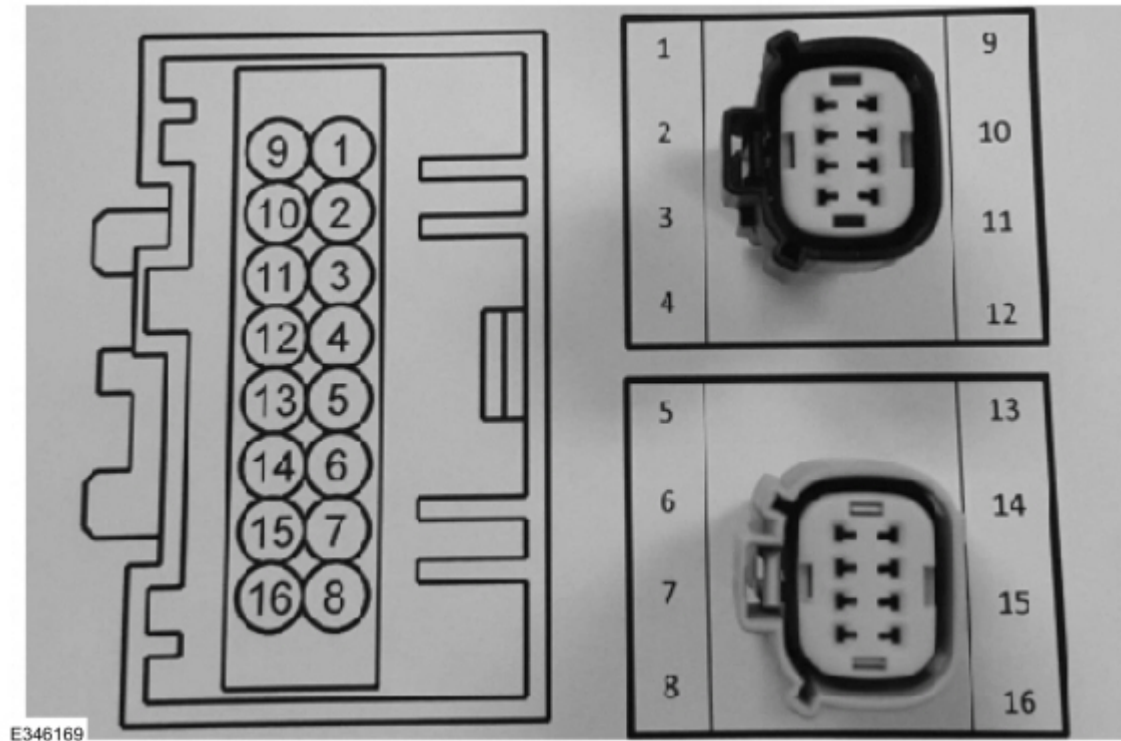
Issue: Some 2013-2014 Fusion and 2013-2020 MKZ vehicles may exhibit unintended exterior mirror movement in wet weather conditions. This may be due to water intrusion into the exterior mirror connector. To correct the condition, follow the Service Procedure steps to remove the 16 pin connector and install two weather tight 8 pin connectors.

1. Remove the affected exterior mirror. Refer to WSM, Section 501-09.
2. Remove the original 16-pin mirror connector by cutting the wires 13 mm (1/2 inch) from the connector and splice to the 8-pin gray and 8-pin black male connector pigtails by following the wiring repair kit instructions included with the pigtail kit. (Figure 1)
