IMPORTANT SAFETY RECALL NOTICE

Subject: Can-Am® Ryker - Wheel nut may crack - New VINs Added in the Warranty Campaign and New Steps in the Procedure

WARRANTY BULLETIN SAFETY CAMPAIGN

Subject: **Wheel Nut May Crack**

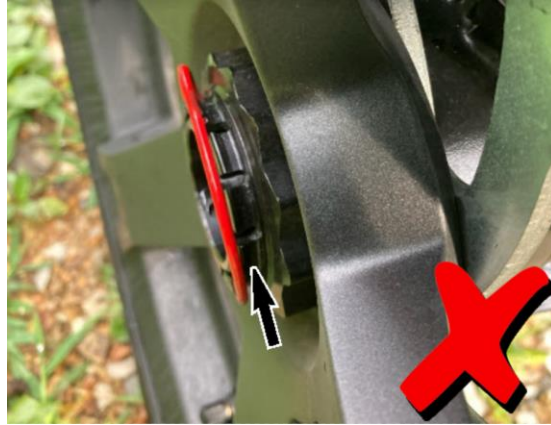
RED LOCKING CLIP OUT OF THE GROOVE

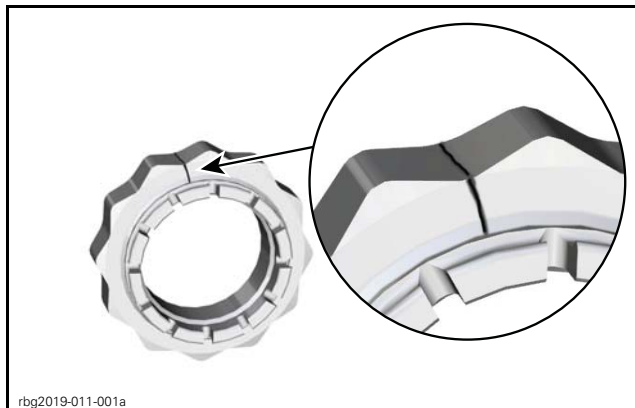
One or more wheel nuts may crack resulting in a reduced clamping force. This could eventually affect the integrity of the wheel assembly and the vehicle's behavior. This may increase the risk of a crash.

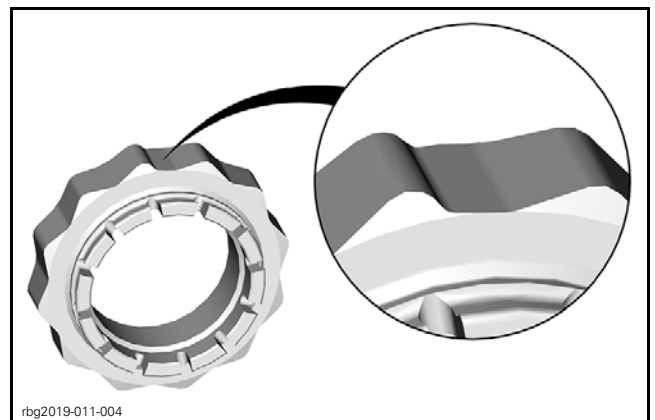
The improved nut has a pronounced groove on one of its edges.

Replace all wheel nuts on the vehicle.

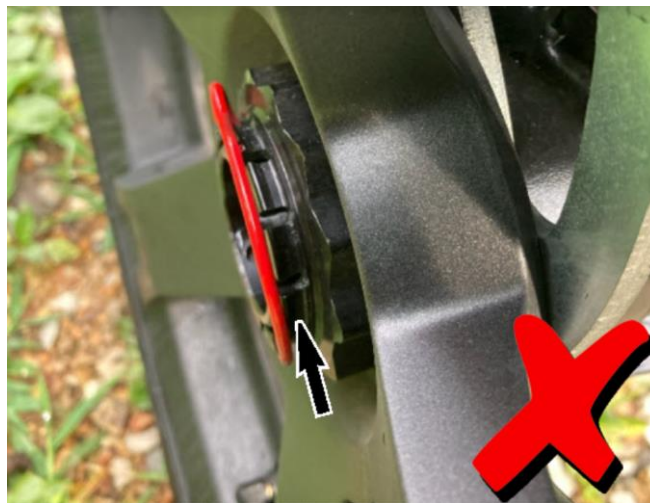
A properly installed red locking clip is sitting well into the groove all around the nut. If you see an installation like the picture below - red locking clip NOT installed properly, contact your dealer to organise transportation of your vehicle to the dealership.

RED LOCKING CLIP OUT OF THE GROOVE

If the red locking clip is NOT well installed, do not drive your vehicle as you may lose a wheel while driving.
