**Countries:** CANADA, UNITED STATES, MEXICO **Document ID:** IK1600233  
**Availability:** ISIS, NotSIR **Revision:** 3  
**Major System:** CAB / SLEEPER / HOOD **Created:** 9/21/2017  
**Current Language:** English **Last Modified:** 10/9/2020  
**Other Languages:** NONE **Author:** Steven Bautz  
**Viewed:** 1483

**Title:** Cab Lean Concern

**Applies To:** All models except CV, PayStar, and HX.

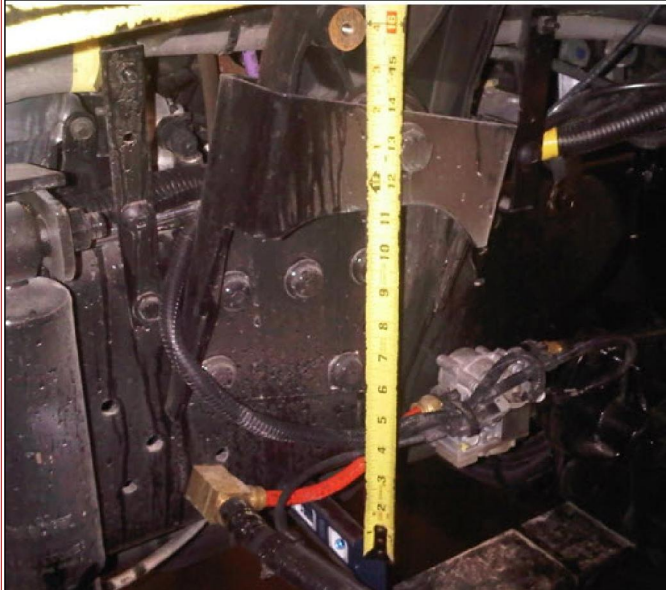
| Step | Action | Process |
|---|---|---|
| #2 | | <ol style="list-style-type: none"> <li>1. Park vehicle on a level surface.</li> <li>2. Hold a level to the bottom of the frame rail directly under the cab front isolator and center the level's bubble. Refer to picture – ProStar shown in the example.</li> <li>3. Measure the distance from the level to the center of the cab front isolator bolt. Note the inner front fender may need to be removed for access on some vehicles.</li> <li>4. Repeat the procedure on the opposite side of the vehicle and compare the measurements.</li> </ol> <p><b>NOTE:</b> The maximum allowable delta between the measurements is 9.5mm (3/8") MAX.</p> <p>If a lean greater than 9.5mm is confirmed via the measurements per above, please proceed to the repair process.</p> |

1. The front cab mounts are adjustable and no longer hucked together. (Prostar cab mount used for demonstration purposes.)
2. With the fenders still removed, safely place 2 bottle jacks under the cab to secure the cab in place.
3. Loosen all 8 cab mounting bolts.
4. Lower the side that has the higher initial measurement and snug the mounting bolts down.
5. Raise the side that had the initial low measurement and snug the bolts down.
6. Replace bolts and nuts as needed. See parts information for the correct bolt and nut part numbers.
7. If the adjusted lean condition is less than 9.5mm (3/8") and looks satisfactory torque all cab mount bolts 195 - 240 lb/ft (265 - 325 Nm).
