PS299 (Rev 4, 10/06/2020)

## CORRECT PROCEDURE FOR RAISING WINDSHIELD WIPERS

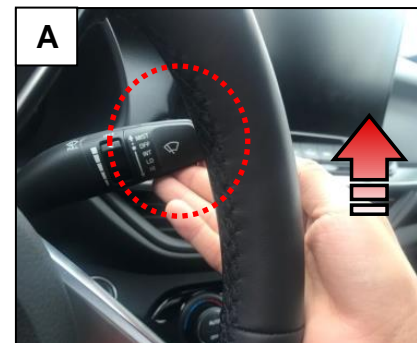
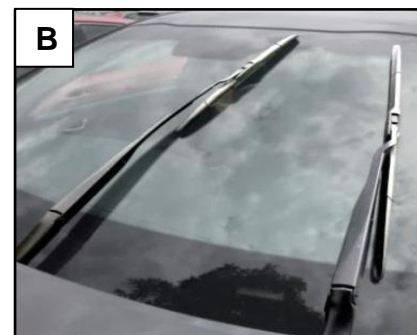
When servicing windshield wipers on the below listed vehicles, including during PDI, ensure to raise the wiper arms to a vertical position to **avoid damaging the paint on the rear edge of the hood**. The wipers are recessed below the hood to provide an enhanced appearance and reduced wind noise characteristics. This procedure applies to both key start and SMK type ignition systems.

1. Turn the vehicle Ignition ON with the engine OFF and then turn the ignition OFF.
2. Within Three (3) seconds after turning the vehicle ignition OFF; raise the Wiper Blade Control Stalk, and hold it for more than Two (2) seconds (A).
3. The Wiper Arms will move upward, and stop in the vertical position (B). The Wiper Arms may now be moved away from the Windshield for servicing (also during PDI).
4. Once finished servicing the Wipers, turn the vehicle ignition ON with the engine OFF. Then, move the Wiper Blade Control Stalk up to return the Wipers to the "park" position.
5. Finally, turn the vehicle ignition to the OFF position.
