GROUP BOD	MODEL 2021MY Telluride (ON)
	NUMBER 213	DATE October 2020

TECHNICAL SERVICE BULLETIN

SERVICE ACTION: DOOR BELT LINE MOLDING INSPECTION AND REPLACEMENT (SA445)

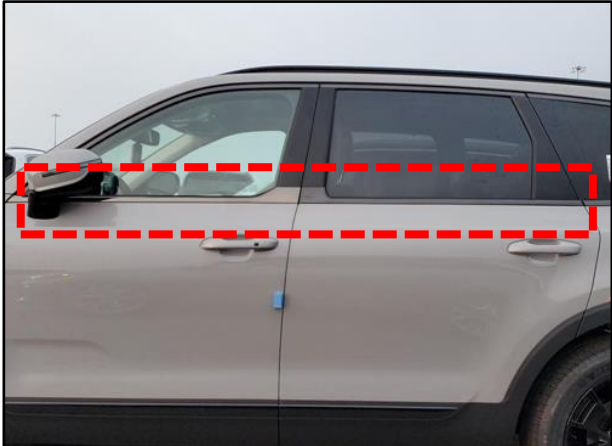
This bulletin provides the procedure to inspect and replace the front door(s) belt line molding on some 2021MY Telluride (ON) vehicles produced from September 14, 2020 through September 18, 2020, which may have had the incorrect color molding installed during assembly and do not match the rear door belt line moldings. To correct this concern, inspect the front door belt line moldings and if necessary, replace with the correct door molding(s). Before conducting the procedure, verify the vehicle is included in the list of affected VINs.

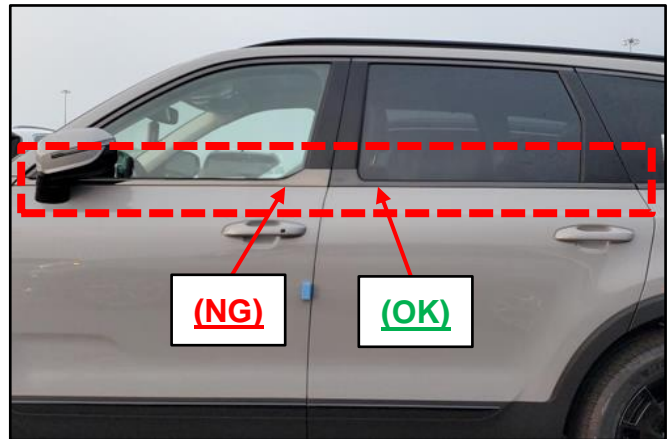
1. Inspect the two (2) front doors, driver (left) and passenger (right) and compare to the rear door moldings.

If the belt line molding(s) match the rear door moldings **(OK)**, then this service action is complete.

If the belt line molding(s) are mismatch from the rear door moldings **(NG)**, proceed to replace the belt line molding(s) by following the 'Replacement Procedure' below.
