Technical product information

Topic	New Continental GT - New Continental GTC and Bentayga Driver/Passenger door power latch creak on close
Market area	Bentley: worldwide (2WBE),Hongkong-Macau (5HK)
Brand	Bentley
Transaction No.	2052394/9
Level	EH
Status	Approval
Release date

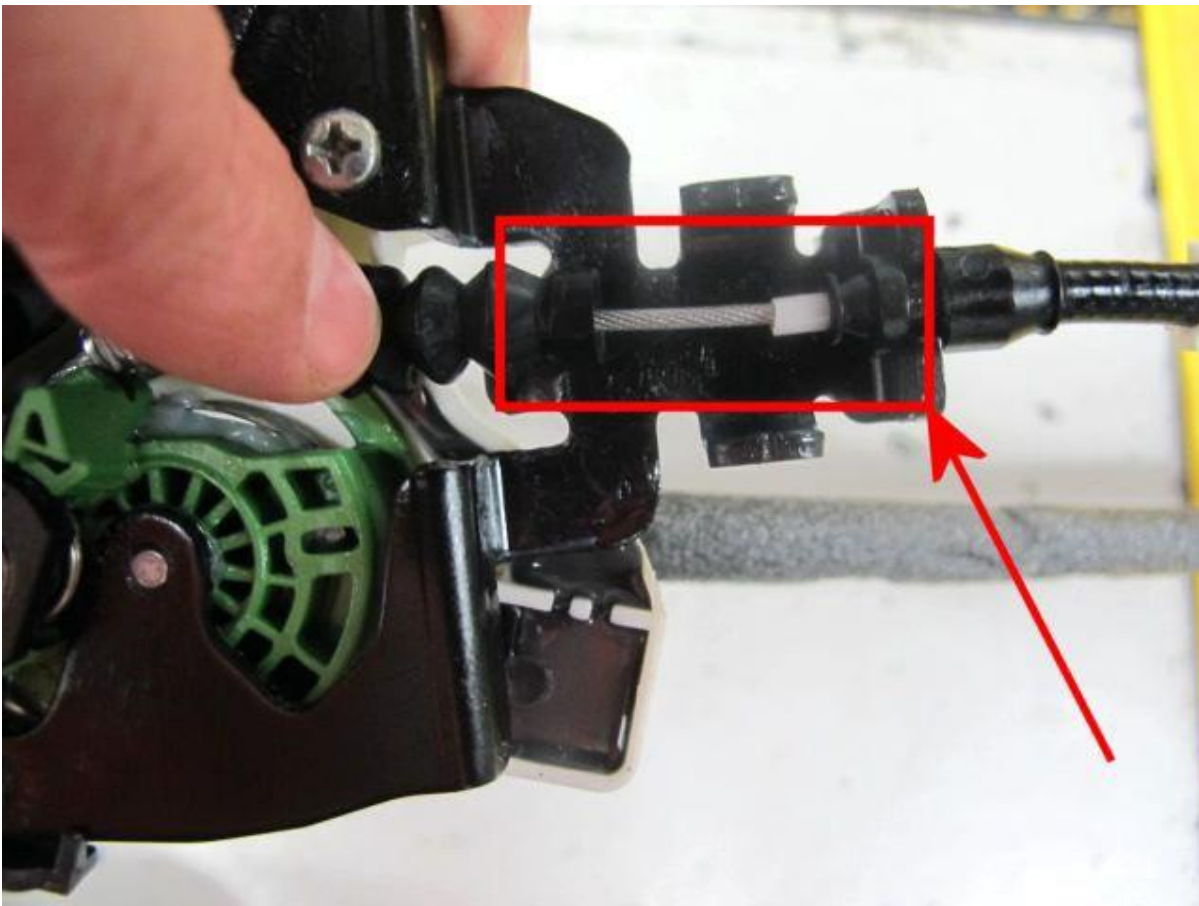
Figure 1

Driver or Passenger door creak during the power latch "Close" function

- 1) Obtain a clear video recording of the issue (save the video as it may be required for analysis)
- 2) Remove the applicable front door trim - Refer to Repair manual Rep.Gr 70
 - Remove the front door inner closing panel -Rep.57
 - Remove the door latch -Rep.Gr57
- 3) Referring to Figure 1, Remove the rubber boot - Apply Dow Corning Molycote 33 extreme - Low temperature bearing grease to the inner cable
 - Refit the rubber boot
