MODEL  
2021MY  
K5 (DL3a)

NUMBER  
216

## TECHNICAL SERVICE BULLETIN

**SERVICE ACTION: MULTIFUNCTION CAMERA (MFC)  
REPLACEMENT (SA442)**

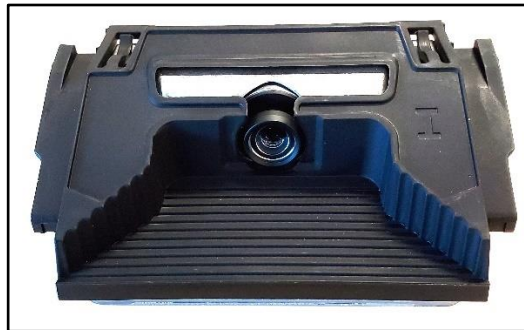
This bulletin provides the procedure to replace the multifunction camera (MFC) on some 2021MY K5 (DL3a) vehicles produced between September 1, 2020 through September 16, 2020 due to an internal control chip concern inside of the camera which may illuminate warning lights in the instrument cluster and/or MIL ON with DTC C160449. Before conducting the procedure, verify the vehicle is included in the list of affected VINs.

**DTC Description: C160449 - ECU Hardware Error**
