MODEL  
2021MY  
K5 (DL3a)

NUMBER  
094

## TECHNICAL SERVICE BULLETIN

**SERVICE ACTION: A/C DISCHARGE HOSE AND  
SUNVISOR CLIP CONFIRMATION (SA441)**

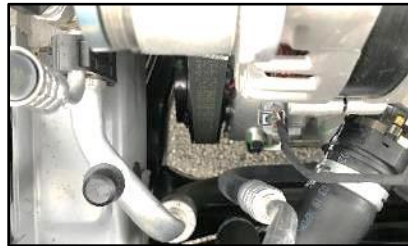
AC Discharge Hose  
Inspection

Item	Description	Inspection/Repair Type
1	A/C Discharge hose	Discharge hose misrouted and/or contacting the compressor pulley
2	Sunvisor Loose	Poor appearance or operation, retaining clip may be loose (missing a screw) or not properly seated at the pivot

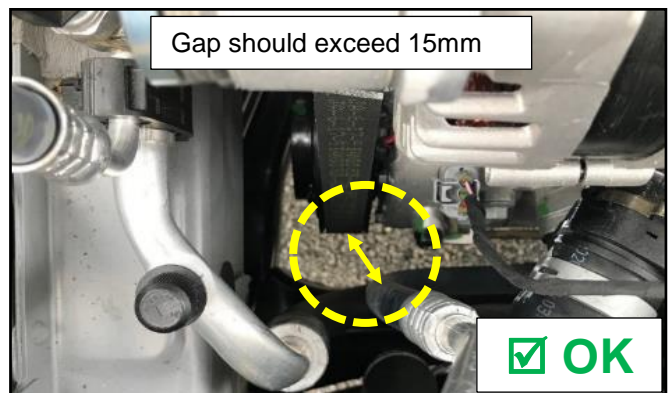
- 2b. Inspect A/C discharge hose for damage and confirm there is sufficient clearance (at least 15mm>) between the compressor pulley (D) and the discharge hose (E).

- 2c. If the clearance is not a minimum of 15mm proceed to Step 3.

**If damage is present, replace A/C discharge hose by referring to the “Heating, Ventilation, and Air Conditioning → Air Conditioning System → Refrigerant Line → Repair procedures” chapter in the applicable Shop Manual on KGIS.**

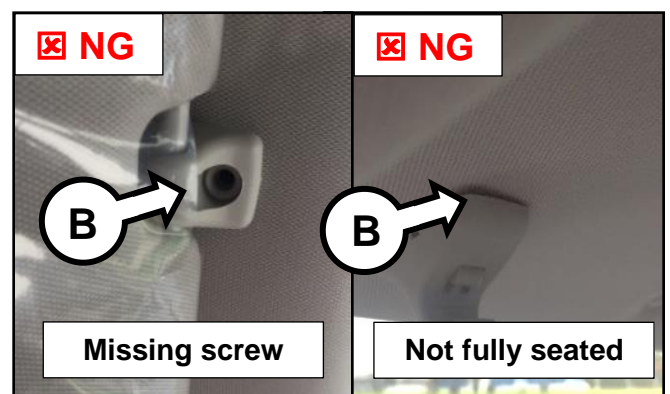
- 2a. Open and extend the sunvisor(s) and inspect the sunvisor retainer clip (B) for poor seating against the headliner.

- 2b. If the retainer clip is not seated correctly, re-install the retainer (B) to the headliner.

If the retainer clip is missing the retaining screw, install the missing screw using P/N: 85289 3V000.

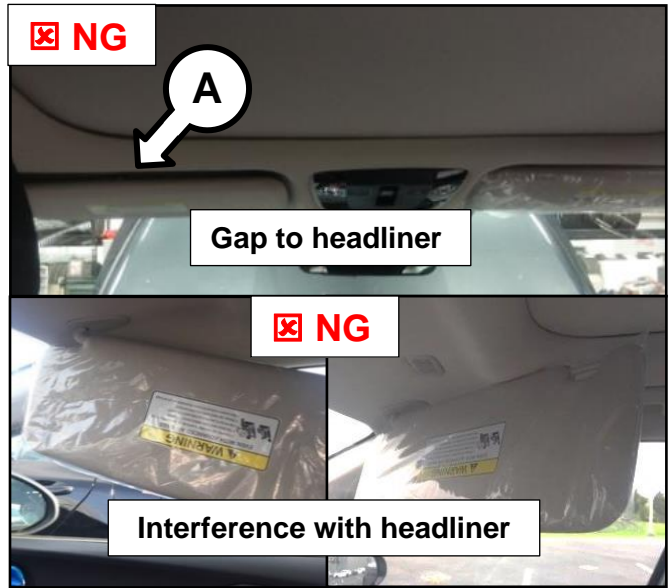
- 2c. Inspect the condition of the sunvisor (A) seated to the headliner. The following conditions may occur if not seated correctly to the headliner:
1. Sunvisor will not fold up all of the way.
  2. Sunvisor feels loose at the base when opening and closing the sunvisor.
  3. Sunvisor does not sit horizontal from the base when unclipped from the retainer.
