Release Date	10/27/2020	Technical Service Bulletin	
90Q1 UPDATE

Audi
Instrument Cluster Software Update – (NVLW)

Applicable Vehicles				
Country	Beginning Model Year	Ending Model Year	Vehicle	Vehicle Count
USA	2021	2021	Q5	7,997
CAN	2021	2021	Q5	999

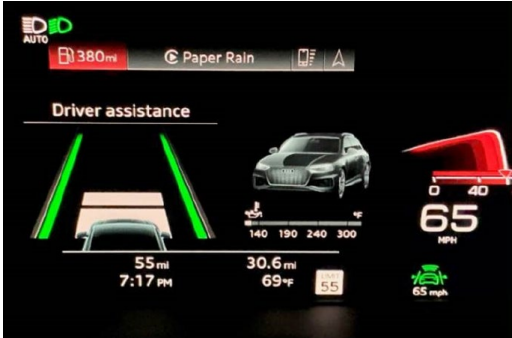
This Update has been proactively released to prevent the following condition(s) from occurring in the vehicle:	
Criteria	Technical Background
FY	<p>The vehicle image displayed on the driver information system tab of the instrument cluster is an A4 Avant instead of a Q5.</p>

Criteria	Remedy
FY	Update instrument cluster software
