Technical Service Bulletin

Subject: DTC U2050:55 STORED AFTER REPLACING OR REPROGRAMMING TCU	Bulletin No.: 09-013/20
	Last Issued: 10/06/2020

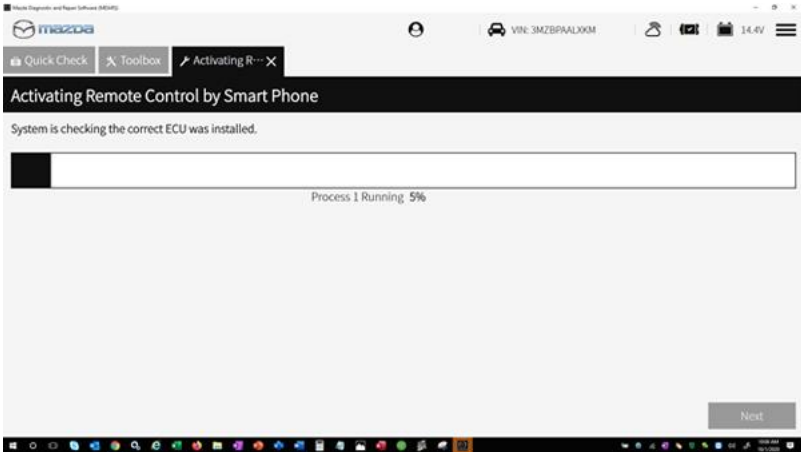
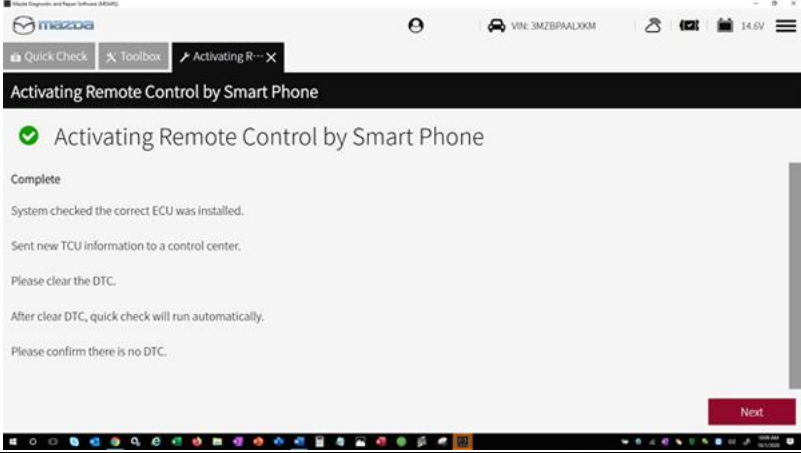
1. If TCU is not being replaced, ignore "Complete installation of new TCU" (a).
2. Battery voltage must be 14-14.5V (b). (see SA-063/20)

3c. Follow the on-screen instructions.
