2020-2021MY
Telluride (ON)

213

TECHNICAL SERVICE BULLETIN

SVM/AVM CAMERA DISPLAY IMAGE QUALITY

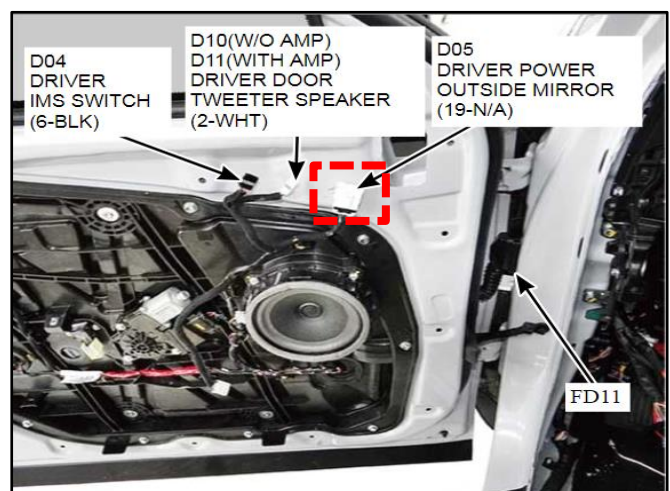
4. **Driver side door:** Locate the **D05** connector in the upper right side of the doorframe. (Refer to image)

Passenger side door: Locate **D25** in the upper left side of the doorframe.

Disconnect the connector and use the mirror side of the connection when completing the next few steps.

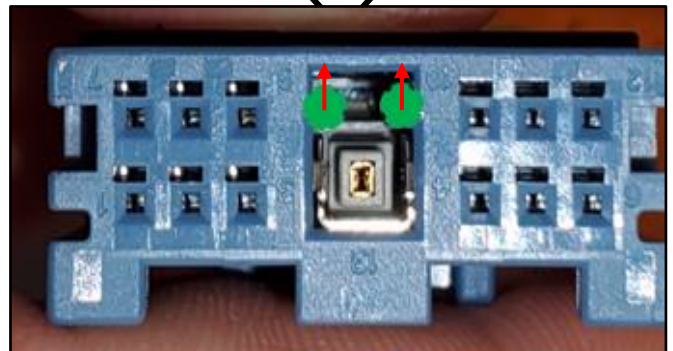
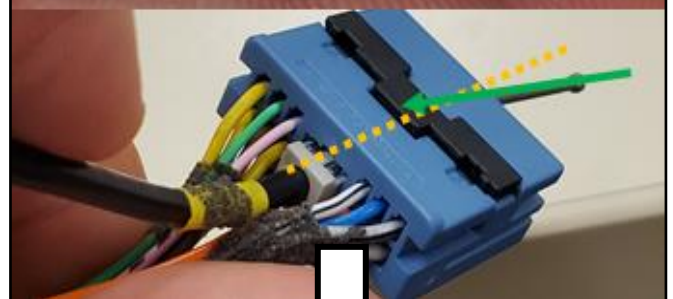
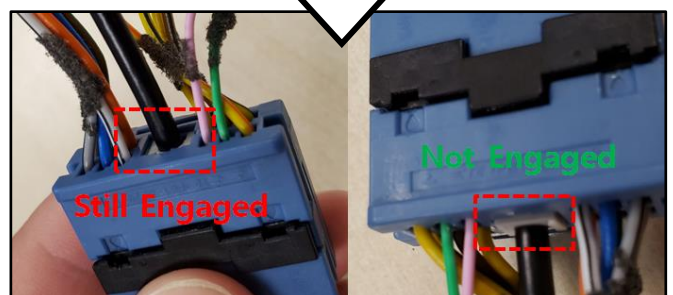
- 7a. Inspect the coaxial connector.

Note: The walls need to align parallel and evenly spaced.

Adjustment of 0.10~0.15 mm is recommended. To gauge proper adjustment, there will be a noticeable improvement in connection tension when mating male and female coaxial connections after adjustment is made.

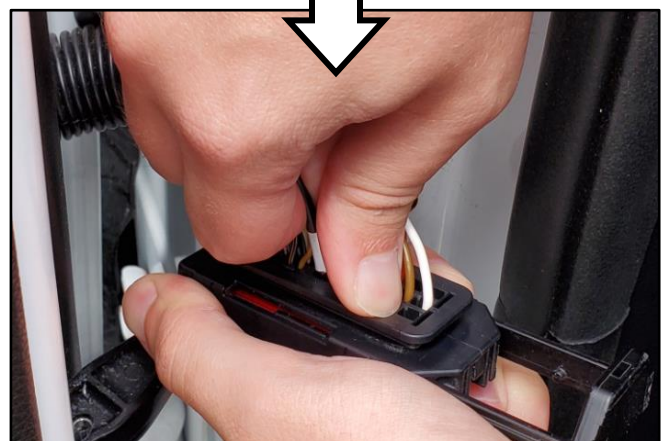
13. Inspect the coaxial connector.

Note: The walls need to align parallel and evenly spaced.

Adjustment of 0.10~0.15 mm is recommended. To gauge proper adjustment, there will be a noticeable improvement in connection tension when mating male and female coaxial connections after adjustment is made.
