## Technical product information

<b>Topic</b>	Vibration noise from the powertrain when park or neutral is selected
<b>Market area</b>	Bentley: worldwide (2WBE),Hongkong-Macau (5HK)
<b>Brand</b>	Bentley
<b>Transaction No.</b>	2053428/4
<b>Level</b>	EH
<b>Status</b>	Released for publishing
<b>Release date</b>	29-Oct-2020

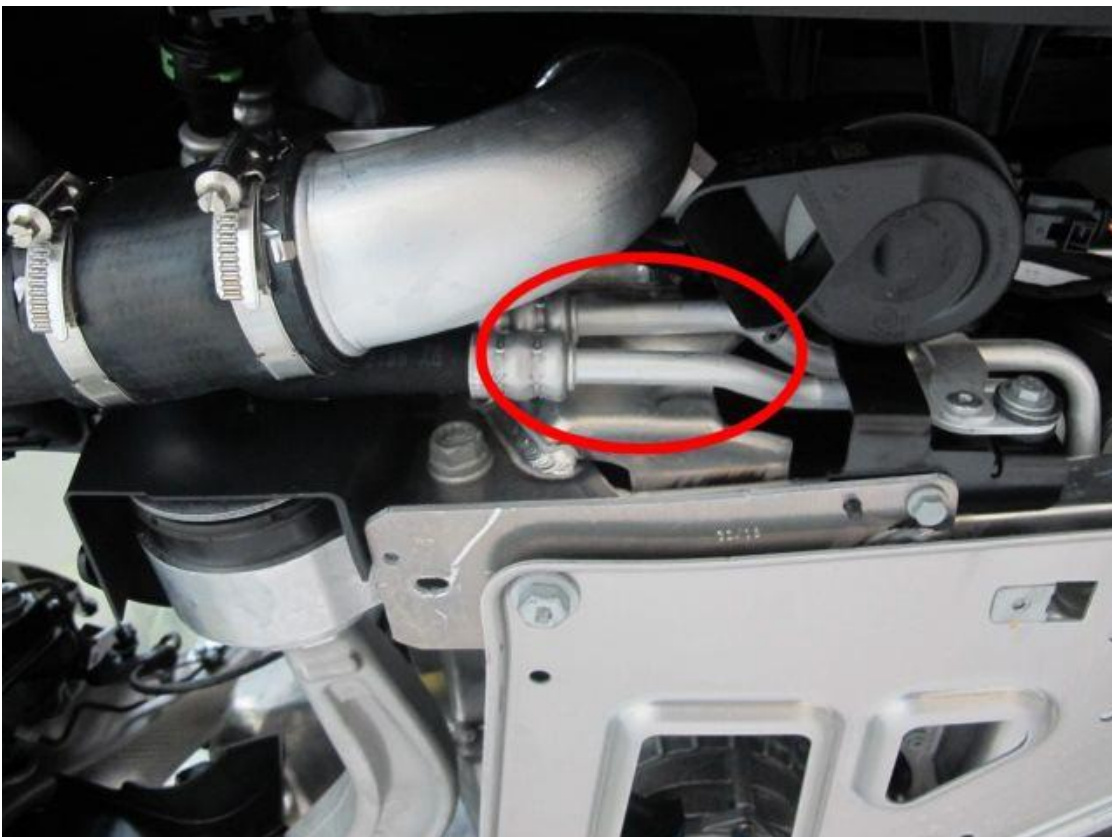
The noise is caused by contact between the transmission cooler pipes and the front subframe

- 1) Referring to Repair manual Rep.Gr 66 – Remove the front undersheet
- 2) Referring to Figure 1 - Locate the area (circled) at the front right hand side of the front subframe

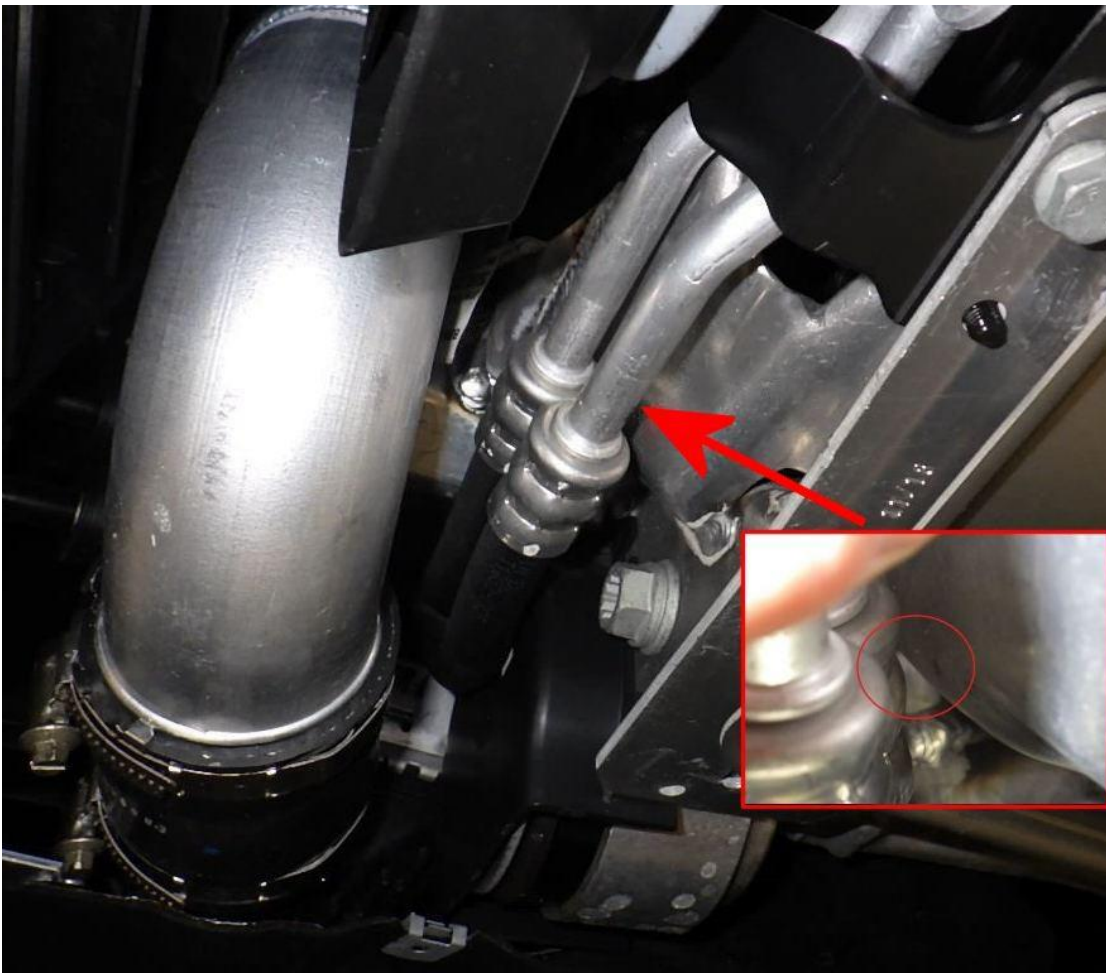
Figure 2

- Referring to Figure 2, Carry out a visual check of the transmission pipes to confirm the pipes are contacting the front subframe at the location shown

3) Should contact be confirmed – Taking care not to damage the pipes or securing points/brackets reposition the pipes ensuring clearance is maintained between the pipes and the subframe
