Technical product information

Topic	Rotating screen alignment
Market area	Bentley: worldwide (2WBE),Hongkong-Macau (5HK)
Brand	Bentley
Transaction No.	2051526/5
Level	EH
Status	Released for publishing
Release date	21-Oct-2020

New Continental GT - New Continental GTC and New Flying Spur

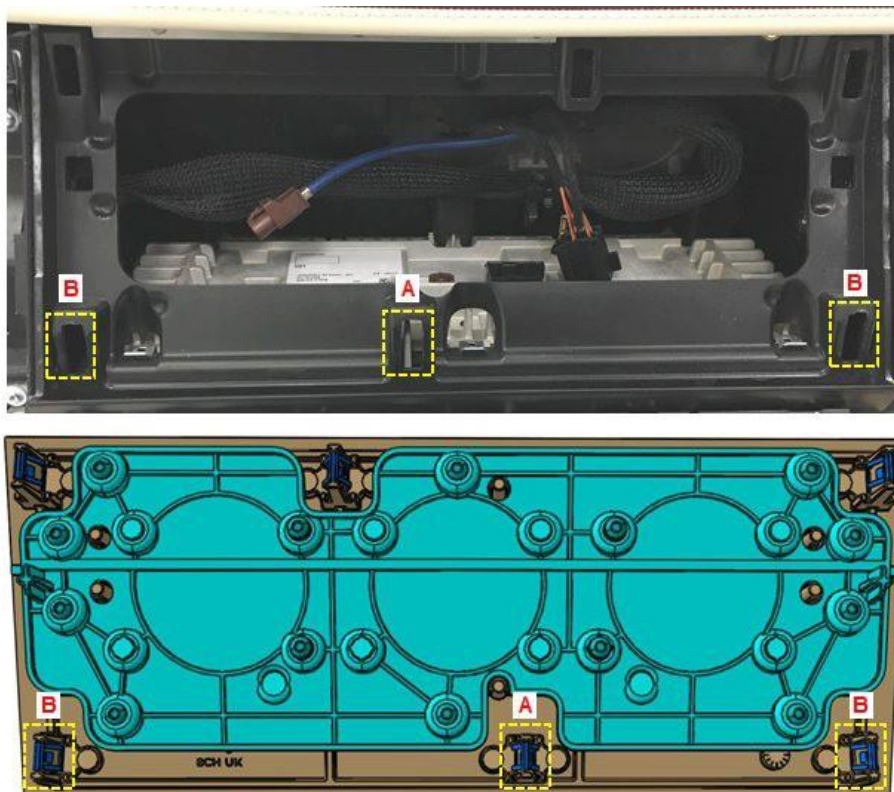
Figure 1

The veneer face fascia panel is fixed to the “BRD” by six locator pins and receiving holes. See Figure 1.

The following locator pins (A & B) control the position of the fascia panel as follows:

A = Side to side axis

B = Up and down axis

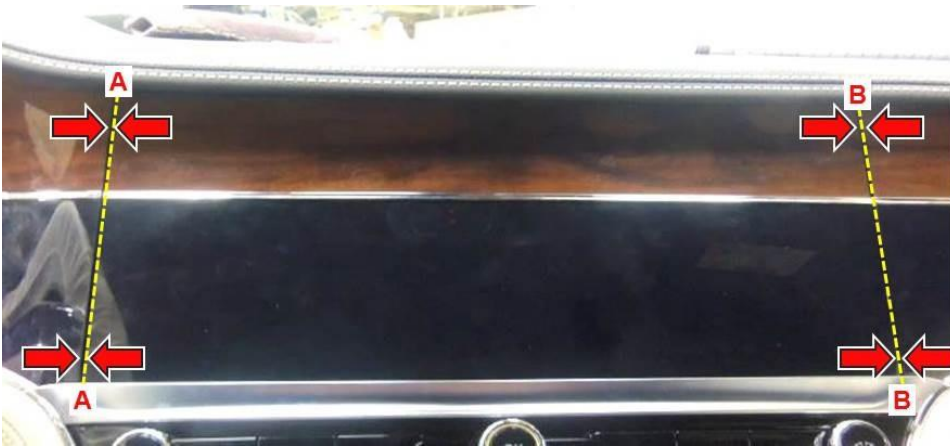
Figure 2

Measure the gaps (A & B) between the veneer face fascia panel and the passenger and drivers side fascia panels. See Figure 2.

The specified gapping is 1.5mm +/- 0.5mm tolerance. The gap between the "BRD" veneer face fascia panel and passenger and drivers side fascia panels **MUST** be parallel on both sides.

If the gaps are not within the specified values then adjust as follows.

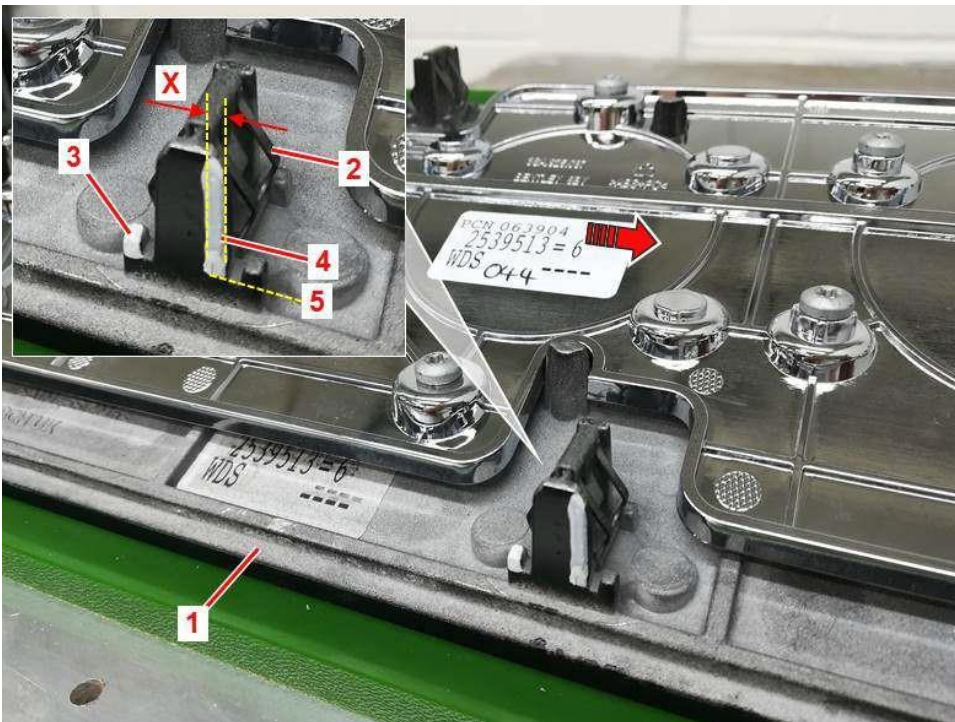
Figure 3

i Only the centre lowermost locator pin shown governs the side to side movement of the fascia panel. Only this locator pin will require modifying.

Place the veneer face fascia panel (1) face down on a soft, clean and protective work surface and mark accordingly the direction in which the panel needs to move (arrow). See Figure 3.

Remove the spring retaining clip (2) from the lowermost locator pin. If the fascia panel requires moving by 0.5mm then remove the same amount of material (X) from the appropriate side of the lower centre locator pin (4) as shown on the aluminium substrate casting. In addition, file the trailing RPS point (3) flat, level with the recess. See Figure 3.

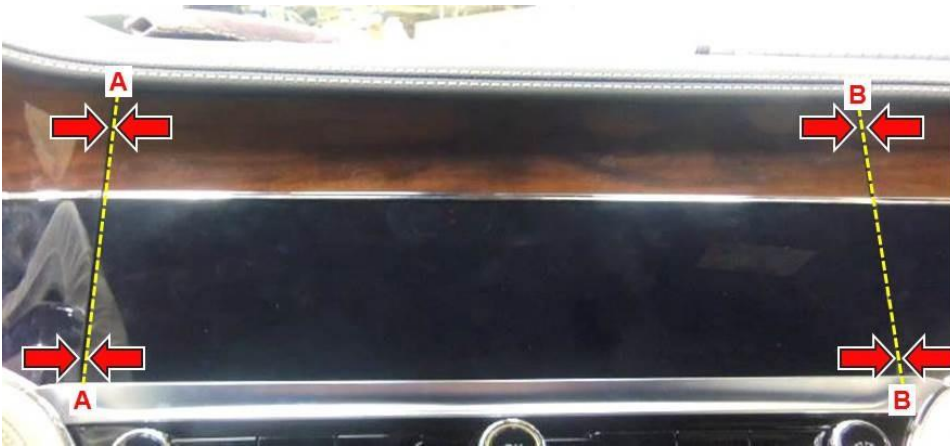
Figure 6

Again measure the gaps (A & B) between the veneer face fascia panel and the passenger and drivers side fascia panels. See Figure 6.

The correct gapping is 1.5mm +/- 0.5mm tolerance. The gap between the veneer face fascia panel and passenger and drivers side fascia panels MUST be parallel on both sides.

If the gaps are not within the specified values then add/remove anti-creak tape to adjust accordingly.

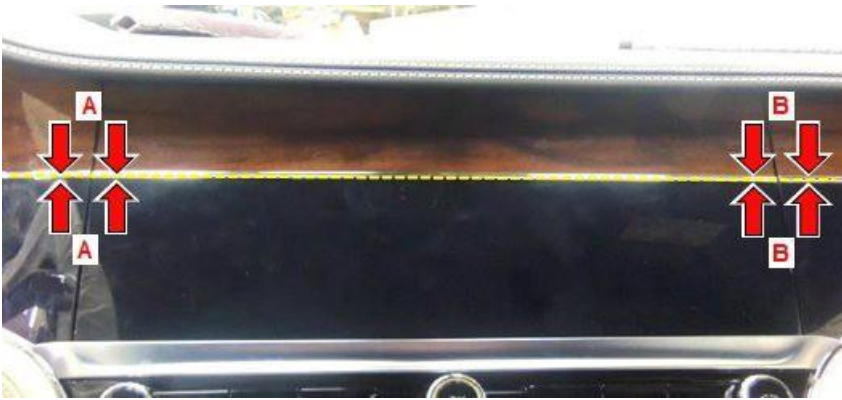
Figure 7

Visually check that the chrome brightware strip on the "veneer face" fascia panel is aligned with the chrome strips at points A & B on the passenger and drivers side fascia panels. See Figure 7.

The specified tolerance in the vertical plane (A & B) is 0.5mm.

If the chrome brightware strip on the "veneer face" fascia panel is out of line, carry out the following to adjust the panel.

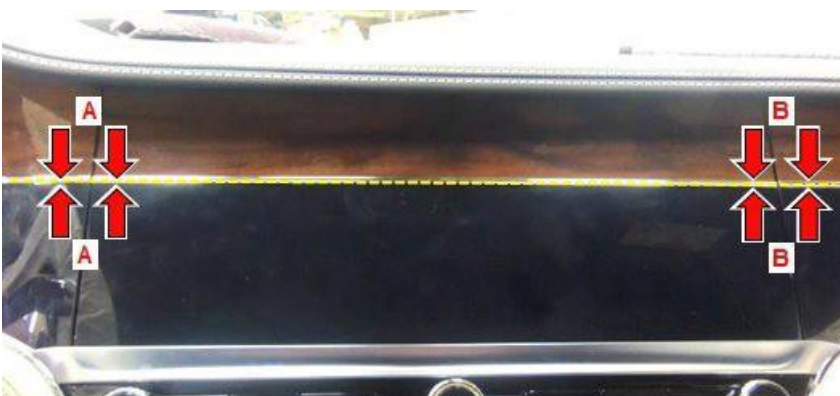
Figure 10

Visually check that the chrome brightware strip on the "veneer face" fascia panel is aligned with the chrome strips at points A & B on the passenger and drivers side fascia panels. See Figure 10.

The tolerance in the vertical plane (A & B) is 0.5mm.

If the chrome brightware strip on the “vener face” fascia panel is still out of line, and is not within the specified tolerance then add/remove anti-creak tape to adjust accordingly.

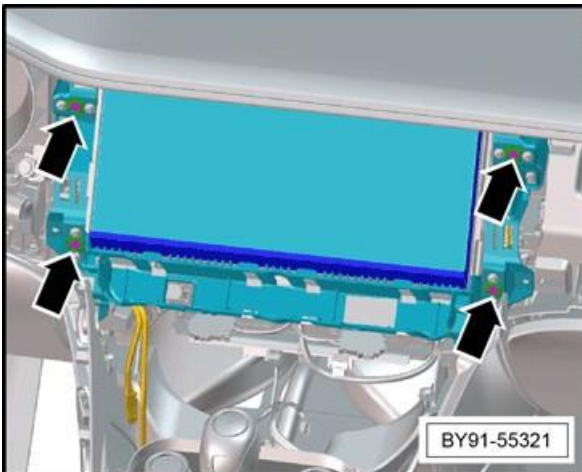
Figure 11

Under no circumstances should any attempt be made to adjust the “BRD” module inboard or outboard by adjusting any of the four setting screws (arrows) shown in Figure 11.

The setting screws (arrows) are factory sealed and any attempt to make adjustments via these four screws may result in failure of the rotating display and/or information display touch screen.

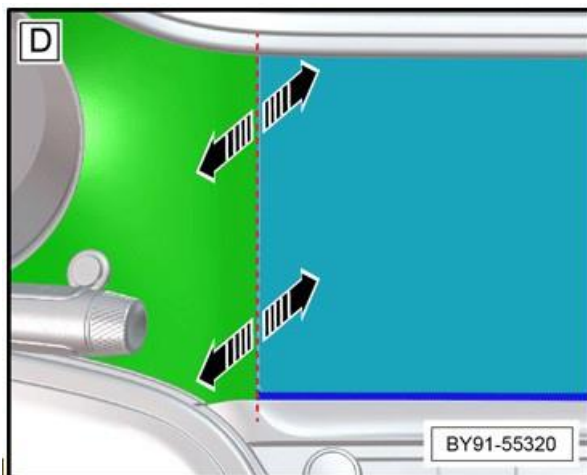
Measure the profile (D) between the “BRD” veneer face fascia panel and the passenger and drivers side fascia panels. See Figure 12

The specified setting dimension for the “BRD” fascia panel is -0.5mm (under flush) +/- 0.5mm tolerance and MUST be equal on both sides.

If either of the passenger and drivers side fascia panels are out of tolerance and require adjustment, make a note of which point requires adjustment and by how much on each panel.

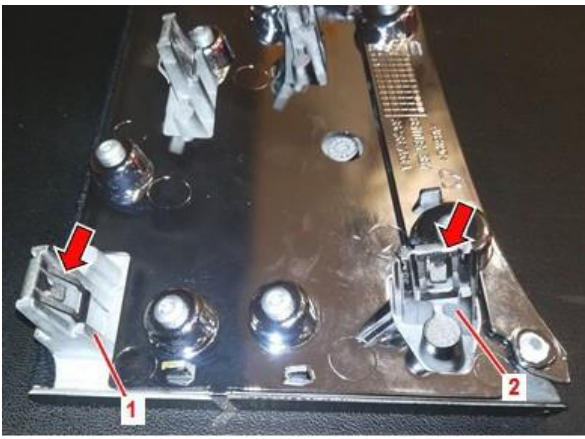
Figure 13

i Note. The locator pin (1) is for adjustment the top of the fascia panel and locator pin (2) is for adjusting the bottom of the fascia panel. All other locator pins are not affected.

With the fascia panel face down on a soft, clean and protective work surface, remove the appropriate spring clip(s) (arrow) as required. See Figure 13.

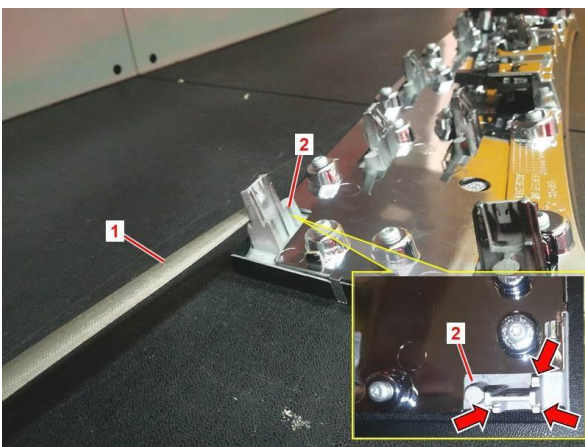
Figure 14

i Note. The upper locator pin (2) has three "RPS" points (arrows) whereas the lower locator pin only has two "RPS" points.

Carefully file the "RPS" points (arrows) by the required amount that the fascia panel needs to move in.

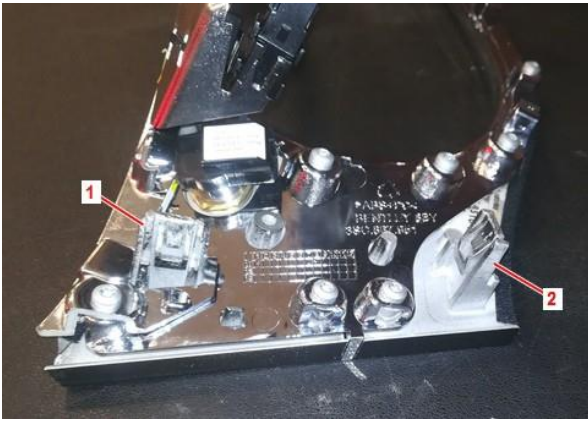
Figure 16

i Note. The locator pin (1) is for adjusting the bottom of the fascia panel and locator pin (2) is for adjusting the top of the fascia panel. All other locator pins are not affected. See Figure 16.

With the fascia panel face down on a soft, clean and protective work surface, remove the appropriate spring clip/s from the locator pin.

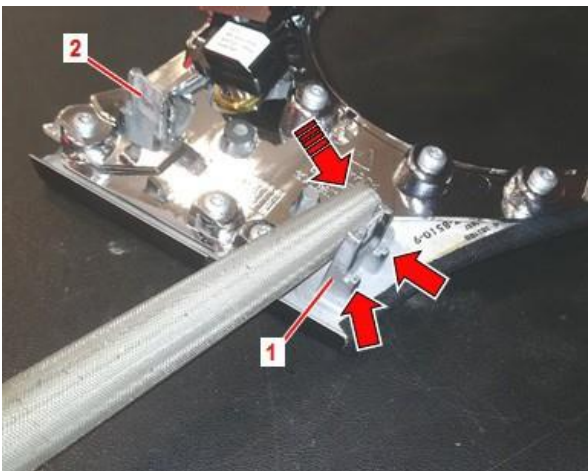
i Note. The upper locator pin (1) has three “RPS” points (arrows) whereas the lower locator pin (2) only has two “RPS” points.

Carefully file the “RPS” points (arrows) by the required amount that the fascia panel needs to move in. See Figure 17
