LTB00761NAS2

TECHNICAL BULLETIN

Hood Finisher Paint / Lacquer Flaking

MODEL:	MODEL YEAR:	VIN:	ASSEMBLY PLANT:
Range Rover (LG)	2013-2016	000001-244690	Solihull

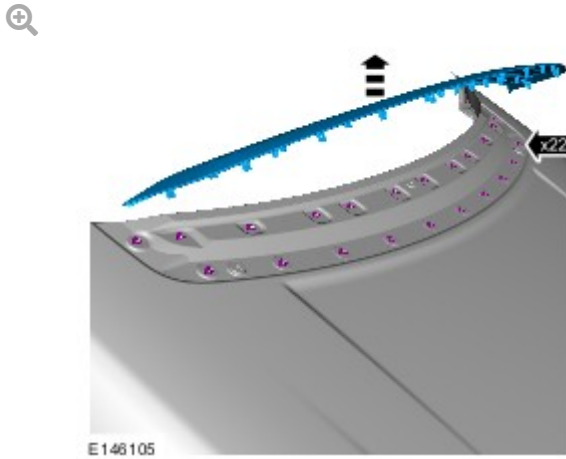
1.

The hood finisher may show signs of the paint and/or lacquer 'flaking'.

This may be caused by poor paint adherence between the base coat and clear lacquer.

Use a suitable tool to remove the hood finisher.
